Spirit of St Louis Replica (Ryan M1/M2 NYP), ES-XCL

AAIB Bulletin No: 1/2004	Ref: EW/C2003/05/05	Category: 1.3
Aircraft Type and Registration:	Spirit of St Louis Replica (Ryan M1/M2 NYP), ES-XCL	
No & Type of Engines:	1 Continental W670-6A piston engine	
Year of Manufacture:	1997	
Date & Time (UTC):	31 May 2003 at 1650 hrs	
Location:	Coventry Airfield, West Midlands	
Type of Flight:	Private	
Persons on Board:	Crew - 1	Passengers - None
Injuries:	Crew - 1 (Fatal)	Passengers - N/A
Nature of Damage:	Aircraft destroyed	
Commander's Licence:	Air Transport Pilot's Licence	
Commander's Age:	59 years	
Commander's Flying Experience:	21,200 hours (of which 190 were on type)	
	Last 90 days - 89 hours	
	Last 28 days - 18 hours	
Information Source:	AAIB Field Investigation

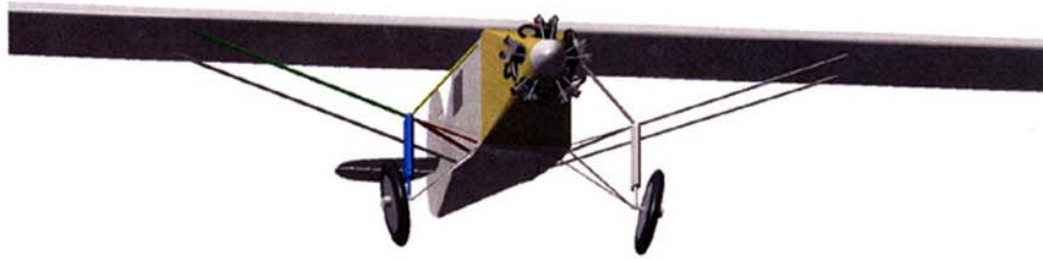
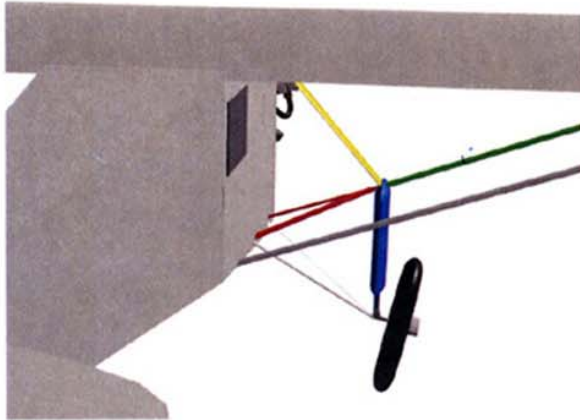
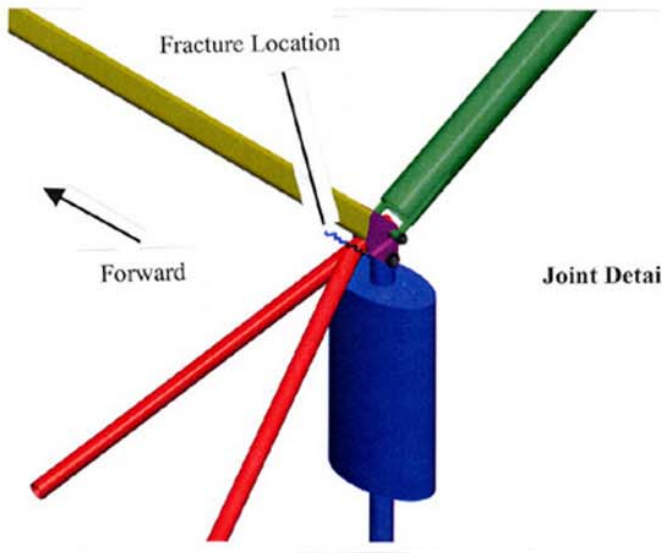
Figure 1: Landing Gear and Wing Strut Support Structure

A tubular steel wishbone strut, mounted from the lower edge of the fuselage and braced to the upper edge, locates and supports both the upper end of the right landing gear shock-strut and the lower end of the forward right wing strut, Figure 1. The wishbone comprises a main strut (the forward leg of the wishbone) of 1.25" outside diameter (OD) steel tube and 0.0625" wall thickness, and a diagonal bracing strut (the rear leg) of 1.0625" OD steel tube and 0.0625" wall thickness. These are welded together at their apex, but the forward leg extends outboard slightly beyond the apex joint, where it is welded to the bracing tube connecting to the top of the fuselage frame. This joint is stiffened and braced by a pair of steel 'fish-plates' welded on either side of the wishbone strut main tube and the fuselage bracing tube, and this also forms, in effect, a pair of locating sockets for the top of the landing gear strut and bottom of the wing lift strut.

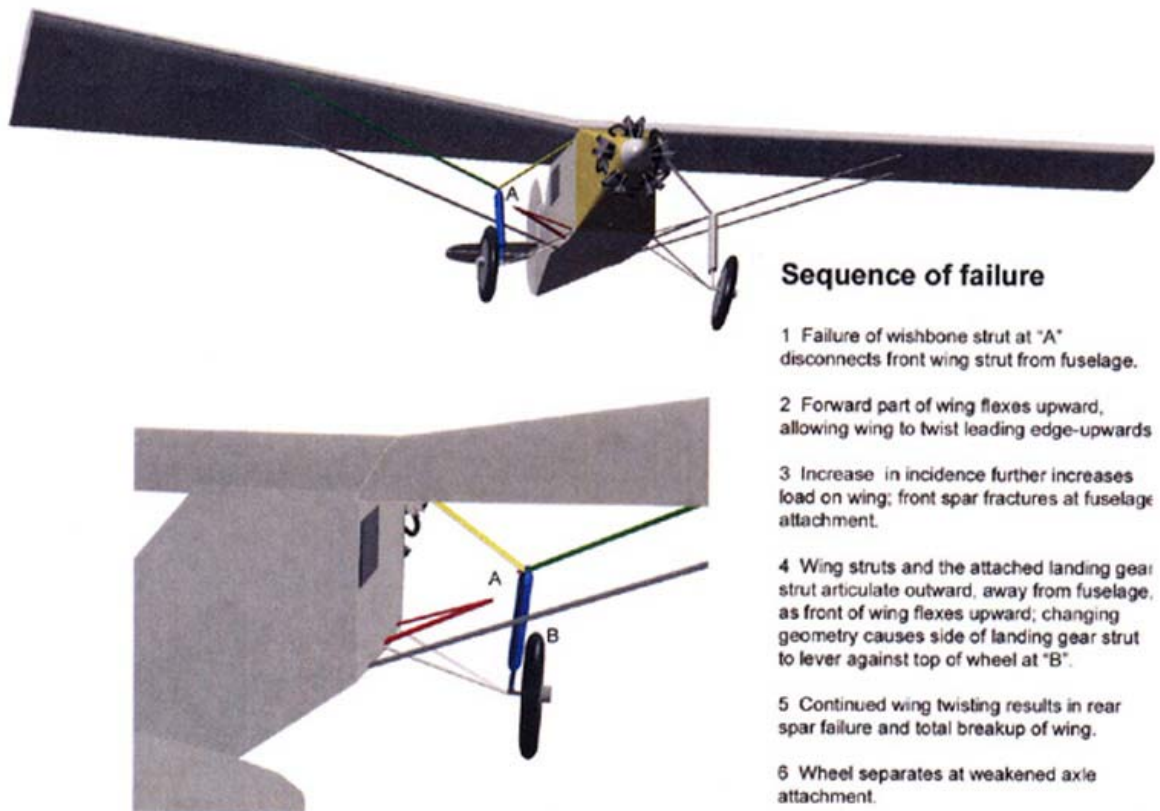
Figure 2: Sequence of failure

A detailed examination of the wreckage, in situ, quickly established that the outboard end of the tubular wishbone strut had failed in flight as a result of a fatigue crack. Initial examination revealed that the crack extended through approximately 90% of the cross-section area and that surface corrosion was evident over much of the fatigue crack fracture surface. The final 10% of the fracture surface, which exhibited characteristics consistent with a tensile overload mode of failure, was clean. The geometry of the external bracing struts on the 'Spirit of St Louis' design is such that the fatigue failure of the wishbone strut would effectively dislocate the lower end of the right wing forward lift strut, which supports the right wing front spar. This would allow the lower end of the lift strut, together with the top end of the right landing gear shock strut, to articulate upward and outward. The expected outcome would be the immediate overload failure of the front spar at its root end, ie, the point of maximum bending moment, followed immediately by break-up of the remaining inboard wing structure. The inboard part of the rear spar would also be expected to fail due to the consequent upward and rearward twisting of the wing, Figure 2.

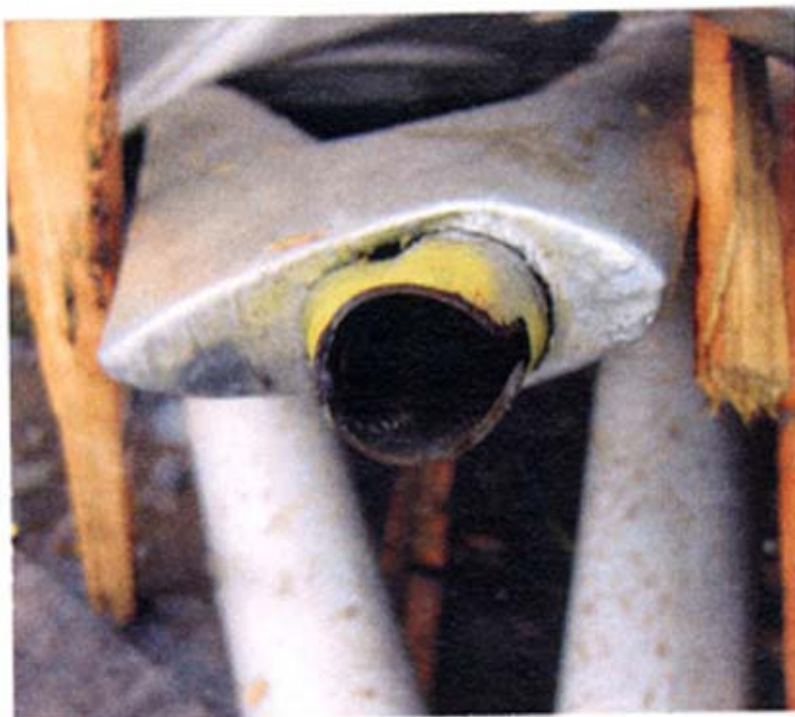
Figure 3: Fractured end of right wishbone strut

Inspection of the fracture surface using a hand lens suggested that the fatigue crack originated in a region of weld forming part of a joint, connecting the two tubes of the strut at its apex. It was also noted that the part of the strut containing this welded joint which lay beyond the outer ends of the aerofoil shaped fairings covering the two strut members and was thus fully exposed, had been oversprayed with a yellow 'chromate primer' type of paint. This paint was of a different colour to the paint used elsewhere on the tubular framework of the aircraft and had evidently been applied after the aircraft had been built, Figure 3.

View on fractured end of right wishbone strut showing evidence of 'fresh' chromate primer type paint around weld area

The external appearance of the weld local to the fracture initiation was out of character with the remainder of the tube-to-tube weld, which indicated that re-welding of this area had been carried out after initial manufacture. Microsections through this region confirmed that capping deposits were present and that high temperatures had been achieved, producing large grain sizes in the microstructure at the surface. However, grain refinement had occurred in what appeared to be the original burnt-through weld deposit, and the alignment of this deposit appeared to be poor relative to the tube being attached. The sections showed the presence of oxide films which reduced the effective material thickness, locally, to about 76% of the original tube.

In summary, the area of re-welding in which the fatigue crack had originated was of poor quality, and this was probably exacerbated by inadequate preparation. In contrast, based on the limited samples examined, the overall quality of the original welding of the wishbone strut (and by implication of the tubular fuselage structure generally) appeared to have been high.

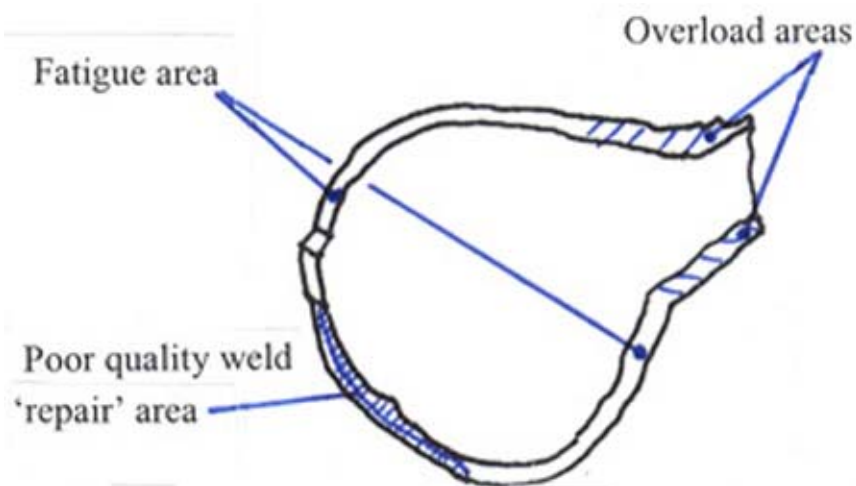
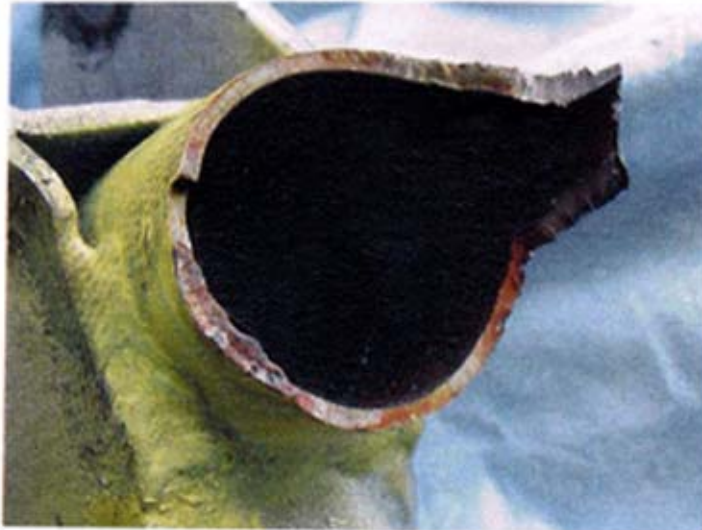
Figure 4: Detail of fatigue crack / overload fracture surface

The fatigue crack had originated at the apex of a weld in the wishbone, at the joint between the two legs of the wishbone and evidence was found of multiple fatigue initiations at the mid-wall of the tube, inboard of the toe of the weld. The weld metal behind these multiple initiations contained a large number of slag inclusions, porosity due to shrinkage and gas inclusion, and oxide films, the presence of which would have seriously reduced the load bearing capacity of this part of the tube and provided potent stress concentrating features.

The fatigue crack, Figure 4, had propagated initially in a radial direction, towards the outer surface of the tube and across the width of the welded region. Thereafter, two crack fronts had continued to propagate independently of one another, each by a fatigue mechanism, traveling circumferentially around the tube wall for about 75% of the circumference, in a plane normal to the tube axis. At this point, the fractures turned and grew longitudinally until final overload failure occurred through the remaining approximate 10% of the section, at 45° to the tube axis in both planes.

The fatigue fracture was characterised by beach marks, with intervening bands of fine striations having a spacing which was often of less than one micron. The numbers of beach marks in the various regions of the fracture were estimated using optical microscopy, and the following results obtained:
