Appendices

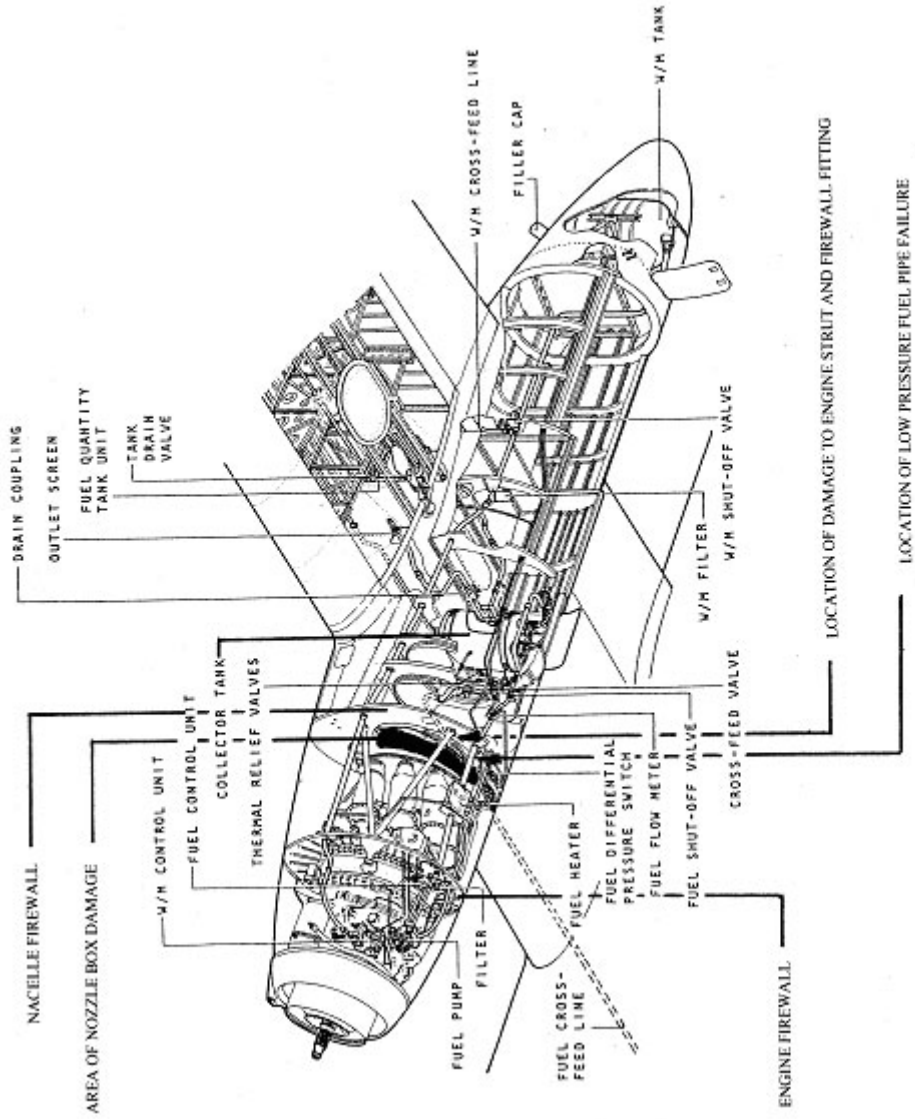
Figure 2 Location of damage to left engine

LOCATION OF DAMAGE TO LEFT ENGINE

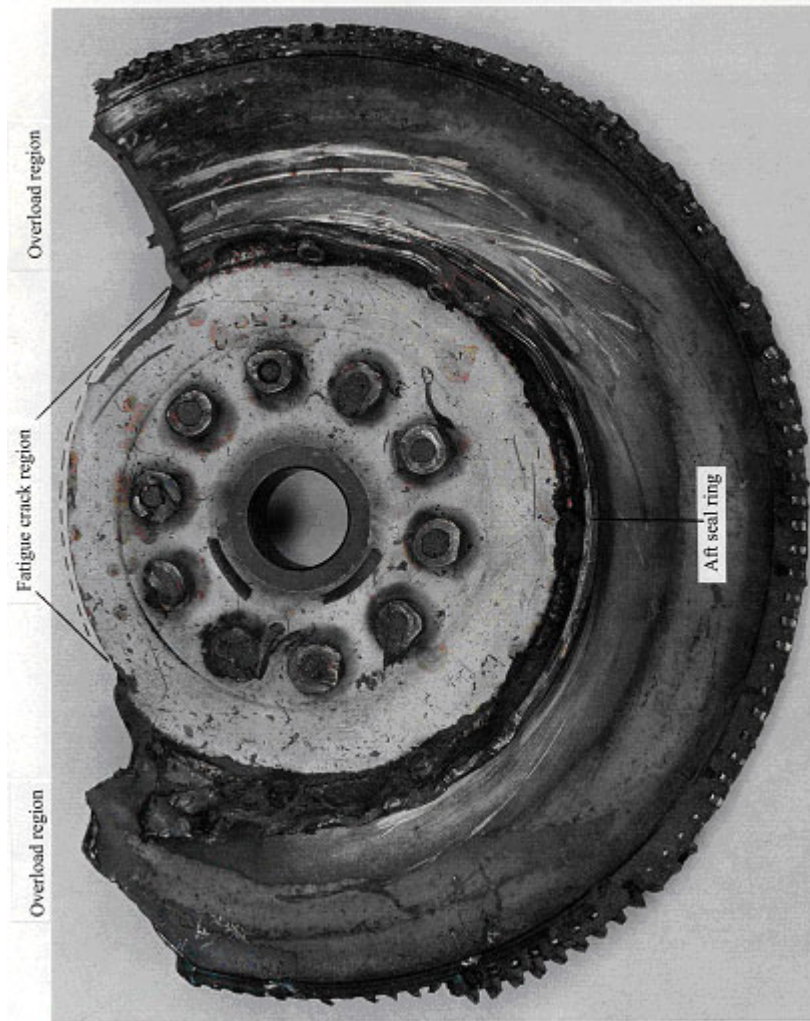
Figure 7 Major segment of HPT disc

MAJOR SEGMENT OF HPT DISC (view on rear face)

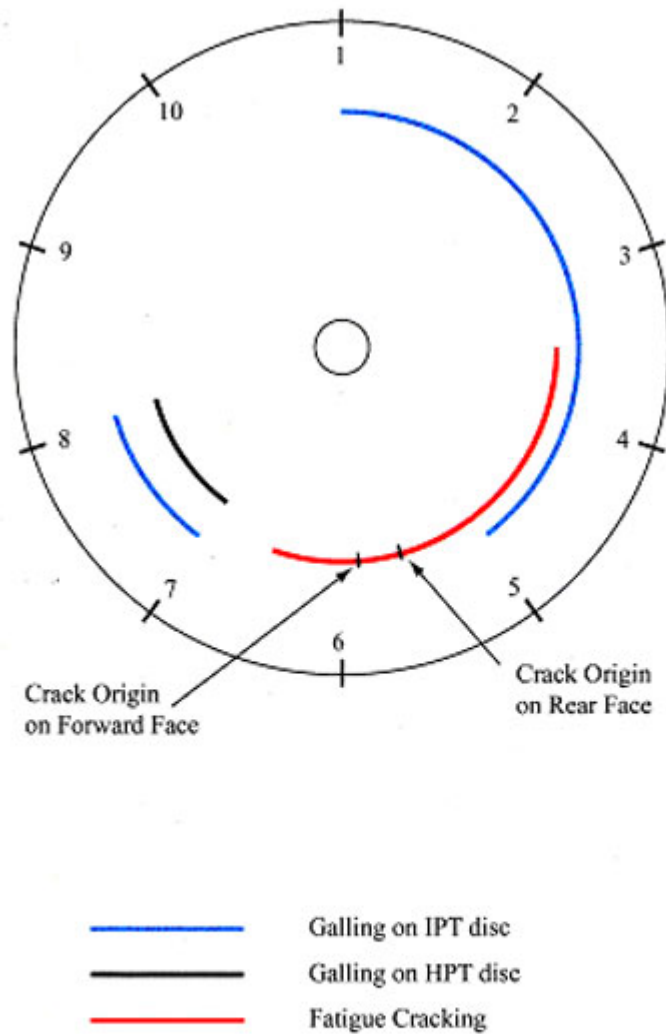
Figure 12 Relative damage locations HPT / IPT seal arm abutment faces / Fatigue Cracking

Relative Damage locations HPT / IPT seal arm abutment faces / Fatigue cracking
