Aircraft Type and Registration: Piper PA-28-161 Cherokee Warrior II, G-BSGL

Date & Time (UTC): 16 December 1992 at 1305 hrs

Location: Near Liverpool Airport, Merseyside

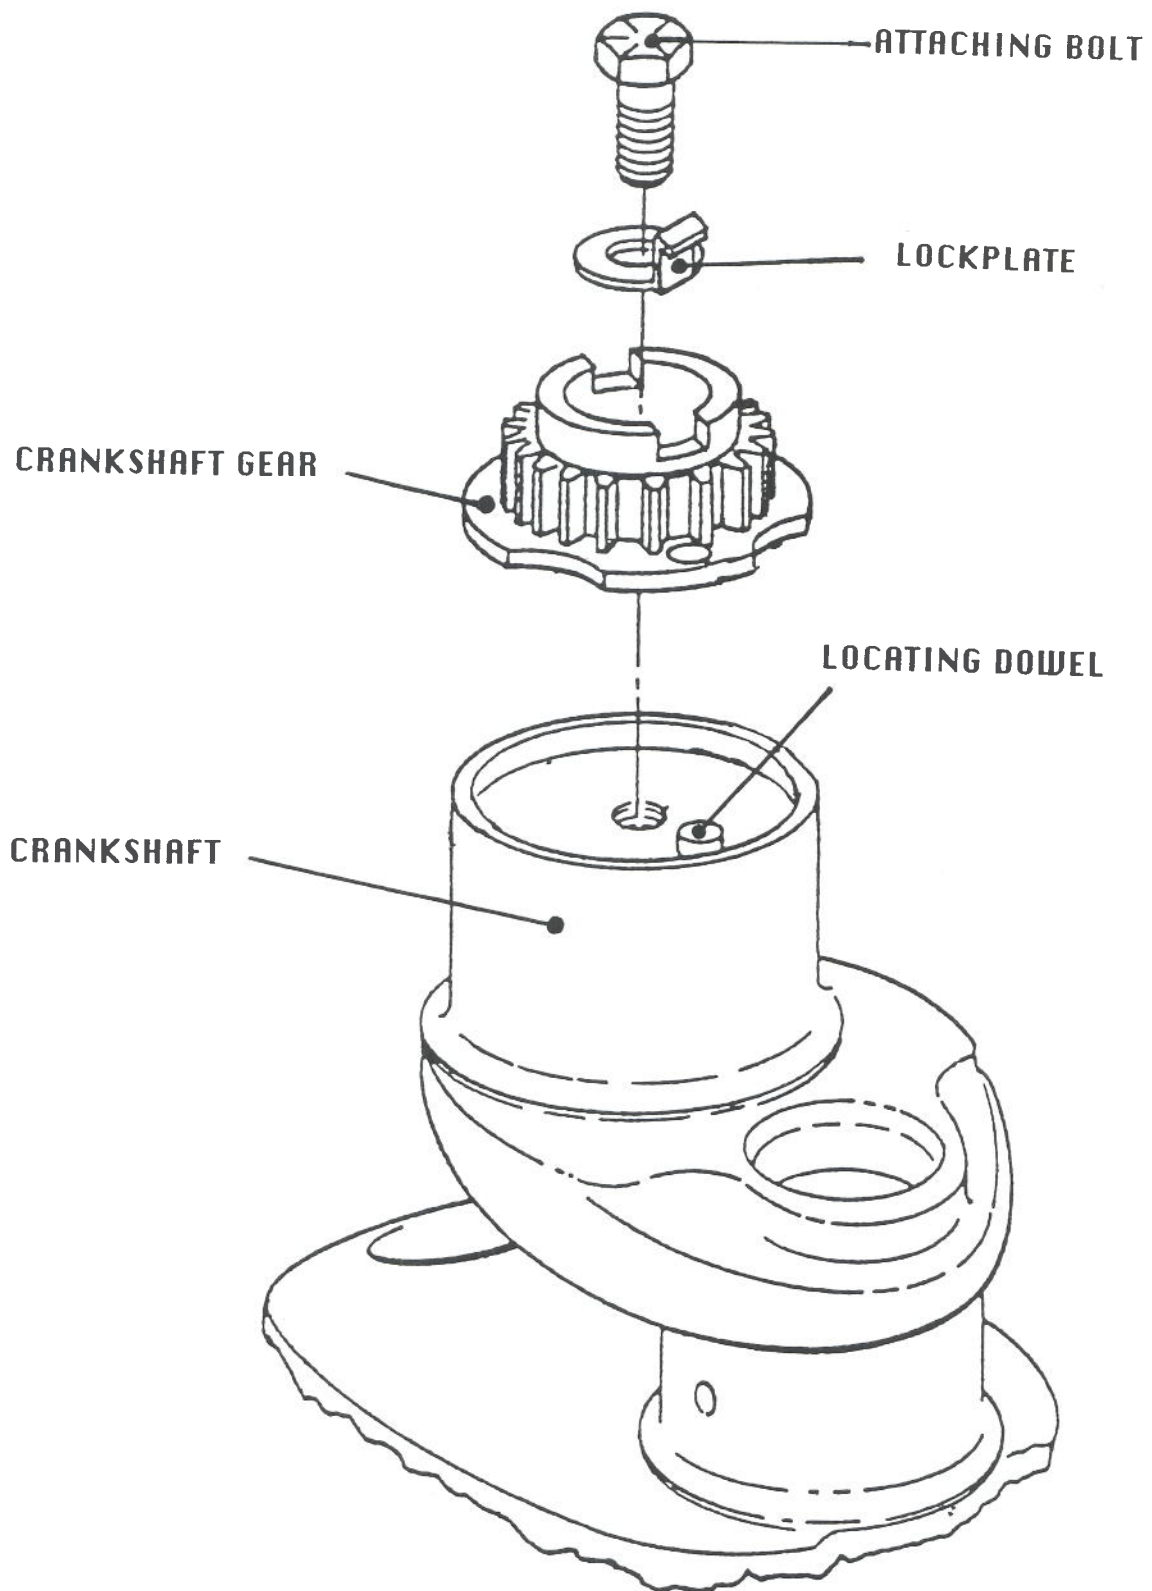
Subsequent strip examination of the engine revealed that the crankshaft gear (*ie* the gear wheel that was attached to the end of the crankshaft to provide the drive to the engine accessory gearbox) had become loose. The crankshaft gear attaching bolt was still in place and correctly locked by its lockplate, but no check torque was made when it was removed. These parts are shown in the diagram at Fig. 1. After removal of the crankshaft gear, it was found that the associated locating dowel had failed (Fig 2) and that the crankshaft and crankshaft gear mating faces displayed evidence of fretting. Examination of the locating dowel fracture showed the dowel to have failed in double fatigue, which had initiated from surface areas which displayed evidence of heavy fretting.

FIGURE 1. REAR END VIEW OF CRANKSHAFT SHOWING ASSOCIATED PARTS

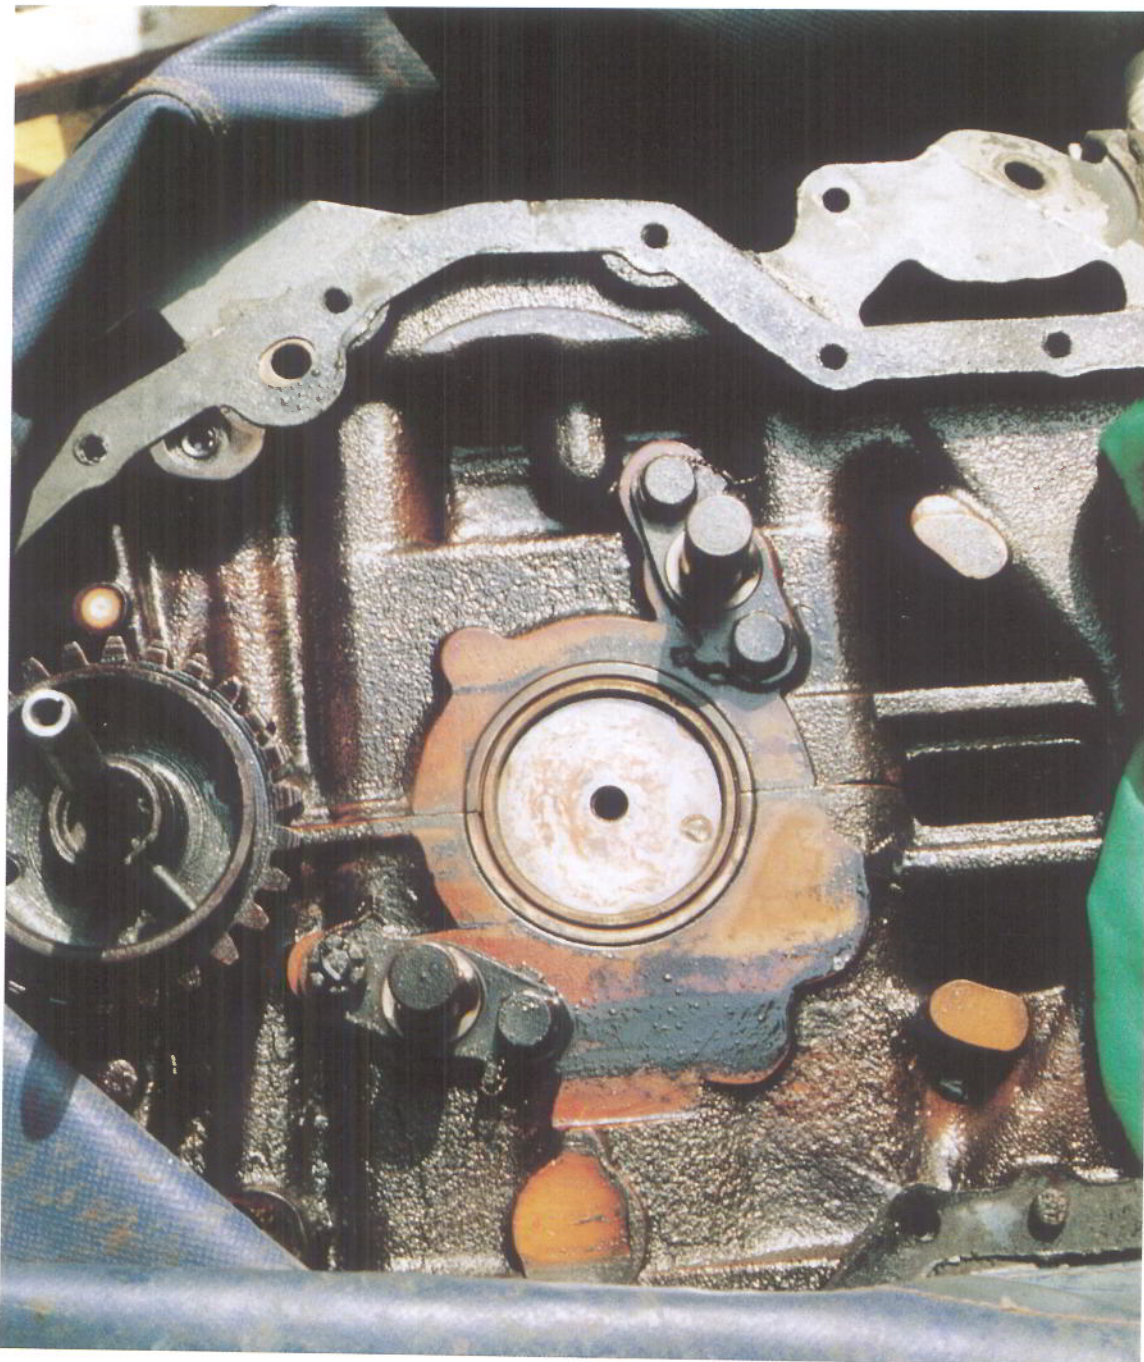
The fretting and fatigue on the locating dowel appeared to have occurred over a considerable period. Examination of the crankshaft gear attachment bolt and its lockplate showed very good evidence of long term fretting between the bolt and its lockplate, indicating that the attachment bolt had either not been torqued correctly when assembled, or that the torque had been lost due to incorrect assembly.

FIGURE 2. SHOWING FRACTURED LOCATING DOWEL
