**No:** 6/91

**Ref:** EW/C91/2/2

**Aircraft Type and Registration:** Boeing 737-300, G-TEAB

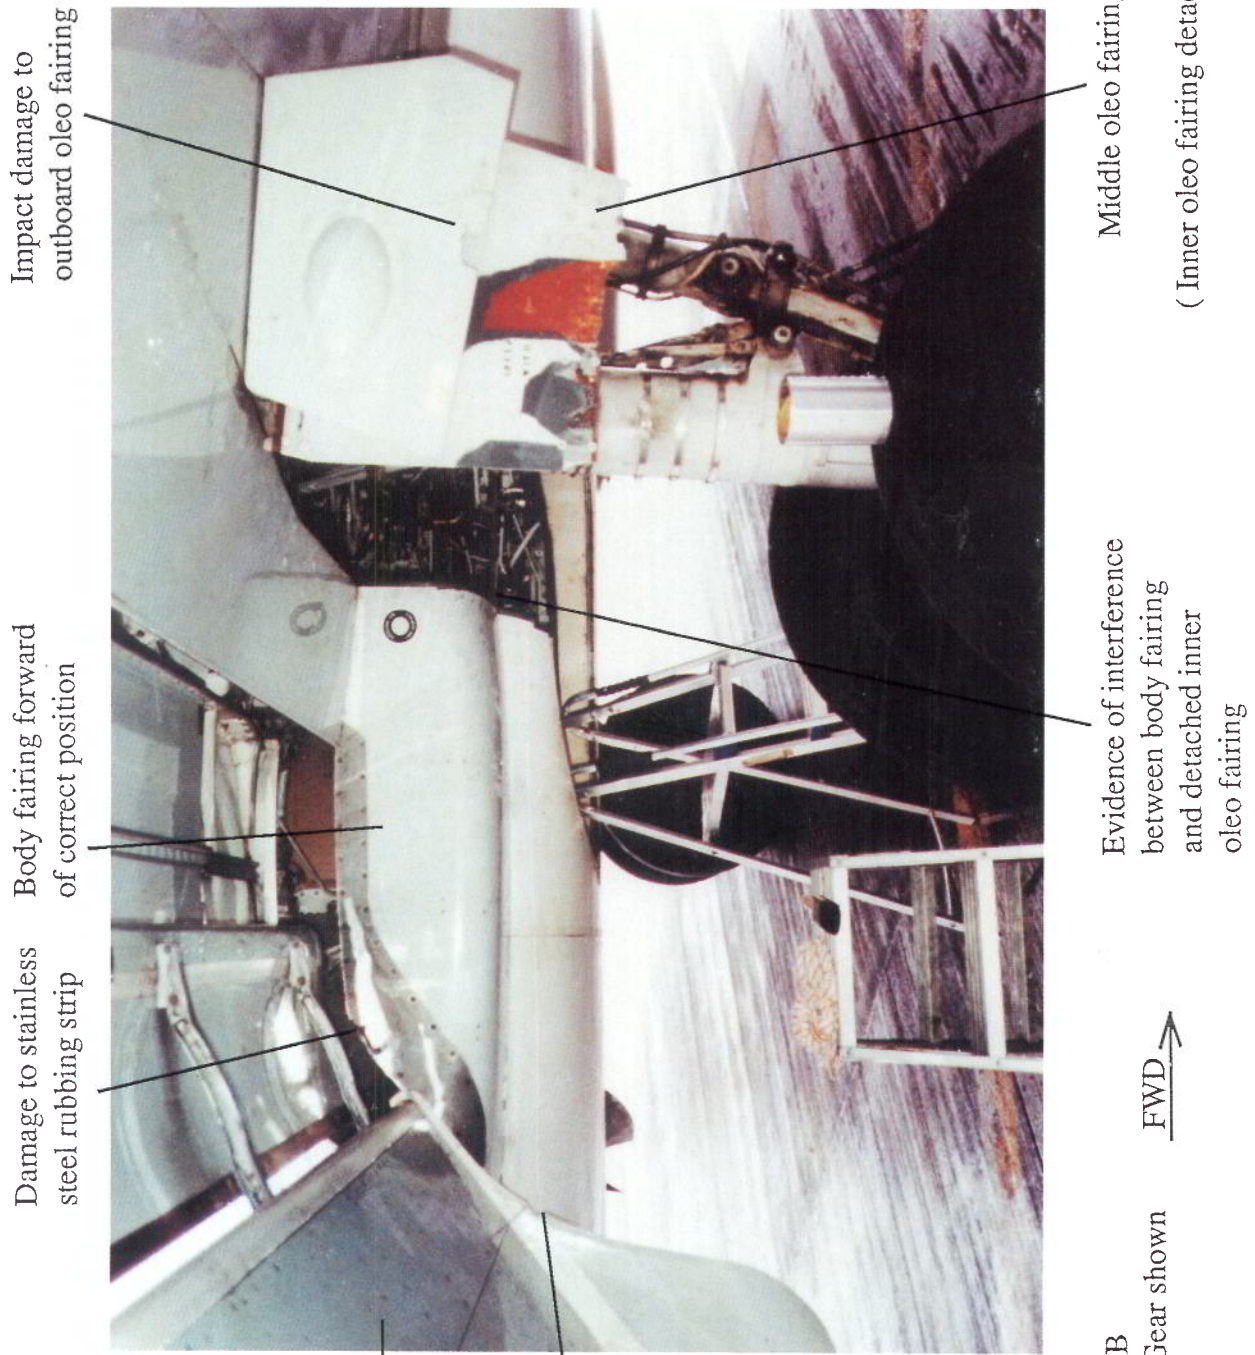
BOEING 737 G-TEAB  
Right Main Landing Gear shown

Following temporary repairs, the aircraft was cleared for a (non-revenue) positioning flight to Manchester. Detailed inspection of the aircraft showed that the lower, inboard, oleo fairing had detached from the aircraft following failure of the mid fairing. The right body fairing had displaced forward of its correct position and was 'hung' on the forward end of one of its mounting spigots, with its diaphragm structure distorted and prevented from moving aft by the spigot. It also showed evidence of contact with the landing gear inboard fairing. The inboard fairing was partly delaminated and showed evidence of compressive damage, in a fore-and-aft direction, and whilst some of this was clearly caused by adjacent aircraft structure, some was probably due to ground impact. Near the aft end of the body fairing, some damage was found at the stainless steel rubbing strip which had come away from the fairing structure. This was local to an area where the seal plate comes into close proximity with the body fairing, and there was corresponding damage to the leading edge of the seal plate. Small amounts of material from the seal plate were found between the composite structure of the fairing and the stainless steel plate. There was also some impact damage to the outboard, or upper, oleo fairing and to the flap assembly in the vicinity of the right main landing gear.

There were three features of the design which, while acceptable in themselves, were identified as having contributed to this incident. The first was the normal working clearance between the seal plate and the body fairing. This is specified in the Maintenance Manual as 0.06 inches (1.5mm), +0.19/-0.06 inches (+5/-1.5 mm). These limits allow the seal plate to contact the body fairing. To accommodate this, the latter is fitted with a stainless steel plate to facilitate rubbing contact. The Maintenance Manual calls for checking of the seal plate clearance after assembly of the flaps or following adjustment of the mounting spigots for the body fairing, but not after re-fitting of the fairing when no adjustment has been required. The second feature is the facility to remove and re-fit the body fairing routinely with only minimal checks. Even though the fairing is extremely close to the seal plate and to the inner oleo fairing, it can be re-fitted with only minimal checks because it is mounted on spigots which accurately control its location. The Maintenance Manual calls for checks on the gaps at the forward and inboard edges of the fairing after fitting, but does not call for inspection of the clearance between the outboard face of the fairing and the seal plate. The third feature of the design is the provision of a chamfer on the body fairing at the location where the seal plate first makes contact with it during flap retraction. When the clearances are correct there is usually no contact with the chamfer, but if the seal plate makes initial contact inboard of its intended position, it is eased over the edge of the body fairing by the chamfer. The chamfer includes the edge of the stainless steel rubbing plate and therefore the leading edge of the seal plate must pass over the interface between the two materials, but has the potential to separate them and jam itself between them.

Impact damage to outboard oleo fairing

Body fairing forward of correct position

Damage to stainless steel rubbing strip

Damage to leading edge of seal plate

Middle oleo fairing (Inner oleo fairing detached)

Evidence of interference between body fairing and detached inner oleo fairing

As a result of the investigation the maintenance organisation has introduced a visual check of the seal plate gap and alignment following routine re-fitting of the body fairing. The AAIB has made a Safety Recommendation to the CAA which would introduce a similar check to the Maintenance Manual.
