AAIB Bulletin No: 2/93

Ref: EW/C92/9/5

**Aircraft Type and Registration:** (1) McDonnell Douglas DC9 - 32, G-PKBE  
(2) Boeing 747-400, PP-VPG

**Location:** Runway 09R holding area at London Heathrow Airport

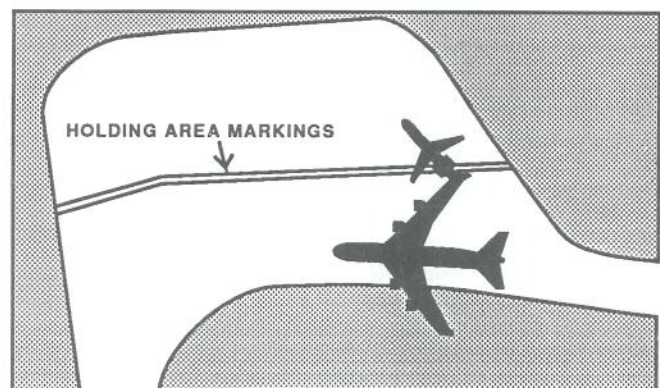
The DC-9 was examined shortly after the incident by a senior engineer. Damage to the paint on the underside of the left stabiliser and elevator was obvious but there was no deformation of the structure and the aircraft was cleared for return to service pending repairs to the paintwork. After the Boeing 747-400 took off but before it departed from Copenhagen, the airline's station manager requested by telephone and telex that a damage check be carried out by Danish engineers. This was done but no reference to the check was entered in the aircraft's maintenance log apparently because no damage was found. The aircraft was examined by the AAIB later that night on its return from Copenhagen to London under the command of another Captain. There was no apparent damage to the the winglet apart from erosion of the paint at the rearmost tip of the winglet.

The approximate positions of the 747-400 and DC-9 at the moment of collision have been identified from marks on the DC-9 and sketches provided by the 747 commander and airport authority. The damage was limited to paintwork probably because the flexibility of the 747-400 wing allowed it to bend slightly downwards as the swept-back winglet struck the rear of the DC-9's elevator.
