AAIB Bulletin No: 7/94 **Ref:** EW/G94/05/01 **Category:** 1.3

Aircraft Type and Registration: Cessna 195, G-BBYE

Date & Time (UTC): 1 May 1994 at 1555 hrs

Location: HMS Daedalus, Lee-on-Solent, Hampshire

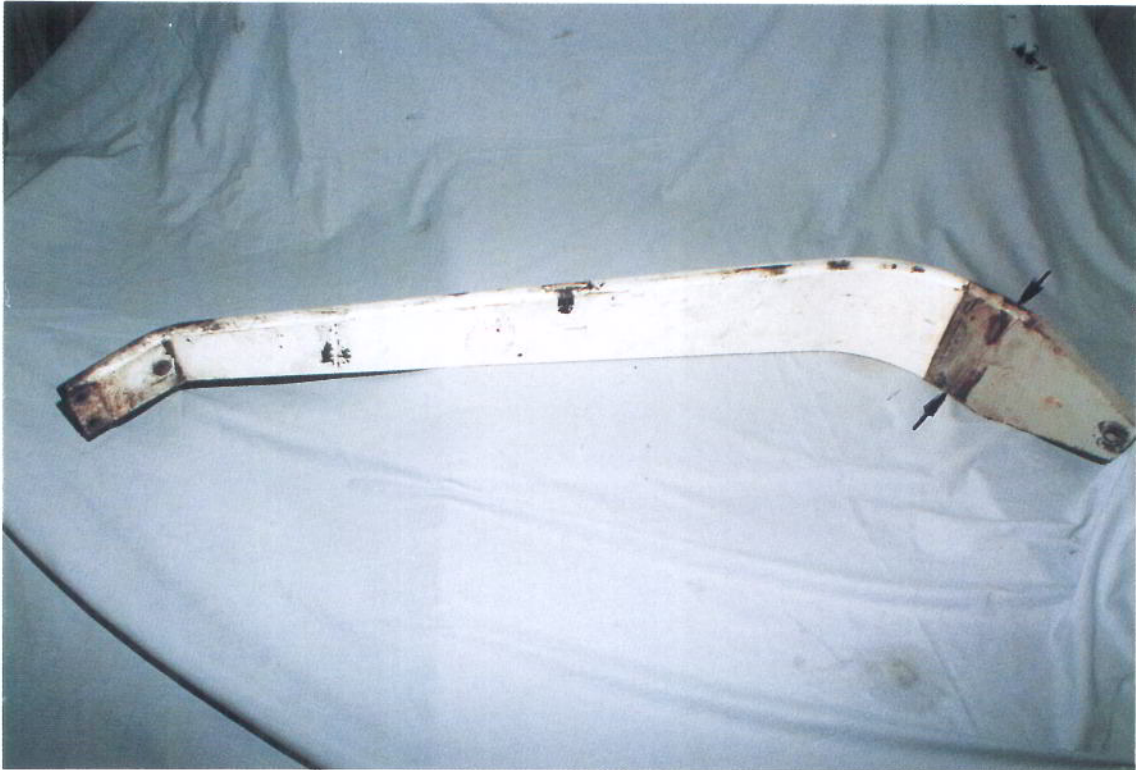
On the Cessna 195 the landing gear is of the undamped steel leaf type. The inboard end of the leg is bent to form a horizontal tongue which locates in the fuselage structure; it is retained by a bolt at its inboard end within the fuselage and supported in a slotted housing in the fuselage skin. The leg had failed in downward bending from a pre-existing fatigue crack at the top front corner of the spring leaf at the outboard edge of the supported area in the slotted housing (see photographs). The fatigue crack ran aft 15 mm in the chord-wise direction and 5 mm down the leading edge of the leaf. Very rapid progression of the fatigue had taken place just before the final separation. This was probably a result of high cyclic loads during the ground loop rather than an indication of the crack reaching its critical

Fig 1: Left mainleg with position of fracture indicated by arrow

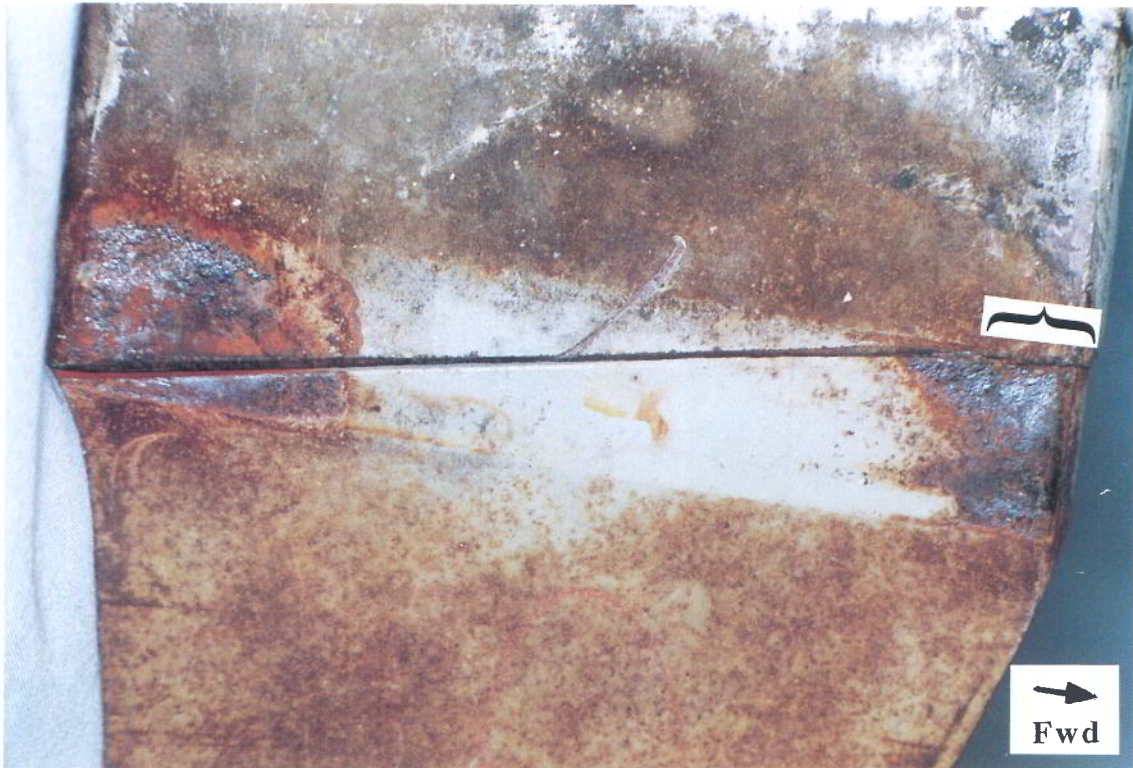
length where it would fail under normal loading. The crack had probably, therefore, been exploited by the loads sustained during the ground loop but it had existed for a long time and had been driven by stresses just in excess of the endurance limit. The fatigue crack had multiple origins and local corrosion and fretting, caused by contact top and bottom with the support housing, had been factors in the fatigue initiation. However, the top surface had not been shot-peened, as had the underside, and it did not, therefore have the additional fatigue resistance provided by that process. The underside's surface hardness was 350HV(10) (Vickers hardness test) whereas that of the top was 250HV(10), the core hardness. The metallurgist pointed out that in an undamped spring landing gear the rebound stresses can be almost as high as the initial impact stresses. If the top surface had been shot-peened its fatigue endurance limit might well have been raised above the marginally high stress levels that it had been sustaining, giving it an unlimited fatigue life. The tensile strength of the steel from which the leg had been made was approximately 115,000 lb/in², equivalent to S96.

Fig 2: Top surface of mainleg failure area with extent of fatigue fracture indicated and showing corrosion and fretting in contact areas within support housing
