Aircraft type and registration: Piper PA31-Navajo G-BFON

Date and time (UTC): 11 June 1986 at 1145 hrs

Location: 1/2 mile north of RAF Brize Norton, Oxon

Information Source: AIB Field Investigation.

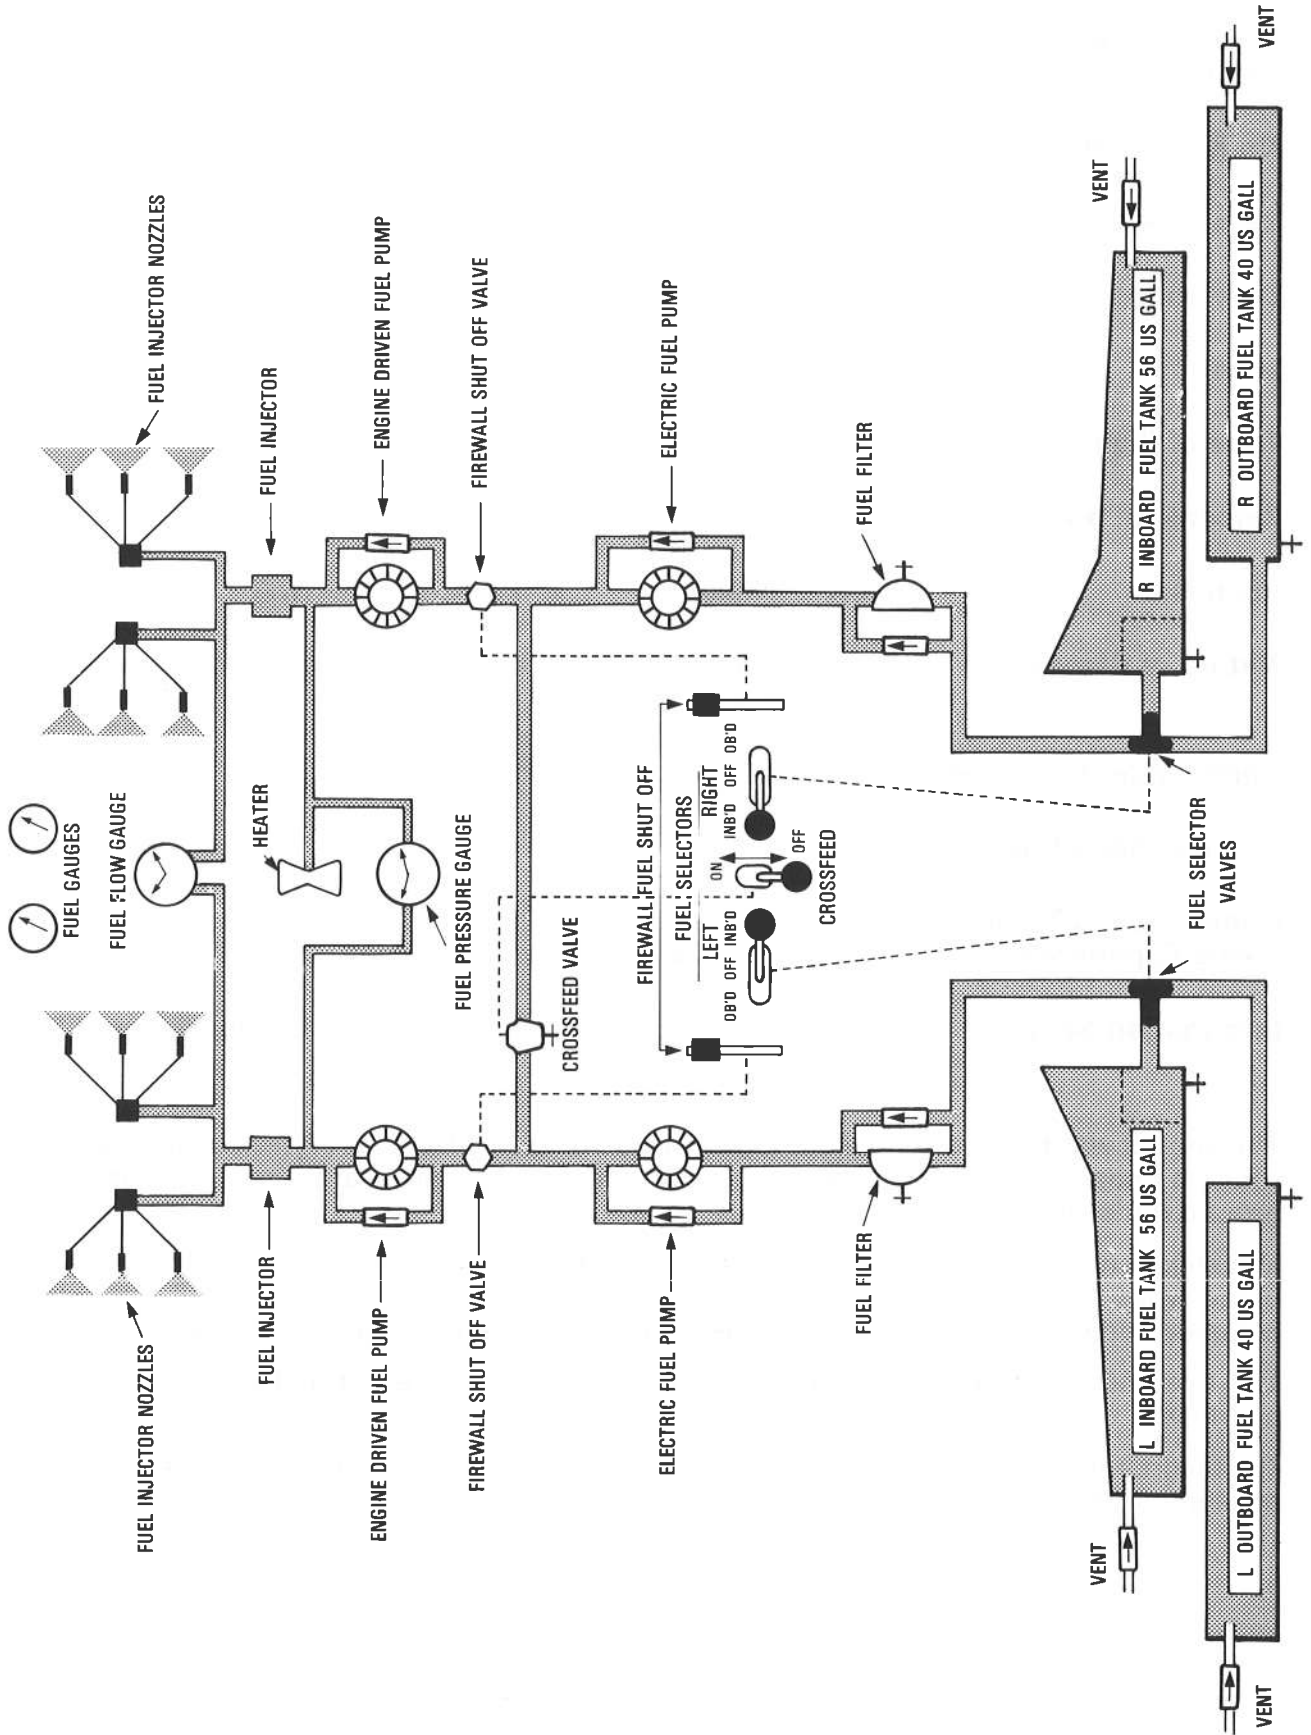
PA-31-310 FUEL SYSTEM

The aircraft was removed to AIB Farnborough for examination, particularly of the fuel system (see diagram) which is designed to operate with the left and right sides independent of each other unless the crossfeed valve is opened.

The fuel selector panel on the PA31-310 Navajo is located on the aircraft centre line at floor level and slightly behind the pilots' seats, nested against the main spar with a pair of fuel gauges overhead showing the contents of the tanks selected. A rigging check of the crossfeed selector showed that the OFF and ON detents did correspond to closed and open states of the crossfeed valve respectively; the crossfeed valve, however, would open at about 25% of the lever travel towards ON. Similar rigging checks on the left and right fuel tank selectors showed that the fuel selector valves would open at about 50% of the lever travel from OFF to INBOARD.
