**ACCIDENT**

<b>Aircraft Type and Registration:</b>	Piper PA-38-112 Tomahawk, G-BYLE	
<b>No &amp; Type of Engines:</b>	1 Lycoming O-235-L2C piston engine	
<b>Year of Manufacture:</b>	1982	
<b>Date &amp; Time (UTC):</b>	22 October 2005 at 0839 hrs	
<b>Location:</b>	Near Biggin Hill Airport, Kent	
<b>Type of Flight:</b>	Training	
<b>Persons on Board:</b>	Crew - 2	Passengers - None
<b>Injuries:</b>	Crew - 2 (Fatal)	Passengers - N/A
<b>Nature of Damage:</b>	Aircraft destroyed	
<b>Commander's Licence:</b>	Commercial Pilot's Licence with Flying Instructor Rating and CAA authorised Flight Examiner	
<b>Commander's Age:</b>	60 years	
<b>Commander's Flying Experience:</b>	4,451 hours (no record of any experience on type) Last 90 days - 39 hours Last 28 days - 18 hours	
<b>Information Source:</b>	AAIB Field Investigation

**Synopsis**

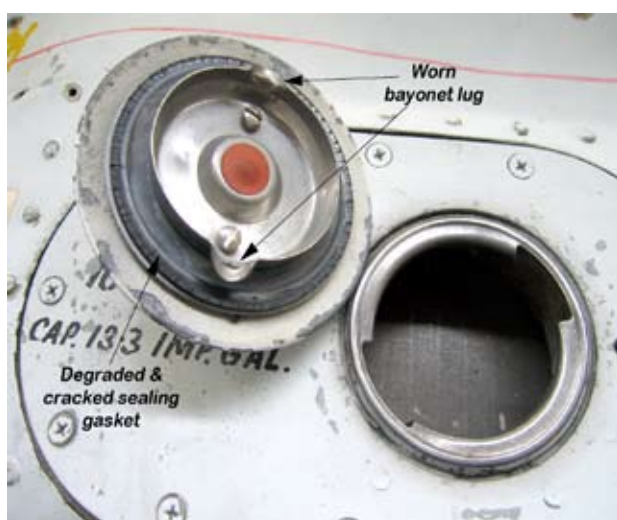
**Figure 1**  
Fuel filler cap

Examination of the filler cap bayonet mechanisms revealed that on each cap the projecting lugs (which abut the bayonet-cams) were grossly worn, to the extent that each lug was worn right through, beyond its full thickness, see Figures 1 and 2. The effect of this wear was to reduce significantly the extent to which the cap was pulled down onto its seat, with a commensurate reduction in the amount of compression of the seal assembly and an associated loss of seal effectiveness.

Age-related cracking was clearly visible around the periphery of the rubber sealing gasket from the left cap, but for the most part these cracks did not extend into the working (contact) area of the seal. This cracking was less significant in terms of the deterioration in seal performance than the reduced compression of the seal assembly caused by the wear in the bayonet mechanism.

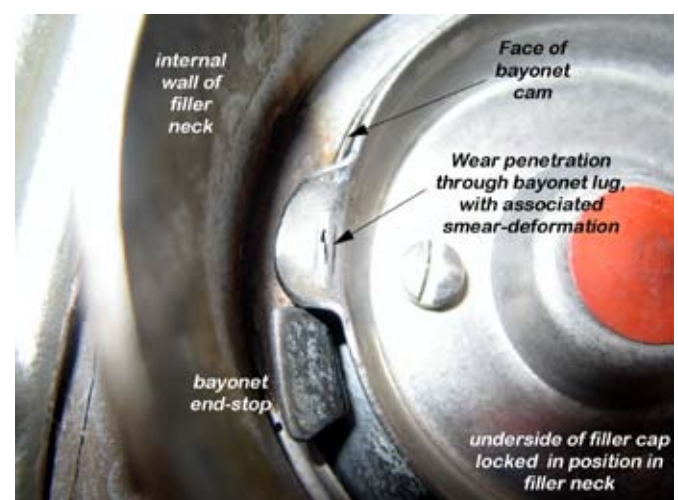
**Figure 2**  
Underside of filler cap showing worn bayonet cams

stack. The reduced compression of the fitted cap meant that the seal was no longer in proper contact with the seat and the cap would be prone to leakage. Any appreciable wear in the bayonet cam faces would also have contributed to a poor seal.

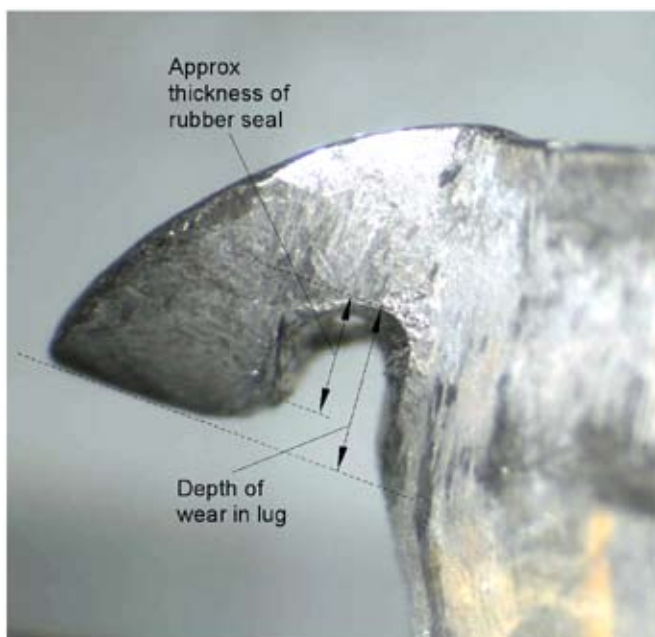
**Figure 3**

Whilst the rubber sealing gasket on the left cap had visibly degraded and cracked, for the most part these cracks did not extend into the interface region, and were not in themselves responsible for the absence of an effective seal. Rather, the loss of seal effectiveness was almost wholly caused by wear in the bayonet fittings, which reduced the distance through which the cap was pulled down onto its seat in the filler neck as it was locked down. It was not possible to measure precisely the extent of this wear, but the depth of wear in the lugs alone, illustrated in Figure 3, exceeded the rubber gasket's thickness by some 40% and approached the total thickness of the complete gasket

Illustration of wear in bayonet lug  
(viewed from the side)

The UK CAA should alert light aircraft owners, operators and maintainers of the dangers inherent in using worn, degraded or loose-fitting fuel tank filler caps.

The European Aviation Safety Agency should instigate a one-off inspection of PA-28 and PA-38 aircraft fuel filler caps to identify any with unserviceable rubber gaskets or excessive wear in the metal locating lugs and require refurbishment or replacement of any defective caps.
