ACCIDENT

Aircraft Type and Registration:	Topsy Nipper T.66 Series 2, G-ATBW	
No & Type of Engines:	1 Volkswagen 1834 (Acro) piston engine	
Year of Manufacture:	1962	
Date & Time (UTC):	3 February 2011 at 1530 hrs	
Location:	South of Flemings Farm, South Hanningfield, Chelmsford, Essex	
Type of Flight:	Private	
Persons on Board:	Crew - 1	Passengers - None
Injuries:	Crew - None	Passengers - N/A
Nature of Damage:	Propeller detached from the aircraft	
Commander's Licence:	Private Pilot's Licence	
Commander's Age:	51 years	
Commander's Flying Experience:	394 hours (of which 243 were on type) Last 90 days - 3 hours Last 28 days - 1 hour	
Information Source:	AAIB Field investigation

Synopsis

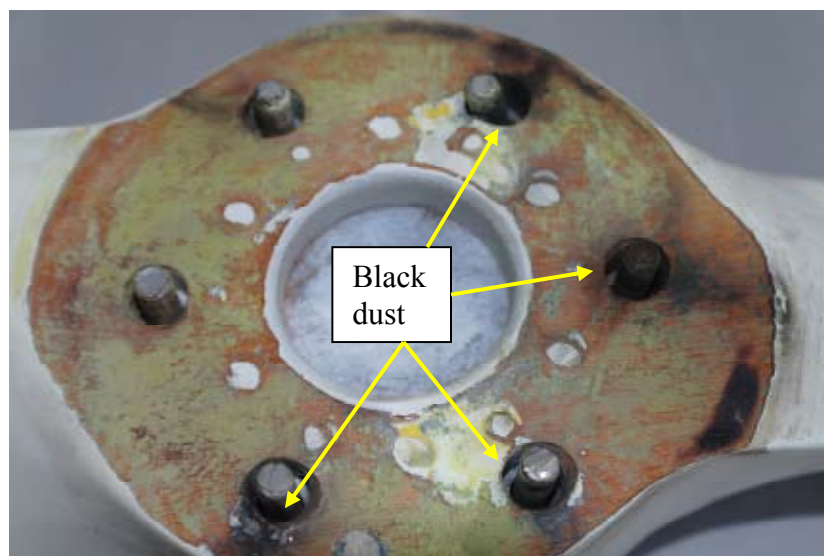
Figure 1

the propeller to the attachment plate on the engine crankshaft had all failed at the end of the threaded portion. The remaining threaded portion of the bolts remained in the inserts (lugs) fitted to the attachment plate. An examination of the fracture surfaces on two of the bolts revealed evidence of fatigue cracking emanating from the threads, with the bolt finally failing in ductile overload. Other bolts showed evidence of overload, one of which was covered in a black dust consistent with the oxidisation of fine particles that are generated when a bolt is subjected to fretting. The black dust was also apparent in three of the other holes through which the bolts were fitted, Figure 1.

Black dust around bolts.

The damage to the failed portion of the bolts is consistent with them having failed as a result of a loss of torque to a number of the bolts. The damage to the ends of each bolt and the location of the black dust indicates that probably four of the bolts had worked loose leaving the remaining two bolts to take the load. It was not possible to establish if the bolts had been correctly torqued or had worked loose as a result of the inadequate wire locking or a change in moisture content in the wooden propeller hub. While the re-torque had been carried out within the required hourly maintenance interval, the low usage of the aircraft meant that the torque had not been checked in almost two years. Therefore, for such low usage aircraft, it might be more appropriate to base the re-torque of the propeller securing bolts on a calendar basis.

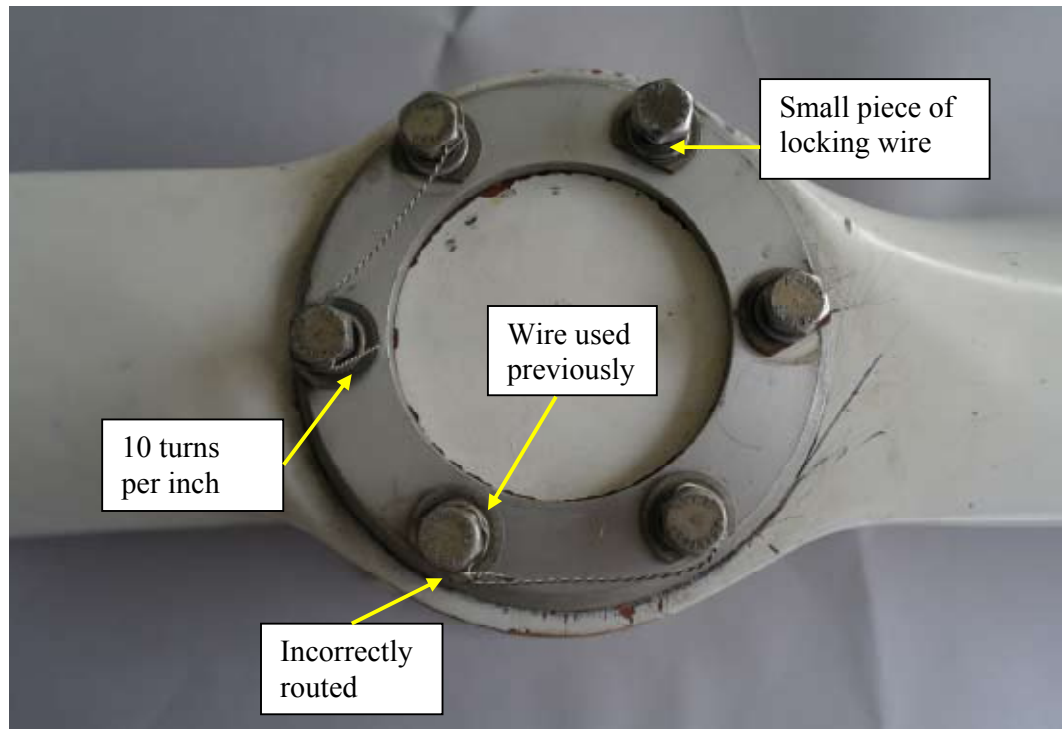
Figure 2

From a photograph of the heads of the bolts, taken after the spinner was removed, it can be seen that only two pairs of the bolts had been wire locked; however, a small piece of locking wire remained in the hole in the head of one of the unlocked bolts, Figure 2. The wire locking of one pair of bolts was incorrectly routed and the distortion of the wire around the head of one of the bolts indicated that this section of wire had been twisted at least once before. There were approximately 6 twists

Wire locking on propeller bolt heads

per inch in the wire between each bolt head, which is within the recommendation of 6 to 8 twists per inch for this gauge of wire. However, the number of twists at the tail of the wire on one of the bolts was approximately 10 twists per inch. This over-twisting can result in the wire work hardening such that it becomes brittle and easy to break. Overall the standard of wire locking was assessed as being inadequate to prevent the bolts from becoming loose.

The LAA has published information on the maintenance of wooden propellers. They have also advised the AAIB that they will use this accident to inform their members of the necessity to check regularly the torque of the bolts used to secure the propeller to the engine, the correct way to wire lock bolts and the requirement to maintain complete records of work carried out on aircraft.
