SERIOUS INCIDENT

Aircraft Type and Registration:	Airbus A320, G-DHJZ
No & Type of Engines:	2 CFM56-5B4/P turbofan engines
Year of Manufacture:	2003
Date & Time (UTC):	5 July 2007 at 1205 hrs
Location:	Kos Airport, Greece
Type of Flight:	Commercial Air Transport (Passenger)
Persons on Board:	Crew - 6 Passengers - 180
Injuries:	Crew - None Passengers - None
Nature of Damage:	Severe damage to main landing gear
Commander's Licence:	Air Transport Pilot's Licence
Commander's Age:	47 years
Commander's Flying Experience:	12,100 hours (of which 950 were on type) Last 90 days - 174 hours Last 28 days - 38 hours
Co-pilot's Age	34 years
Co-pilot's Flying Experience	381 hours (of which 147 were on type) Last 90 days - 154 hours Last 28 days - 49 hours
Information Source:	AAIB Field Investigation, at the request of the Greek Air Accident Investigation & Aviation Safety Board

Synopsis

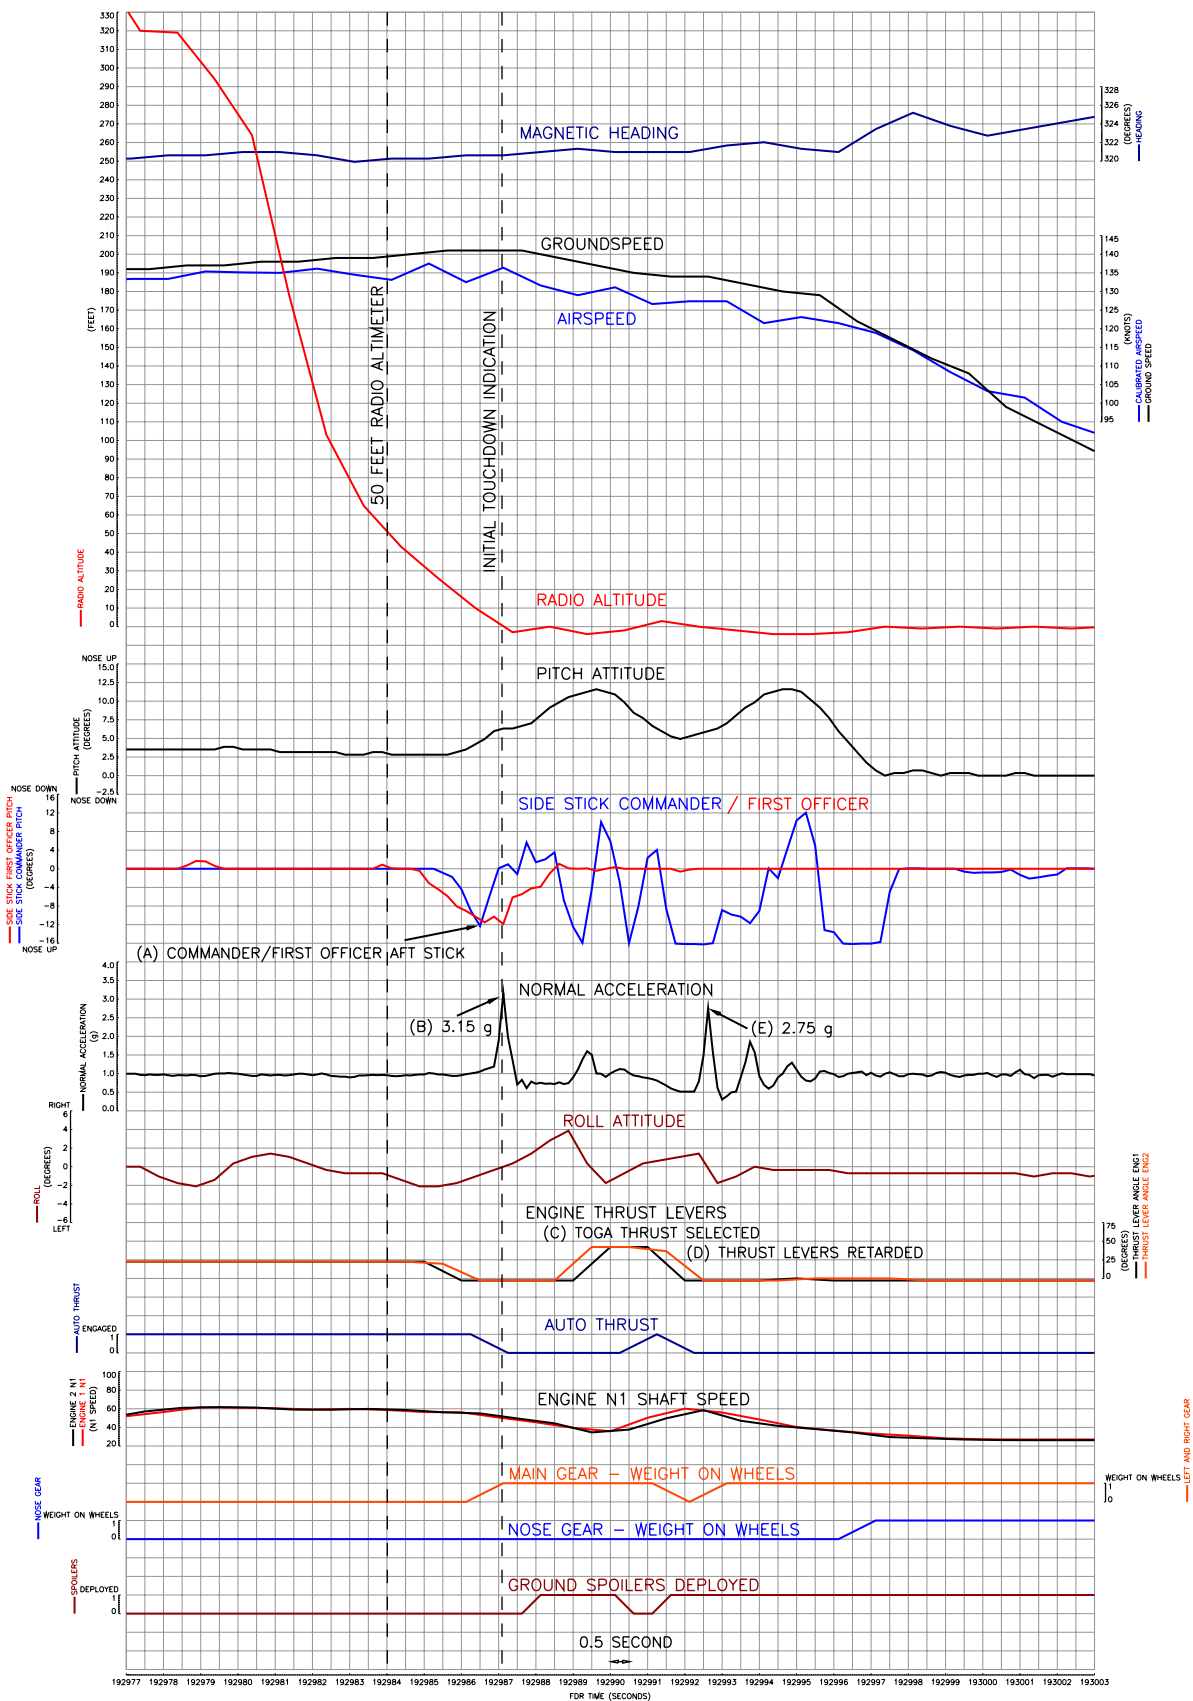
Figure 1

be selected off. The barometric descent rate and the ground speed stabilised at about 1,000 ft/min and 138 kt respectively, equating to a descent path of about four degrees³. At 500 ft aal, the commander stated that the approach was stable. The co-pilot confirmed that the descent rate was being maintained at 1,000 ft/min, and stated that he did not want to increase it any further. Some 11 seconds before touchdown, at about 160 ft aal, the commander confirmed “THREE WHITES AND ONE RED AND CORRECTING”, before advising that the wind was from the left at seven knots. During the final stages of the landing flare, the recorded groundspeed and wind data from the FMGS indicated that the wind direction had changed from a crosswind to a tailwind of between 3 kt and 4 kt.

It was apparent that the commander was ‘coaching’ the co-pilot somewhat during the final approach but he stopped mid-sentence at the automatic FIFTY callout from the RA. The subsequent FORTY, THIRTY and TWENTY callouts came in very rapid succession, with the touchdown occurring almost immediately after the TWENTY callout. At about 35 ft aal, approximately three seconds before main gear touchdown, the co-pilot retarded the thrust levers and started the flare, progressively moving the sidestick aft about two thirds of full travel; the airspeed was 133 kt. Almost co-incidentally, the commander applied nearly full aft sidestick, (A) Figure 1. The aircraft’s pitch attitude increased to about 6° before touching down with a descent rate of 900 ft/min. Normal acceleration was recorded at 3.15g, (B) Figure 1, as the aircraft touched down almost simultaneously on both main landing gears, following which it bounced.

Time history of relevant data covering the landing at Kos

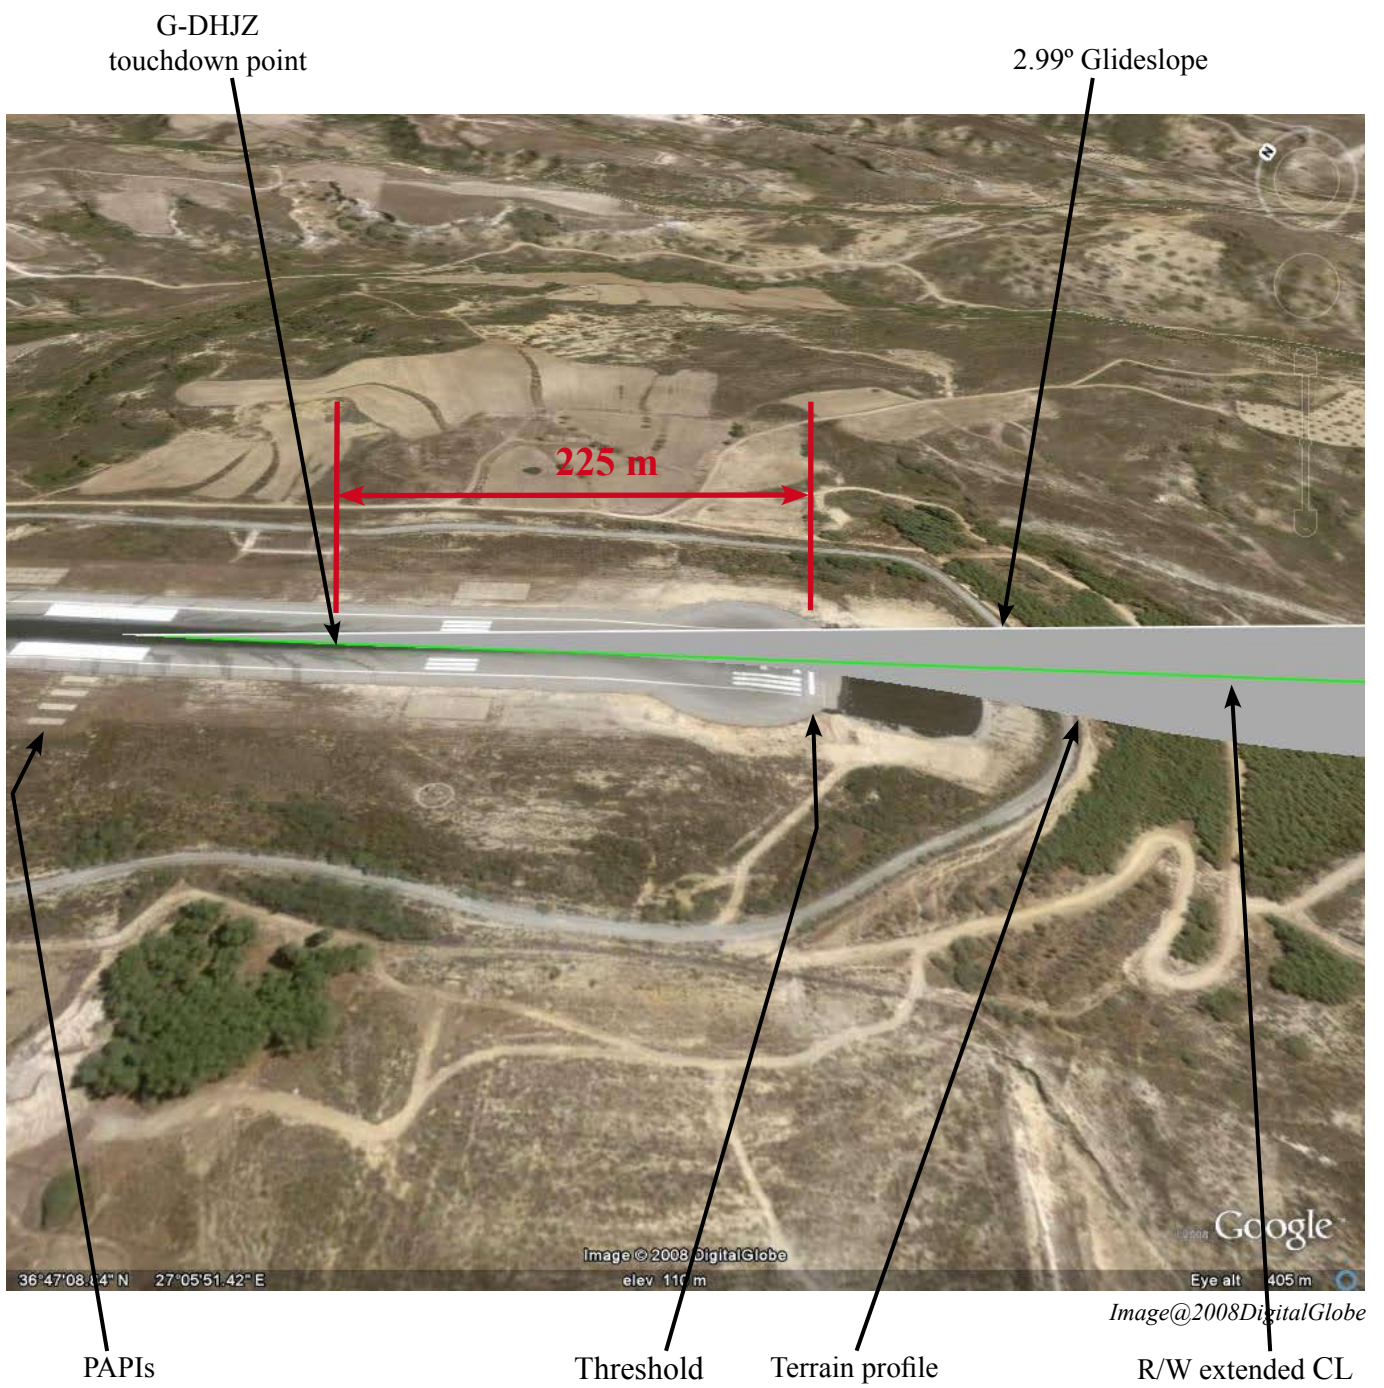
The approach to Runway 32 is unusual, in that it is over a ravine which is aligned with the runway extended centreline (Figure 1) and the ground rises steeply towards the runway threshold. This not only results

in the misleading perspective by night, as mentioned in the airfield brief, but also means that the ‘picture’ by day is unusual. Guidance provided by the aircraft manufacturer warns that an upslope towards the touchdown aiming point may lead pilots to increase the rate of descent inappropriately, with the consequent risk of a hard landing.

Figure 2
Threshold region of Runway 32 at Kos

It is recommended that the Greek Civil Aviation Authority should review the performance of the PAPI installation of Runway 32 at Kos, to ensure that flight crews are able to acquire them visually in time to stabilise their aircraft on the correct glideslope before landing.
