ACCIDENT

Aircraft Type and Registration:	1) P-51D Mustang (Commonwealth CA-18 Mk 22 NA), D-FBBD
	2) Douglas AD-4N Skyraider, F-AZDP
No & Type of Engines:	1) 1 Packard Motor Car Co Merlin V1650-7 piston engine

2) 1 Wright R3350-268 piston engine
Year of Manufacture:	1) 1951
	2) 1960
Date & Time (UTC):	10 July 2011 at 1616 hrs
Location:	Near Duxford Aerodrome, Cambridgeshire
Type of Flight:	1) Private

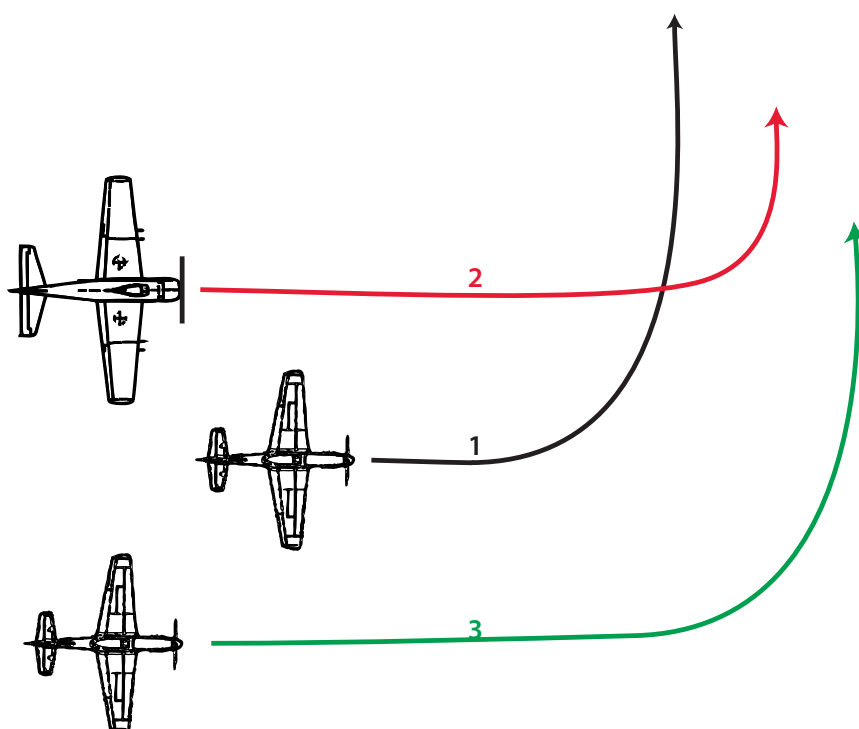
Figure 1

The sequence of the aircraft in the accident element carrying out their respective break manoeuvres

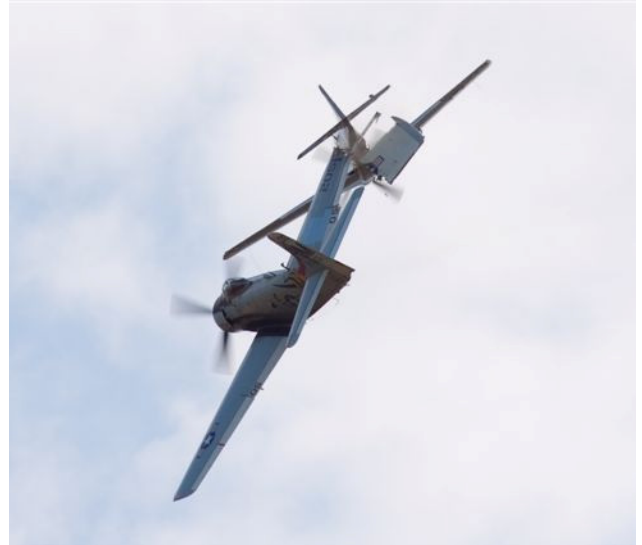
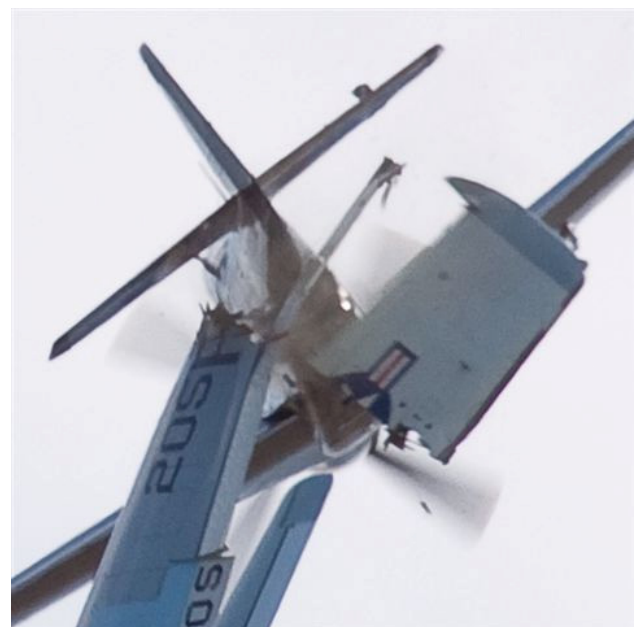
Figure 2

The moment of the collision, with enlargement showing damage to the Mustang's right tailplane

The enlarged image indicates that the Skyraider wing had passed beneath the Mustang's fuselage such that it contacted the leading edge of the right tailplane. This had resulted in a flap of tailplane skin protruding upwards into the airflow. It was not possible to determine the full extent of the damage due to the serious disruption to the tailplane structure during the subsequent ground impact. However, it is likely that the damage caused significant disturbance to the airflow over the tail, with an associated effect on the elevator controls. It can also be seen that the Skyraider's right aileron remained attached, despite the outboard portion being structurally unsupported.

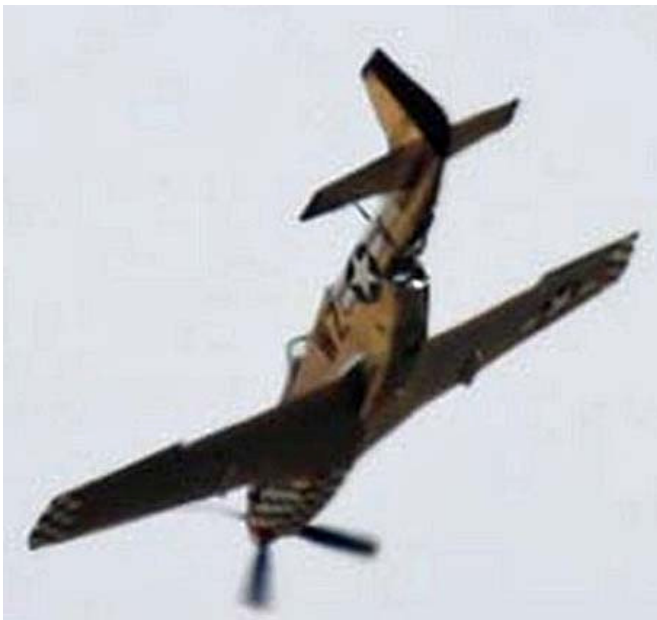
Figure 3 shows a photograph of the Mustang immediately after abandonment by the pilot. It can be seen that the underside of the fuselage has sustained a significant amount of damage in the area that contained the engine coolant radiator. It is considered that this generated the crease in the leading edge of the Skyraider's wing, as noted earlier, and which resulted in its structural failure.

View of Mustang showing damage to fuselage underside

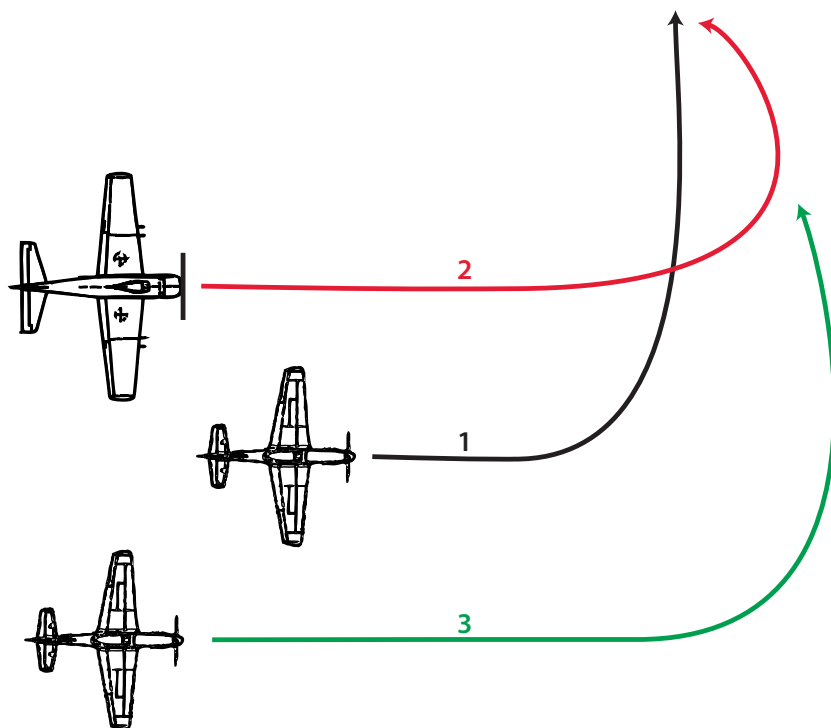
The collision occurred due to the Skyraider continuing the turn without the pilot having sight of the lead aircraft. His turn was tighter and his speed greater than that of his leader, causing the flight paths of the aircraft to converge. The approximate relative tracks of the aircraft in the accident element are illustrated at Figure 4 below.

The approximate relative tracks adopted by the aircraft in the accident element
