INCIDENT

Aircraft Type and Registration: Boeing 747-236, G-BDXH
No & Type of Engines: 4 Rolls-Royce RB211-524D4 turbofans
Year of Manufacture: 1979
Date & Time (UTC): 28 February 1993 at 1130 hrs
Location: London Gatwick Airport
Type of Flight: Scheduled passenger
Persons on Board: Crew - N/K Passengers - N/K
Injuries: Crew - Nil Passengers - Nil
Nature of Damage: Corner of Kreuger flap adjacent to inboard side of No 3 engine pylon detached
Commander's Licence: Airline Transport Pilot's Licence
Commander's Age: 43 yrs
Commander's Flying Experience: 9300 hours (of which 3500 hours were on type)
Information Source: AAIB Field Investigation

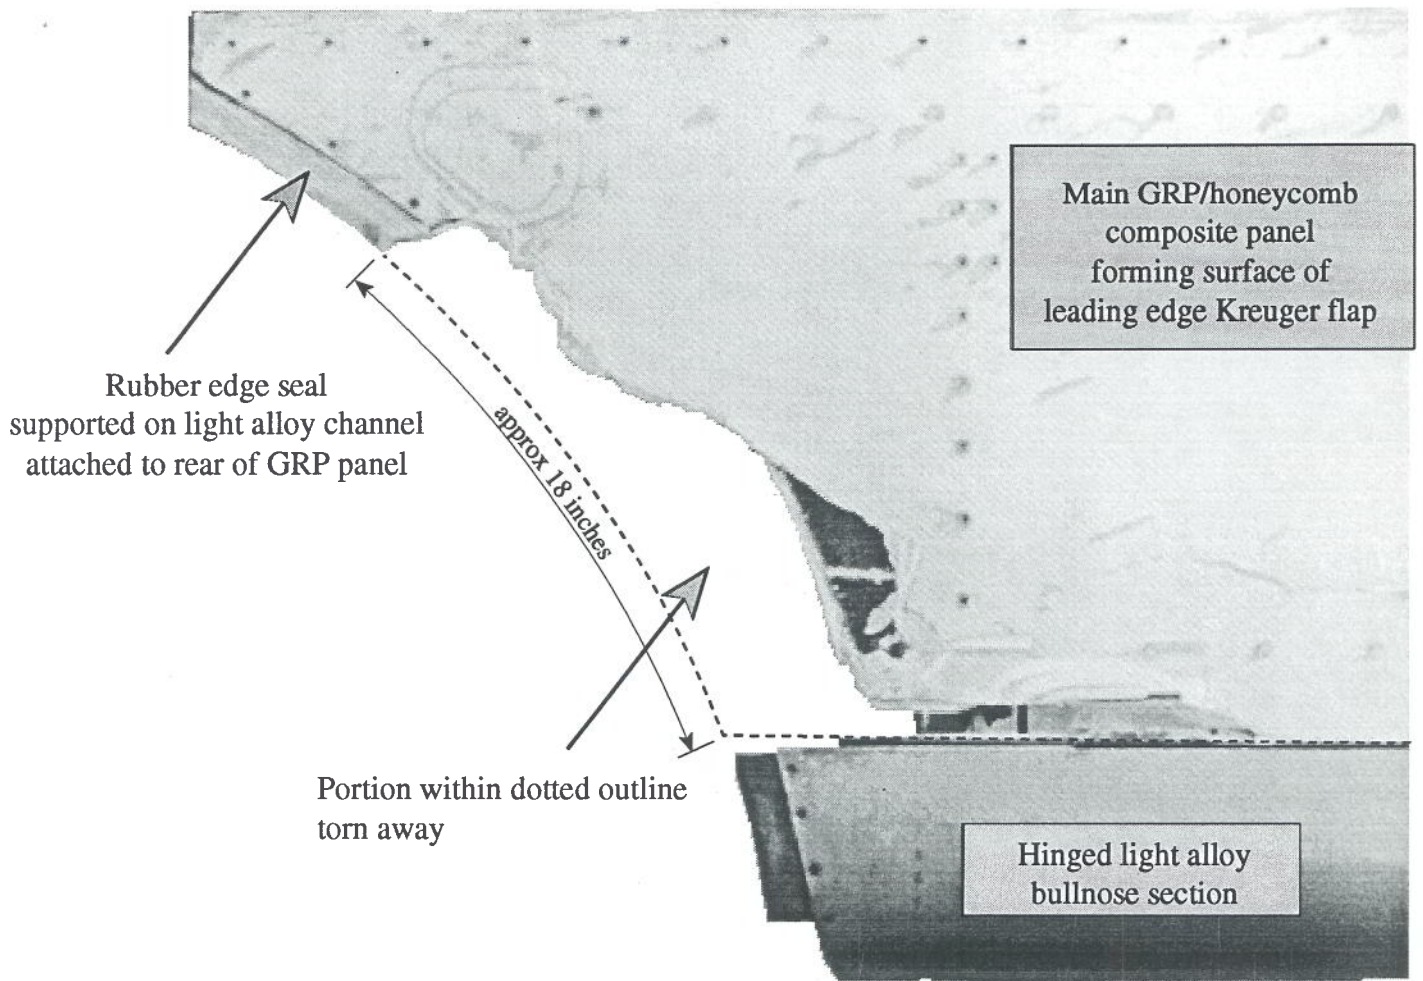
Examination of the damaged panel showed that a strip had separated from the edge of the flap which abuts the pylon when it is deployed (see Figures 1 and 2). The direction in which this strip had peeled off was consistent either with the direction of airloads with the flap deployed or as the result of interference between the flap and the pylon as the flap was retracting.

Since the missing fragment has not been recovered, it is not possible to determine when it became detached.

Fig 1 Damaged outboard end of Kreuger flap

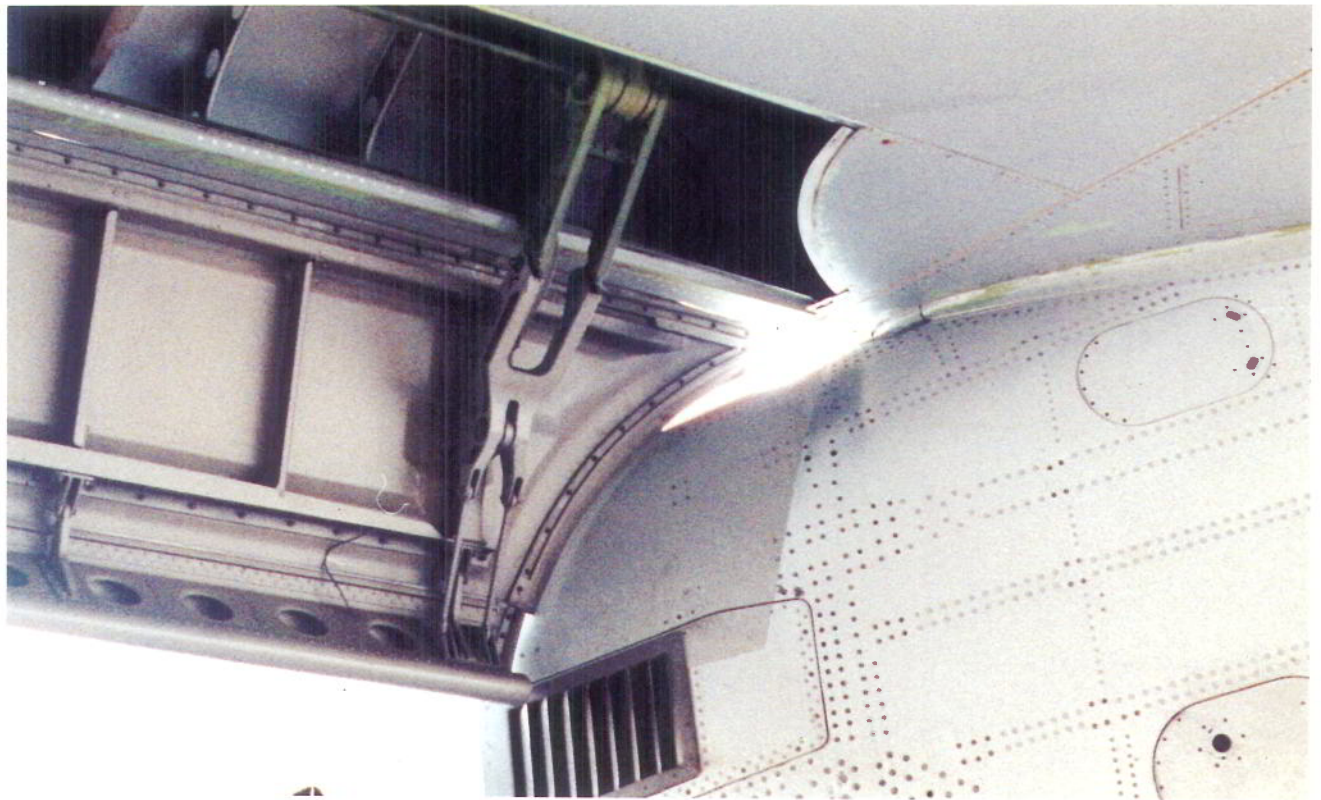
Fig 2 Kreuger flap fully deployed nesting against pylon
