**SERIOUS INCIDENT**

<b>Aircraft Type and Registration:</b>	Boeing 737-33A, G-CELD	
<b>No &amp; Type of Engines:</b>	2 CFM56-3B1 turbofan engines	
<b>Year of Manufacture:</b>	1987	
<b>Date &amp; Time (UTC):</b>	21 February 2009 at 1401 hrs	
<b>Location:</b>	Runway 32, Leeds Bradford Airport	
<b>Type of Flight:</b>	Commercial Air Transport (Passenger)	
<b>Persons on Board:</b>	Crew - 5	Passengers - 115
<b>Injuries:</b>	Crew - None	Passengers - None
<b>Nature of Damage:</b>	Right engine cowling	
<b>Commander's Licence:</b>	Airline Transport Pilot's Licence	
<b>Commander's Age:</b>	54 years	
<b>Commander's Flying Experience:</b>	11,030 hours (of which 5,280 were on type) Last 90 days - 83 hours Last 28 days - 33 hours	
<b>Information Source:</b>	AAIB Field Investigation

**Synopsis**

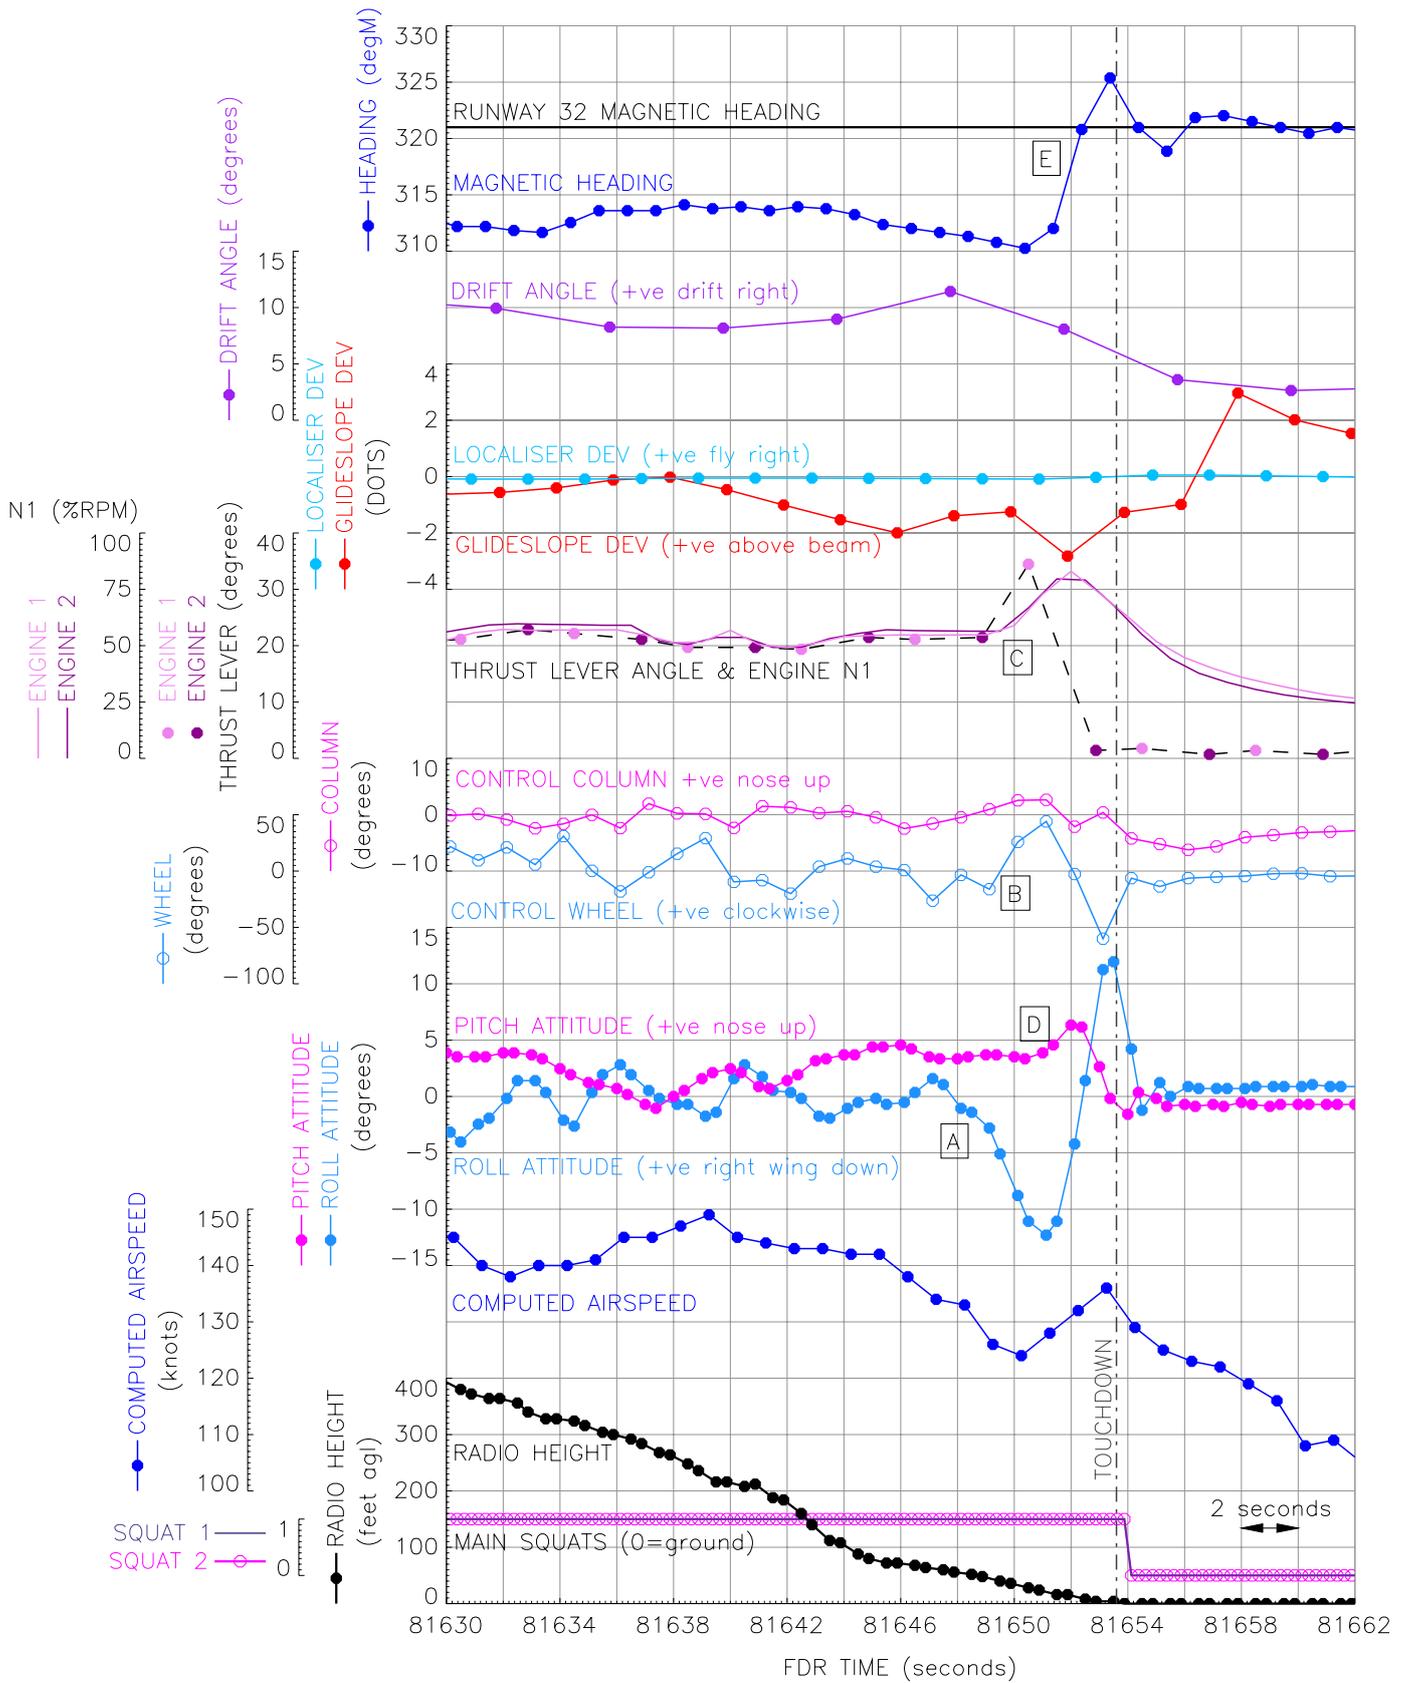
Figure1

of salient parameters for the landing, some of which are presented at Figure 1, were analysed. However, rudder pedal angle and rudder deflection parameters were not recorded. Rudder pedal was originally recorded on the FDR but subsequently removed during a modification to make space for right-flap position. This modification was deemed acceptable by the CAA as the regulations applicable to this aircraft only required primary flight controls to be recorded “when sufficient capacity is available” on the flight recorder system. The CAA is now recommending to the operator to re-instate the rudder position input as they believe this to be a more important parameter to record than right-flap position given the documented history of Boeing 737 rudder system problems, and the fact that left-flap position is recorded.

Figure 1 starts with the aircraft established slightly low on the ILS to Runway 32 and with the autopilot disconnected. The aircraft continued on or below the glideslope, wings level and decelerating, until 50 ft agl, when it started to roll left wing down (see Point A), reaching 12° three seconds later as the aircraft passed through 20 ft agl. The airspeed reached 124 kt as opposite control wheel was applied (Point B) and thrust was applied (point C). The thrust levels increased from a nominal 55%  $N_1$  to 80%  $N_1$  causing the aircraft to pitch up (Point D) and accelerate. However, as the aircraft responded in roll it also started to yaw to the right (Point E).

As the aircraft’s left-roll attitude reduced and passed through wings level, the pitch attitude and thrust were reduced but the aircraft continued to roll and yaw to the right until the point of touchdown. The maximum roll and yaw rates recorded were 13°/second and 8°/second respectively. The aircraft touched down with approximately 12° of right bank and just under 0.2° of

nose-down pitch, at about 145 kt computed airspeed, just as some left-hand control wheel was being applied.

Salient FDR Parameters for Incident Landing to G-CELD

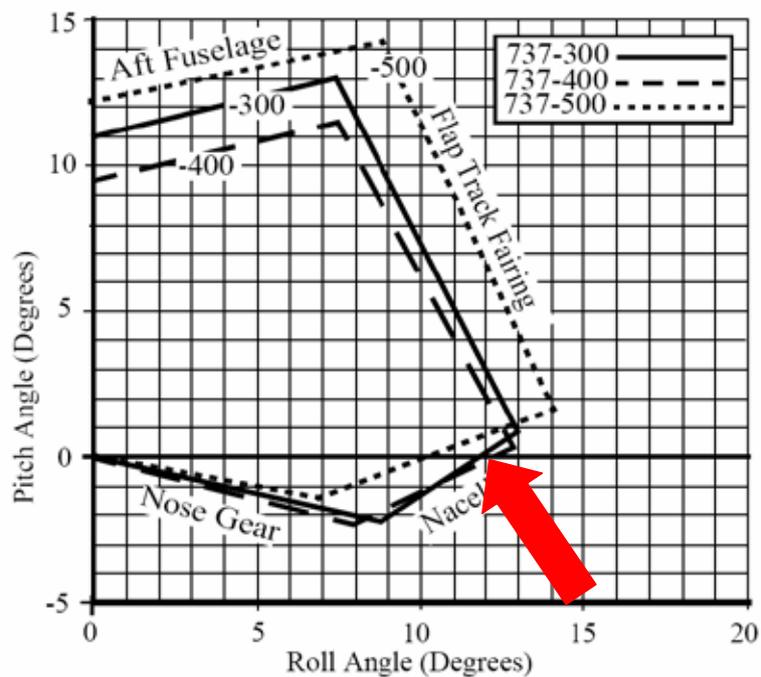
**Figure 2**

Figure 2, taken from the Boeing 737 (B737) Crew Training Manual, illustrates body angles required on landing to contact various parts of the airframe. When the parameters recorded by FDR above are plotted, a probable nacelle impact is indicated (arrowed).

The aircraft had maintained 8-10° of starboard drift during the approach and this drift was ‘kicked off’ in the flare to align the aircraft with the centreline; this induced a right roll. The FDR recorded that this roll was not anticipated with an opposite aileron input. As a result, this roll, induced by the yaw, caused the aircraft to achieve sufficient right bank for the nacelle to strike the ground. Confusion as to which pilot had control,

combined with encountering significant windshear, will contribute to the control instability at this critical time.

As a result of this incident the crew received additional training on crosswind landings in a simulator and the operator issued an Operating Staff Instruction

highlighting the need for a formal handover of control and acknowledgement from the other pilot. The instruction also added that, in normal circumstances, it is not appropriate for the PNF to make flying control or throttle inputs without a request from the PF.
