**INCIDENT**

<b>Aircraft Type and Registration:</b>	Reims Cessna FR172K, G-PJTM	
<b>No &amp; type of Engines:</b>	1 Continental IO-360-KB piston engine	
<b>Year of Manufacture:</b>	1977	
<b>Date &amp; Time (UTC):</b>	25 June 2006 at 1340 hrs	
<b>Location:</b>	Final approach to Runway 09 at Filton, Bristol	
<b>Type of Flight:</b>	Private	
<b>Persons on Board:</b>	Crew - 1	Passengers - 1
<b>Injuries:</b>	Crew - None	Passengers - None
<b>Nature of Damage:</b>	Damage to propeller and engine cowling	
<b>Commander's Licence:</b>	Commercial Pilot's Licence	
<b>Commander's Age:</b>	42 years	
<b>Commander's Flying Experience:</b>	904 hours (of which 500 were on type) Last 90 days - 49 hours Last 28 days - 21 hours	
<b>Information Source:</b>	Aircraft Accident Report Form submitted by the pilot and examination of the propeller by AAIB

**Synopsis**

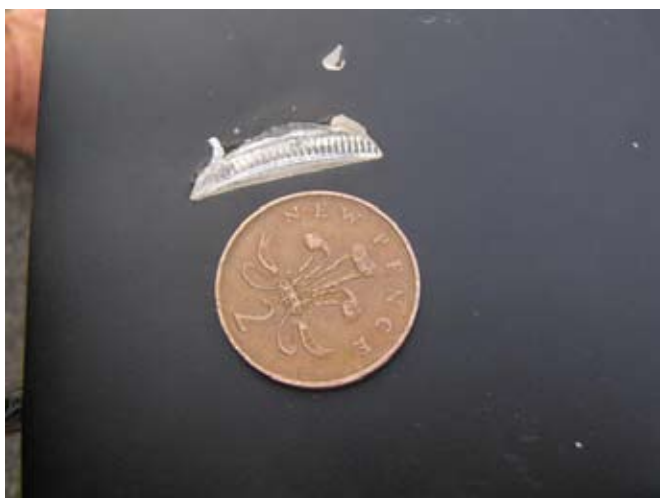
**Figure 1**

Subsequent inspection of the aircraft revealed that both propeller blades had sustained heavy impacts on their rear faces, Figure 1, one of which had resulted in a bulge appearing on the surface of the front face. There was also a significant impact on one of the leading edges that had resulted in the removal of material, Figure 2.

Impact damage to aft face of propeller blade

It was considered unlikely that the damage was caused as a result of a collision with an airborne object, as it is unlikely that such an object could have penetrated the propeller disc to make the marks on the cylinders fins. The nature of the damage to the blades suggested a direct impact from behind, as opposed to a glancing blow, with the object ricocheting between the propeller disc and engine/cowling, damaging the cowling and fins, before falling away. Whilst a list of possible objects capable of causing such damage could include a model aircraft, there was no residue on the propeller or elsewhere that pointed to such an occurrence.

As a suggestion of the type of article that could have been responsible for the damage, Figure 5 shows a photograph of a ratchet adaptor, the serrated edge of which appears to be similar to that seen on the propeller blade shown in Figure 1.

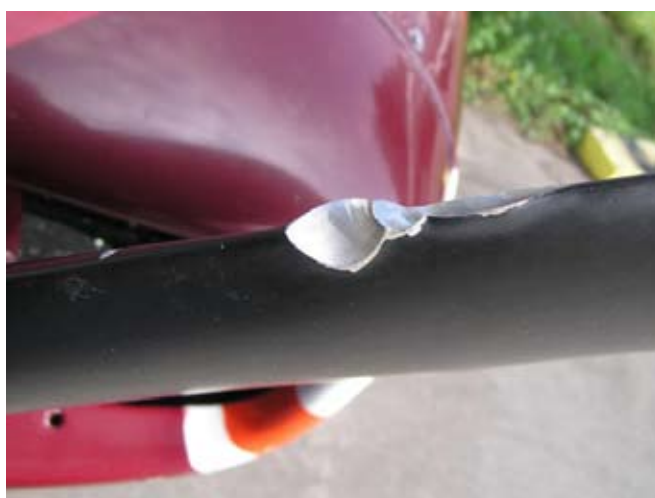
**Figure 2**

Damage to propeller leading edge

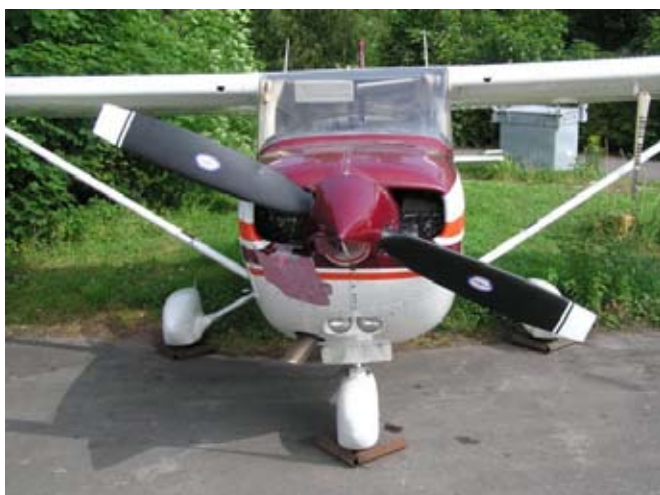
**Figure 3**

In addition, the forward face of the engine cowling had received one or more impacts that had caused the paint to flake off over a considerable area, Figure 3. Inside the engine compartment, there was evidence of mechanical damage over a small area of the fins of the front two cylinders (Nos 3 and 5) on the right side, Figure 4. No part of the aircraft had become detached which could have been responsible for the observed damage.

View showing damage to front of engine cowling

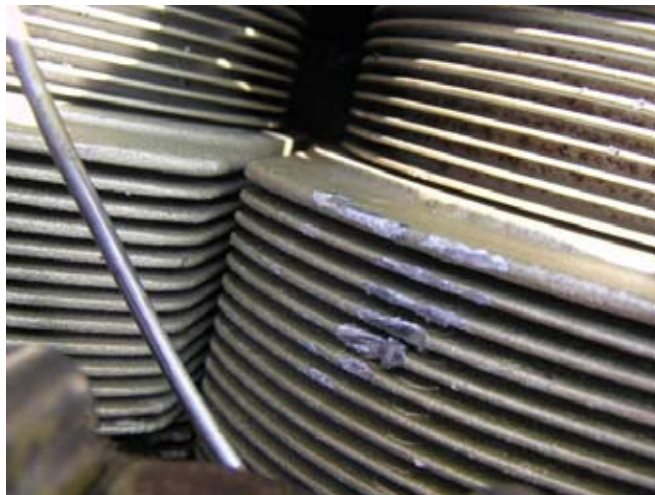
**Figure 4**

View of marks on cylinders

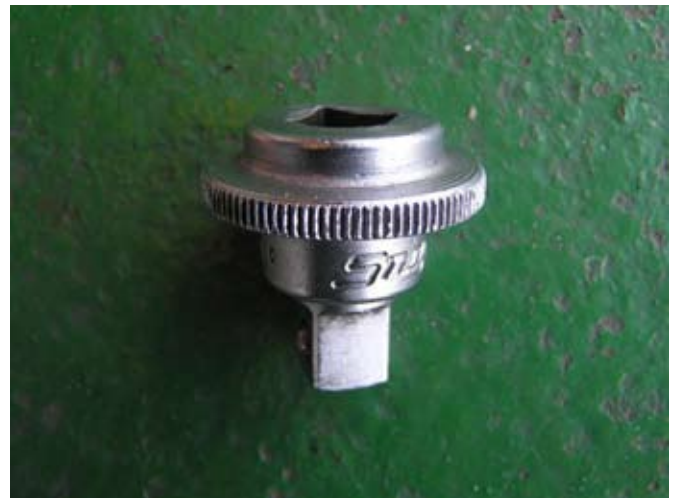
**Figure 5**

The aircraft had undergone a '50 hour' maintenance check approximately four flying hours prior to the incident. The available evidence suggested the possibility that a loose article left in the engine compartment had migrated forwards and out of the cooling air intake. It could then briefly have ricocheted between the propeller disc and the engine/cowling before falling away. However, the object would have had to move forwards against the airflow through the engine compartment, although this

Type of article that may have caused the damage to the aircraft
