ACCIDENT

| Aircraft Type and Registration: | Cessna T303 Crusader, G-PTWB |

Synopsis

The investigation identified that fuel starvation of both engines was the cause of the accident. One Safety Recommendation is made.

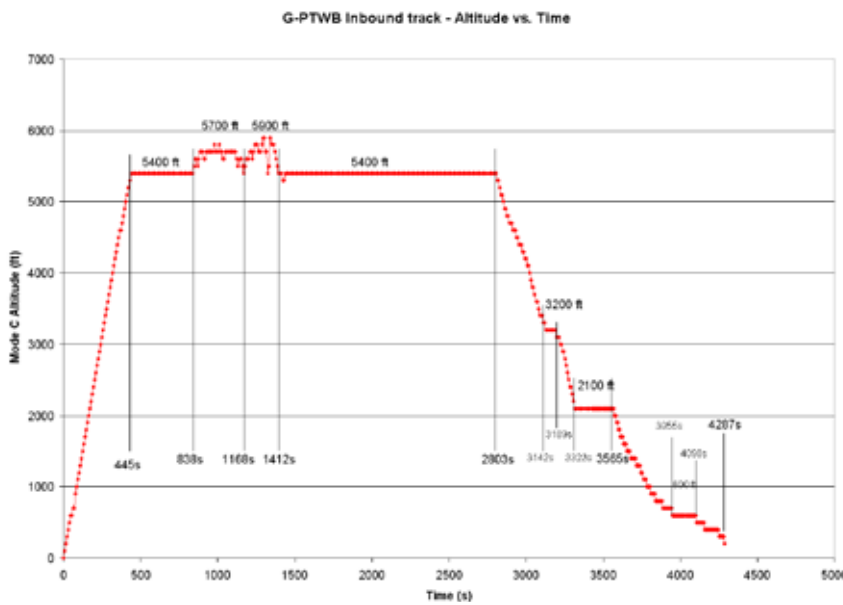
Figure 1

From the recorded radar data, the ground track of the aircraft and the vertical profile of the outbound and return flights were established. The ground track distance for the outbound flight was 196 nm and the return ground distance flown was 184 nm. This was a total increase of 24 nm over the planned distance of 178 nm. The flight profiles were plotted and used to estimate the outbound and return flight fuel consumption.

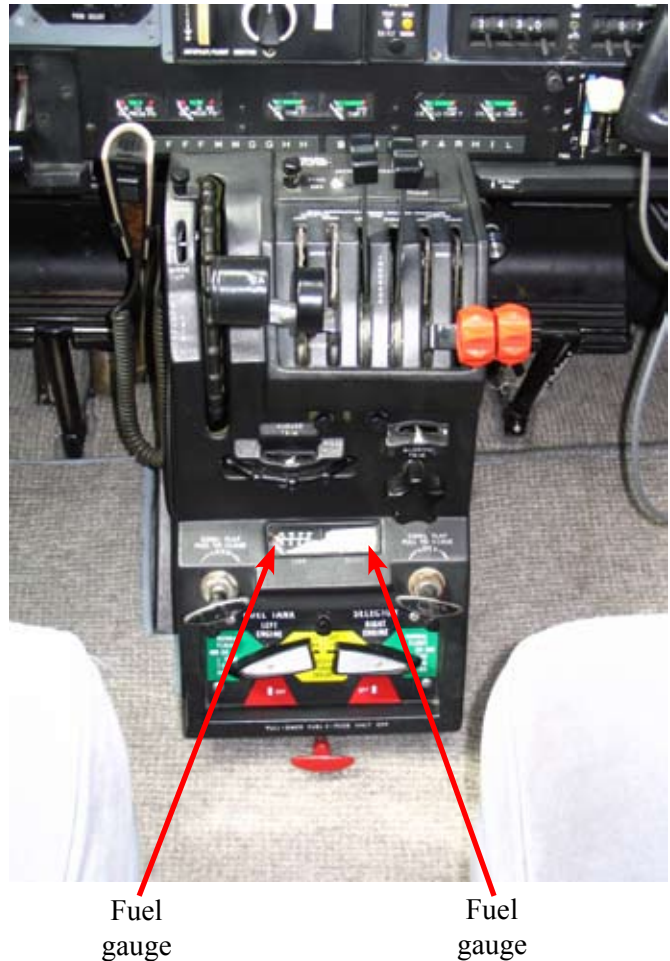
Figure 3

Each selector can be turned to the ‘OFF’, ‘ON’ or ‘CROSSFEED’ position. With the selector set to the ‘ON’ position, the relevant engine is supplied by the tank on the same side of the aircraft. When the ‘CROSSFEED’ setting is selected, the engine on the same side as that selector receives fuel from the tank on the other side of the aircraft, via crossfeed pipes which pass beneath the cabin. To prevent leakage of fuel, should one or both crossfeed pipes become damaged, crossfeed shutoff valves are provided. These are fitted close to the tanks. They ensure that only the fuel volume within the pipes, and no fuel from either tank, can be lost through any crossfeed pipe leakage once the shutoff valves are moved to the ‘OFF’ position. Both shutoff valves are operated via cables within conduits from a single T-handle below the fuel selector valve console. If the handle is pulled when both fuel selectors are in the ‘ON’ position, engine operation is not affected. If, however, it is pulled when a fuel selector is set to ‘CROSSFEED’, the supply to the engine on the side of the selector with that setting will be interrupted and the engine will not continue to operate. The cross-feed shut off valve control handle is painted red, signifying its emergency control status.

The crossfeed pipes have open pick-up points positioned on the inboard closure ribs of the fuel tanks, significantly

During the approach, the fuel crossfeed was used, which was not permitted. The selection of crossfeed from the left tank to the right engine was probably the cause of the right engine running down. This was due to insufficient fuel contents being available to allow fuel to be drawn from the left tank by the crossfeed pick-up. Pulling the crossfeed emergency shutoff control therefore did not contribute to the accident.

The information contained in the POH (Information Manual) and the crossfeed labelling was not clearly understood by either the pilot or the LPC examiner, and so the following Safety Recommendation is made:
