**ACCIDENT**

<b>Aircraft Type and Registration:</b>	Cessna T303 Crusader, G-PTWB
<b>No &amp; Type of Engines:</b>	2 Continental Motors Corp TSIO-520-AE piston engines
<b>Year of Manufacture:</b>	1984
<b>Date &amp; Time (UTC):</b>	5 August 2006 at 1810 hrs
<b>Location:</b>	Denham Green, Buckinghamshire
<b>Type of Flight:</b>	Private
<b>Persons on Board:</b>	Crew - 1                      Passengers - 5
<b>Injuries:</b>	Crew - 1 (Serious)      Passengers - 5 (Serious)
<b>Nature of Damage:</b>	Aircraft destroyed
<b>Commander's Licence:</b>	Private Pilot's Licence
<b>Commander's Age:</b>	60 years
<b>Commander's Flying Experience:</b>	1,717 hours (of which 662 hours were on type) Last 90 days - 37 hours Last 28 days - 5 hours
<b>Information Source:</b>	AAIB Field Investigation

**Synopsis**

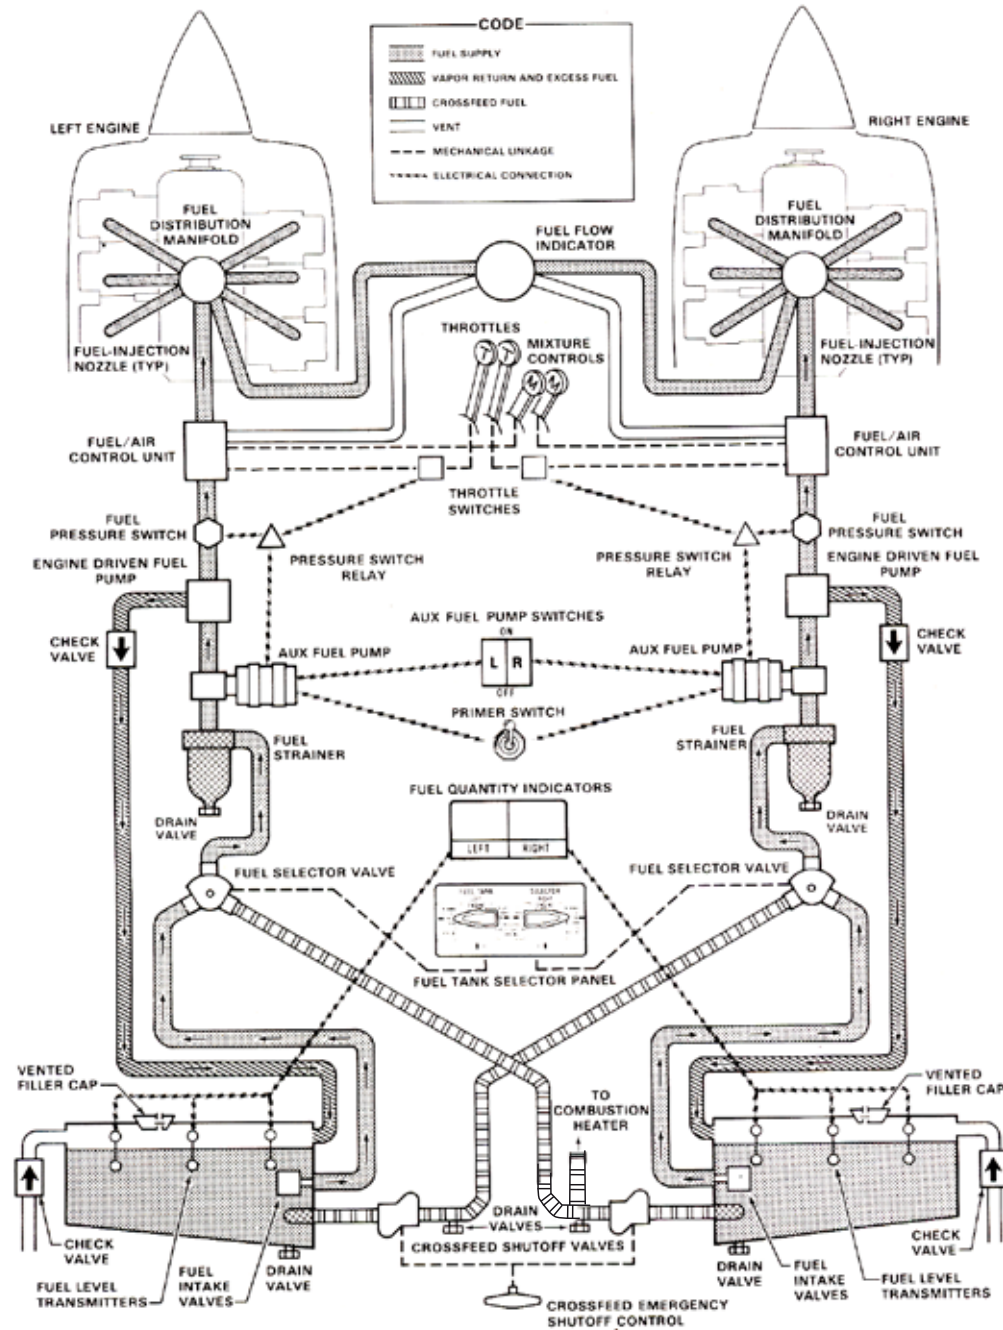
Figure 4  
Fuel system diagram

From the fuel system diagram and the system description text, they concluded that to crossfeed fuel from the left

tank to the right engine, two actions were required. The right engine rotary fuel selector should be turned to the CROSSFEED (yellow sector) position and the crossfeed emergency shutoff control should be pulled out to open the crossfeed fuel line. The use of the crossfeed emergency shutoff control is not clearly explained in the fuel system description. Immediately above the red coloured crossfeed emergency shutoff control, written in white letters on a black background, is the following instruction:

An additional limitation was relevant when using the fuel system crossfeed controls. The crossfeed fuel line pickup in the tank was above the lowest point of the tank. In order to prevent the pilot attempting to crossfeed when the fuel level was lower than the pickup, a minimum fuel level and phase of flight was imposed. This was stated in the fuel system description as follows:

During the approach, the fuel crossfeed was used, which was not permitted. The selection of crossfeed from the left tank to the right engine was probably the cause of the right engine running down. This was due to insufficient fuel contents being available to allow fuel to be drawn from the left tank by the crossfeed pick-up. Pulling the crossfeed emergency shutoff control therefore did not contribute to the accident.

The information contained in the POH (Information Manual) and the crossfeed labelling was not clearly understood by either the pilot or the LPC examiner, and so the following Safety Recommendation is made:
