No: 11/89

Ref: EW/C1126

Aircraft Type and Registration: (1) Stolp Starduster Too SA300, G-DUST
(2) Luscombe Silvaire, G-AKTM

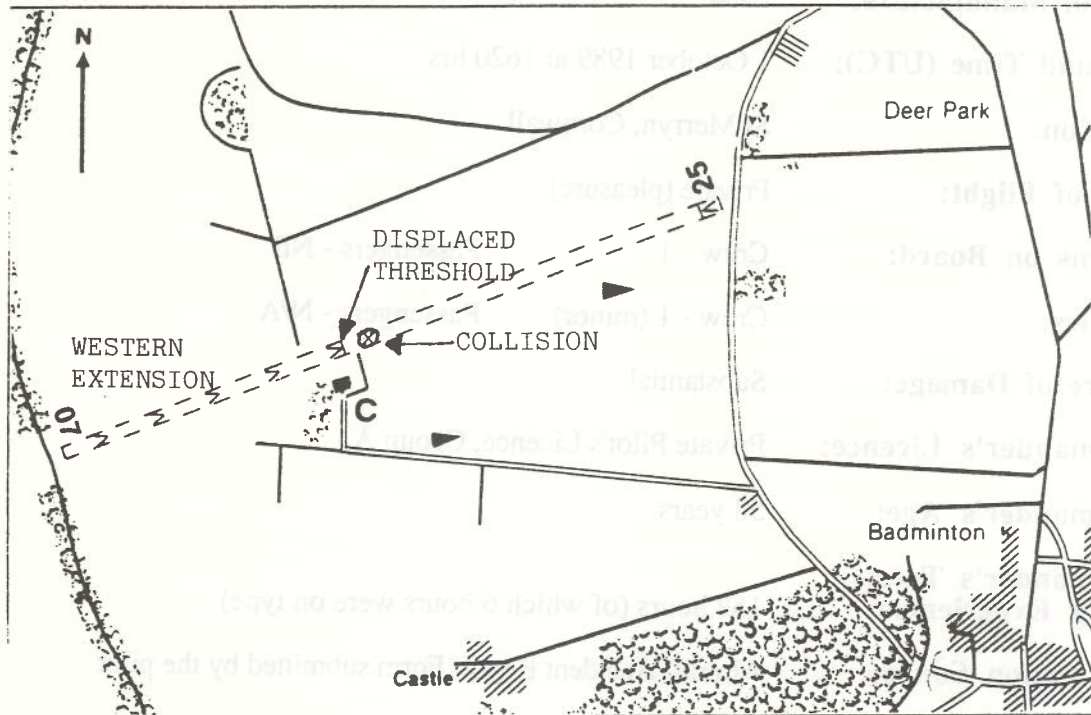
The aircraft were flying in for the annual Badminton Air Day but, because of poor weather earlier that morning, a number of aircraft had delayed their departure to Badminton. At the time of the accident the circuit was extremely busy with a mixture of non-radio and radio equipped aircraft converging on the airfield. The weather at the time of the accident was given as wind 030°/08 kt, visibility 5 km, cloud an estimated 5 oktas at 1,200 feet agl. The grass runway 07 was in use with a published Landing Distance Available of 800 metres. There is however a further extension to this runway of 450 metres to the west which may be used by light aircraft. The control tower, taxiway and parking area are in line with, and to the south of the published 07 threshold. An aerodrome chart for Badminton is reproduced courtesy of Pooley's Flight Guide.
