ACCIDENTS INVESTIGATION BRANCH
Department of Trade and Industry

Report on the accident to
Aeronca C 100 G - AETG
which occurred near High Wycombe,
Buckinghamshire, on 7 April 1969

Civil Accident Report No EW/C/311

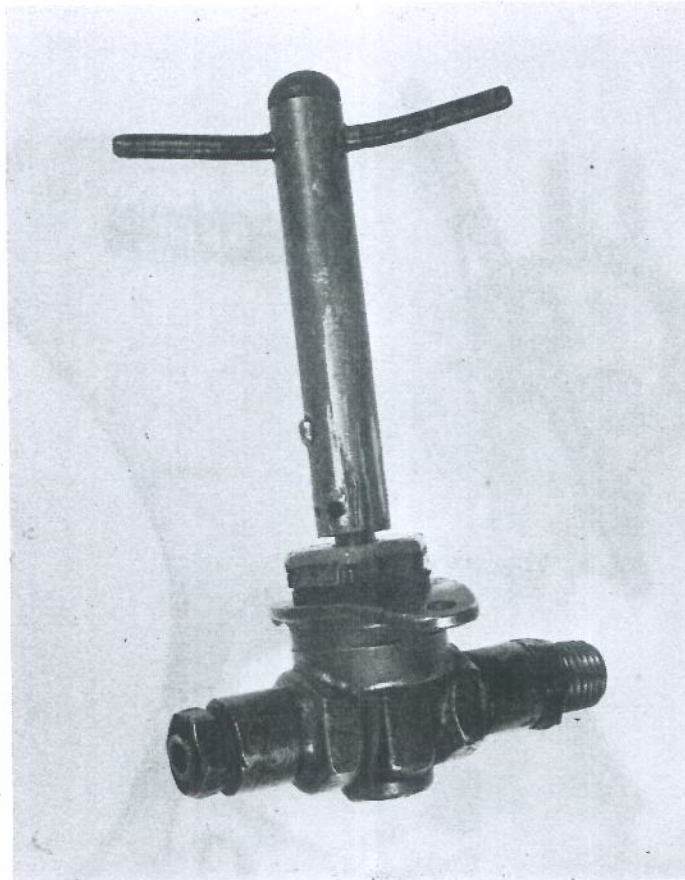
The fuel cock fitted to the aircraft consists of a drilled tapered plug rotating in a matching body. As the plug is rotated, it progressively opens and closes off the supply of fuel alternately every 90° of movement. The original design of this type of cock provides for the addition of a spring to retain the plug on its seating and stops to limit its rotary movement to 90°. These stops would enable the cock to be positively positioned in the ‘open’ or ‘shut’ settings. In the subject aircraft, neither the retaining spring nor the stops had been incorporated and the cock could be rotated through 360° in either direction (see Appendix Fig. 1). The cock was operated by means of an attached ‘T’ handle, the arms of which lined up with self adhesive labels stuck to the instrument panel indicating the fuel ‘ON’ and ‘OFF’ positions. (Fig 3) the labels were correctly positioned and the cock was fully open at the fuel ‘ON’ indication which corresponded approximately to a ‘5 minutes to 5 o’clock’ position of the fuel cock handle and ‘OFF’ at ‘10 past 8’. However, the secretary of the group had instructed members that the fuel cock was not to be turned off or adjusted between or during flights but was to be kept at the ‘5 past 7’ setting (Fig. 3). It has not been possible to establish why it was kept in this position instead of the correctly marked ‘ON’ setting of ‘5 minutes to 5’. During his checks of the fuel system, following the reported engine trouble on 5 April, the secretary had closed the cock slightly to an estimated ‘10 past 8’ position. He found that the engine would cut out when the throttle was opened with the fuel cock in this position but it operated satisfactorily when he had returned the cock to ‘5 past 7’.

The examination of the aircraft and the engine revealed no evidence of pre-crash failure, but the fuel cock, which was not fitted with positive 'ON/OFF' stops, was found near to the 'OFF' position. With the cock at this position, (described in the report as the '5 past 7' position), it provided only a very narrow elliptical-shaped opening for the fuel supply and the tests referred to in paragraph 1.15 of this report established that the fuel flow was so restricted that sustained operation at full throttle could eventually reduce the fuel level in the carburettor until the engine suffered a weak mixture 'cut'. In this accident, once the engine had stopped, there was insufficient height in which to get it re-started.

FIG.1 SHOWING FUEL COCK AND HANDLE ASSEMBLY WITH NO STOPS

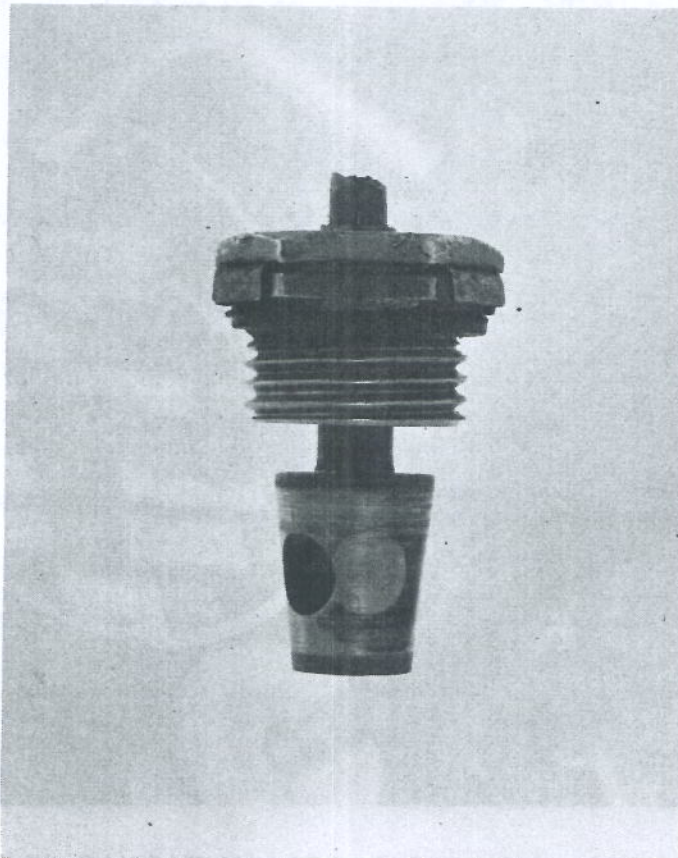
Dismantling of the fuel cock revealed witness marks on the tapered plug and the bore of the body of the cock which indicated that the cock had been set for a considerable period of time in an intermediate position (Fig 2). The marks corresponded to a '5 past 7' setting of the fuel cock handle. When examined after the accident the fuel cock was found stiff to operate and it is considered unlikely that it could have been moved inadvertently.

FIG.2 SHOWING WITNESS MARK ON PLUG OF FUEL COCK
CORRESPONDING WITH HANDLE IN "5 PAST 7" POSITION

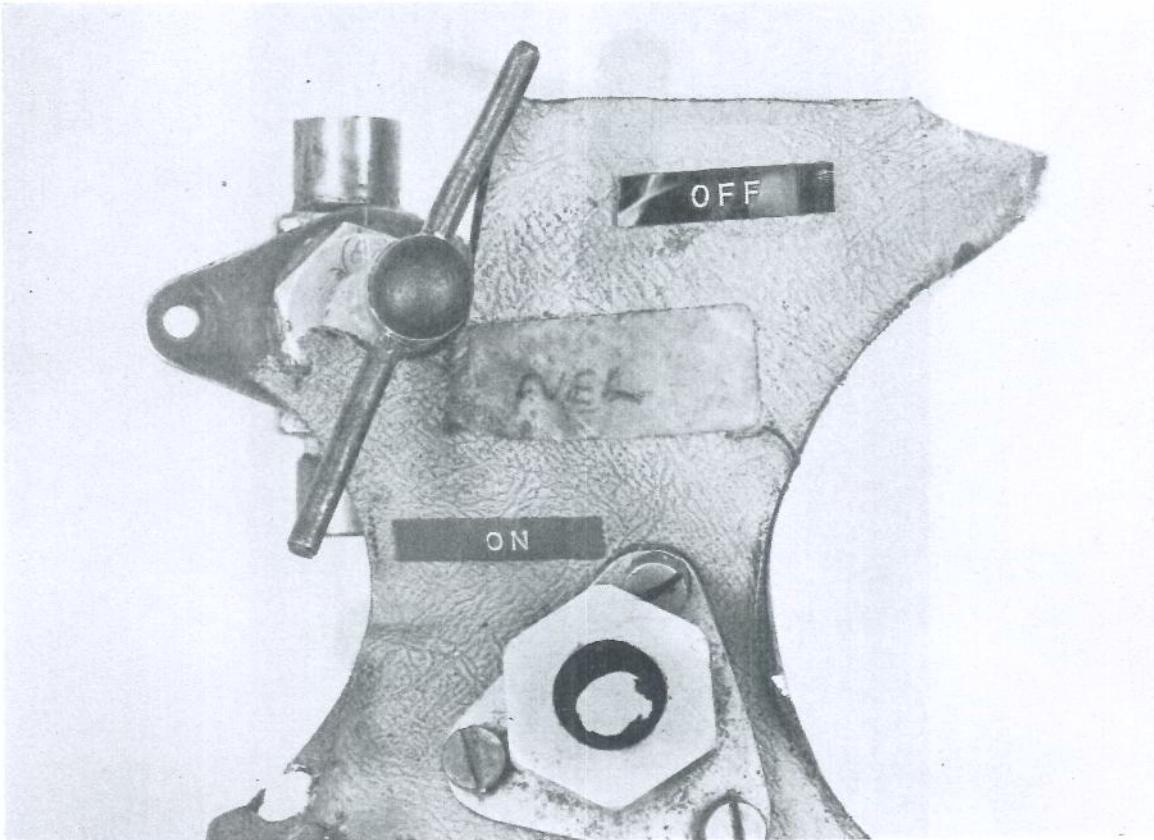
On removal of the fuel cock from the tank at the scene, on the day of the accident, it was noted that it was almost fully closed. When the cock and its associated operating handle were 'offered up' into the positions they appeared to have been in at impact it was noted that the partially open position corresponded to the '5 past 7' position of the cock handle.

Evidence obtained during the investigation shows that instructions had been given by the group secretary that the fuel cock was not to be moved from the '5 past 7' position and this position was accepted by the group pilots as being the correct 'open' position. It has not been possible to determine why this position was selected instead of the correctly-marked 'ON' position at '5 minutes to 5'. At the correct position, the fuel flow was more than adequate to supply the engine at full power. From the test carried out by the group secretary on the day before the accident, the accuracy of the adjacent '10 past 8', ('OFF') position was established. After the test he returned the cock to '5 past 7' although it is difficult to see how an accurate resetting to the original position could have been achieved. In accordance with the secretary's instructions, the fuel cock was not touched by the pilot on the subject flight.

FIG.3 FUEL COCK WITH HANDLE IN "5 PAST 7" POSITION (G-A E T G)

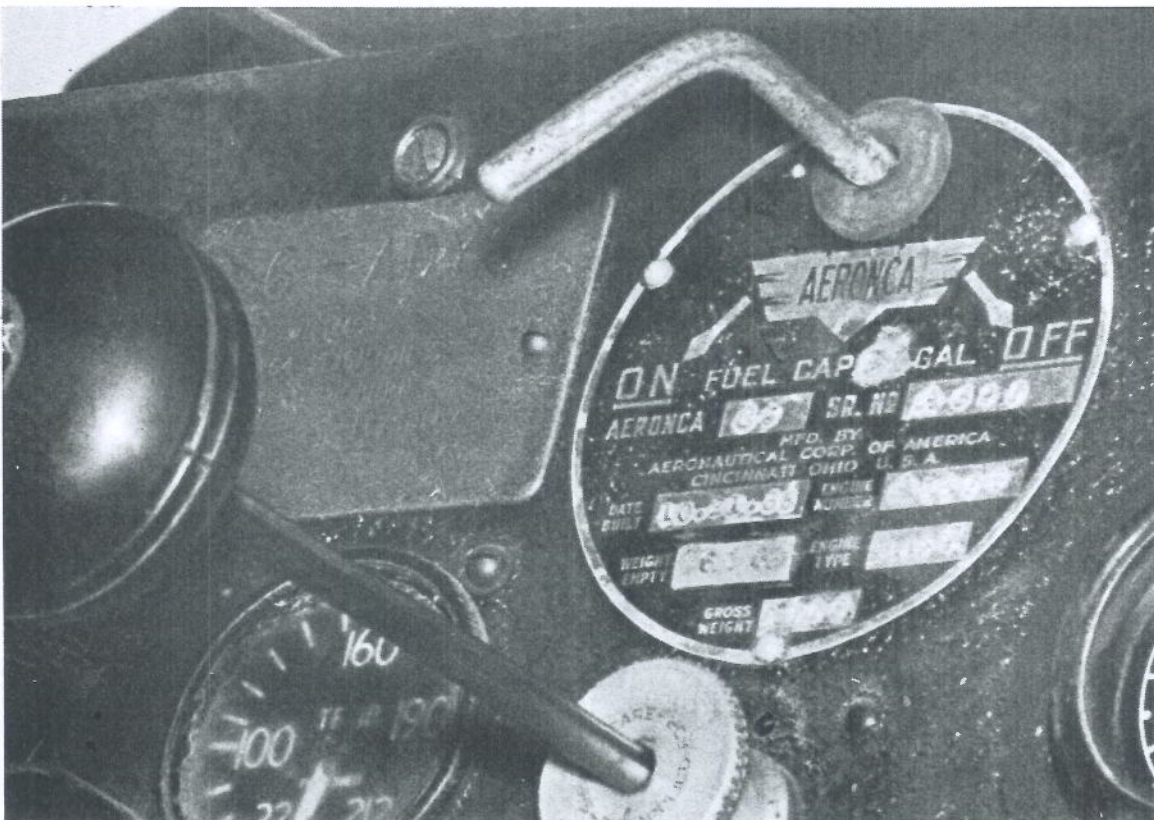
FIG.4 NORMAL AERONCA FUEL COCK HANDLE AND INDICATIONS
