INCIDENT

Aircraft Type and Registration:	Eurocopter EC155 B1, G-ISSV	
No & Type of Engines:	2 Turbomeca ARRIEL 2C2 turboshaft engines	
Year of Manufacture:	2006	
Date & Time (UTC):	10 March 2007 at 1801 hrs	
Location:	Norwich Airport, Norfolk	
Type of Flight:	Public Transport	
Persons on Board:	Crew - 2	Passengers - None
Injuries:	Crew - None	Passengers - N/A
Nature of Damage:	Fire damage to hoist electrical connector and oil cooler support fairing	
Commander's Licence:	Airline Transport Pilot's Licence	
Commander's Age:	46 years	
Commander's Flying Experience:	5,107 hours (of which 47 were on type, including 30 hours simulator training) Last 90 days - 97 hours Last 28 days - 28 hours	
Information Source:	AAIB Field Investigation

Synopsis

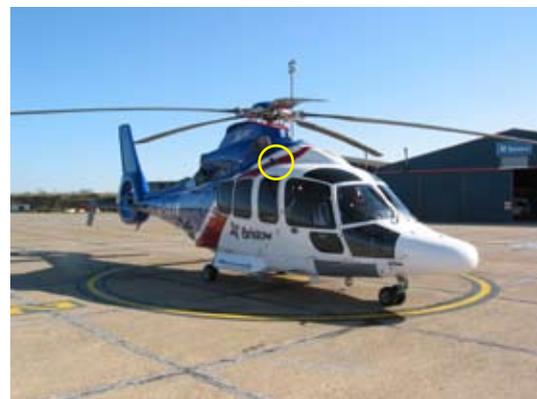
Figure 1

Location of EC155 Hoist Fixed Connector (circled)

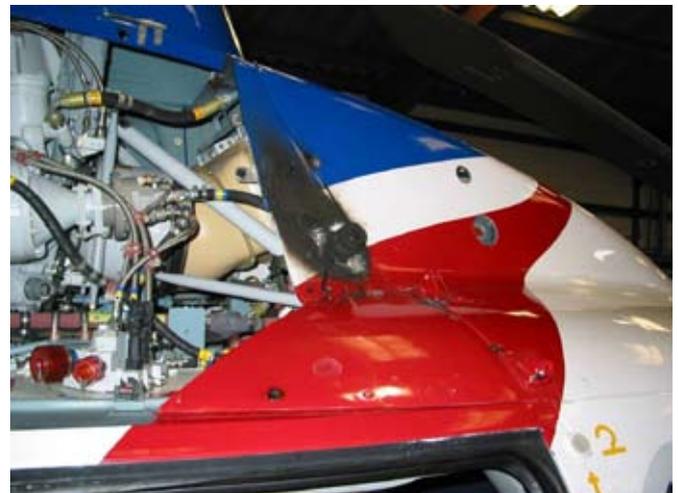
Figure 2

The aircraft was examined in the operator's maintenance hangar at Norwich Airport. The hoist connector was fire damaged and the right side of the oil cooler support fairing was badly charred in the vicinity of the connector (Figure 2). Localised charring was also visible at three fastener locations around the edges of the fairing, where it attached to the aluminium framework of the fuselage. The fire damage was more evident on the external side of the connector and the fairing.

Fire damage to hoist fixed connector and oil cooler support fairing

The strip examination of the fixed connector and shunt plug showed that arcing had occurred between the positive contact 'W' for the hoist motor and the body of the connector. The fire damage to the panel and the charring around the three fastener holes is indicative

that electrical current passed through the carbon fibre fairing and earthed to the aircraft structure. The electrical resistance of the shorting path was sufficiently high that the resulting current did not exceed the 130 ampere rating of the fuse.

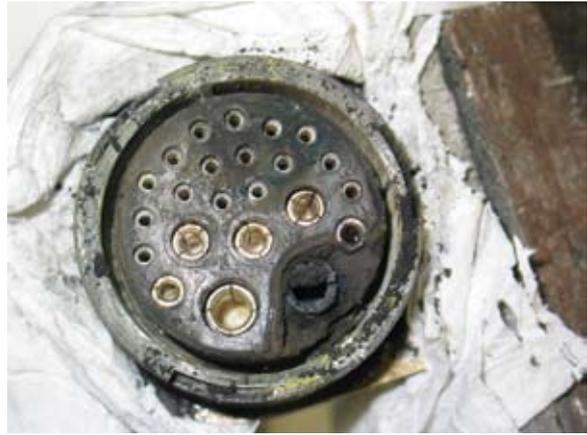
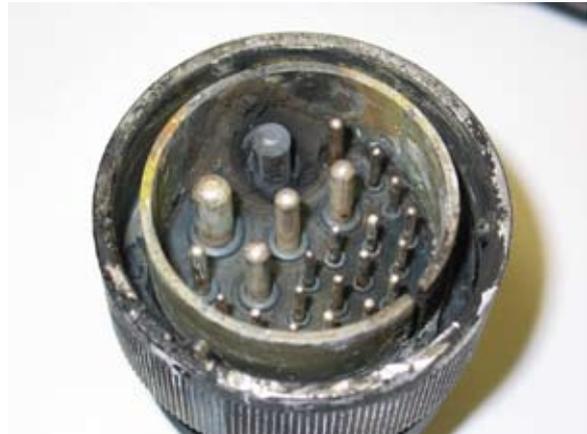
Figure 3

disassembly, evidence was found of arcing between the power contact ('W') and the body of the connector (Figure 3). The burning damage to the inner surface of the body was in the plane of the interface between the fixed connector and the shunt plug. The elastomeric insulator material in the vicinity of the power contact was heavily charred and partly burnt away. The heat damage was greatest in the vicinity of the power contact and the area of shorting on the connector body. The other contacts were free from significant heat damage.

Evidence of arcing between power contacts and body of connector

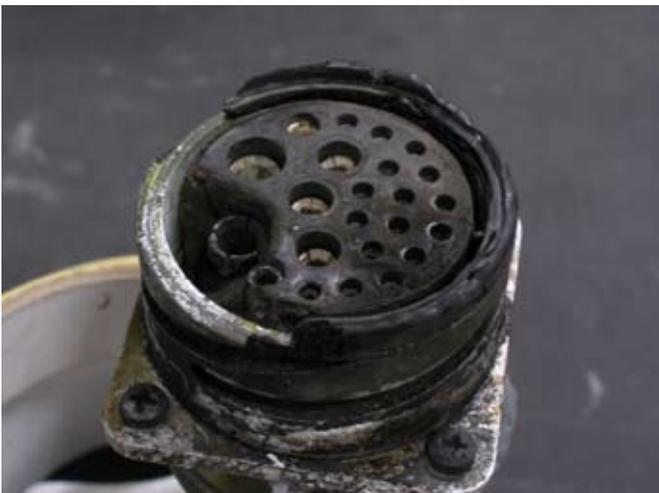
Figure 4

The environmental seal between the two parts of the connector was destroyed in the region closest to the power and earth pins. The remaining 60% of the seal was heat affected, but intact. Examination showed that it was deeply indented around the circumference due to being crushed against the sharp edge of the O-ring groove (Figure 4). Several deep circumferential cuts were also visible on one part of the seal circumference.

Damage to hoist connector environmental seal

have been resistant to the ingress of moisture, given that it was equipped with an environmental seal and the quality of the potting of the shunt plug was acceptable, the cuts in the seal could have provided a path for moisture from rain or aircraft washing, to enter the connector over a period of time. Once inside, it could have accumulated in the small gap at the interface of the fixed connector and shunt plug, until sufficient moisture was present to cause a short circuit.

The use of a square-section seal, whilst retaining the groove for an O-ring on the seal land, provides the potential for the seal to be damaged by being compressed against the sharp edge of the O-ring groove when the connector halves are assembled. To address this issue, the following Safety Recommendation is made:

Safety Recommendation 2007-072

It is recommended that Eurocopter modify the method of sealing the hoist connector '24 DELTA' on EC155 aircraft, to ensure that it is effective in preventing moisture ingress into the connector.

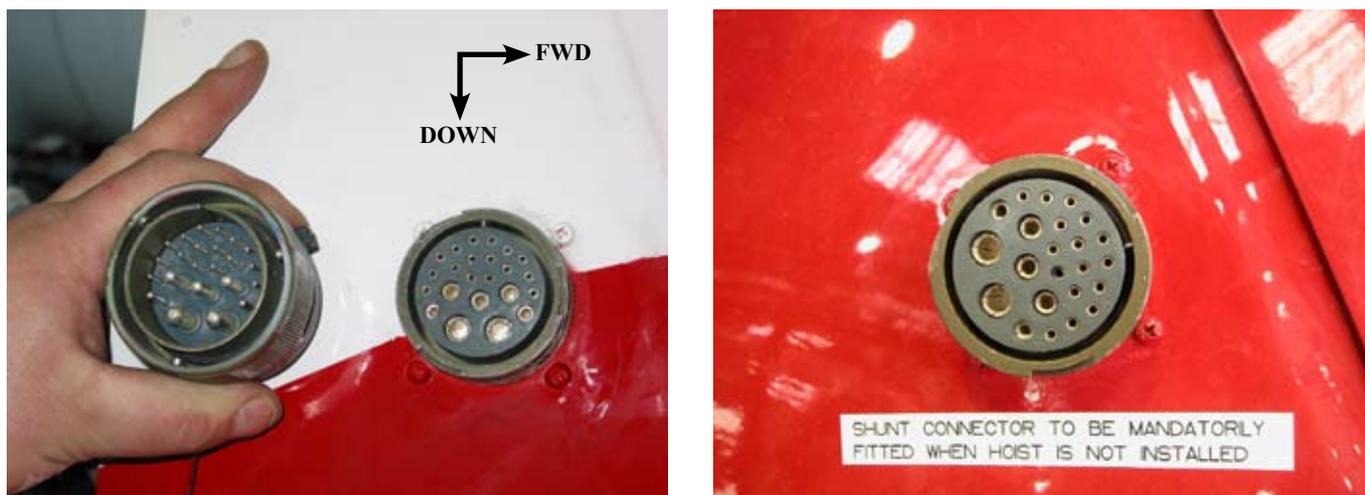
Figure 5

It was noted that the fixed connector on G-ISSV was installed with the power and earth contacts lowermost. The connector on another of the operator's recently-delivered EC155 helicopters was similarly oriented. However, inspection of another new EC155 at the aircraft manufacturer's facility showed that the fixed connector on this aircraft was installed with the power and earth contacts facing aft (Figure 5).

Differing orientations of hoist fixed connector

In this and the previous hoist fire incident, the fixed connector was installed with the power and earth contacts facing downwards. This orientation of the contacts could increase the likelihood of an electrical short if moisture is present within the connector. To reduce the likelihood of shorting, the following Safety Recommendation is made:

Safety Recommendation 2007-073

It is recommended that Eurocopter determine the most appropriate orientation for mounting the EC155 hoist fixed connector to minimise its susceptibility to shorting from moisture ingress.

The ASB requires that operators inspect the hoist fixed connector '24 DELTA' within seven days of receipt of the ASB and, if required, reposition the connector so that the power and earth contacts 'W' and 'X' are facing aft. It also requires that the power supply cable to the hoist fixed connector be disconnected at the electrical master box '2 ALPHA', until such time as a grounding strap has been installed to the body of the connector, in accordance with the instructions provided in the ASB. This is to provide a low resistance path to earth to ensure that the fuse will blow in the event of the power pin shorting to the connector body.
