<b>Aircraft Type and Registration:</b>	Hughes 369HS, G-CSPJ	
<b>No &amp; Type of Engines:</b>	1 Allison 250-C20 turboshaft engine	
<b>Year of Manufacture:</b>	1976	
<b>Date &amp; Time (UTC):</b>	19 July 2003 at 0849 hrs	
<b>Location:</b>	Cudham Lane South, Knockholt, Sevenoaks, Kent	
<b>Type of Flight:</b>	Private	
<b>Persons on Board:</b>	Crew - 1	Passengers - 2
<b>Injuries:</b>	Crew - 1 (Fatal)	Passengers - 2 (Fatal)
<b>Nature of Damage:</b>	Aircraft destroyed	
<b>Commander's Licence:</b>	Private Pilot's Licence	
<b>Commander's Age:</b>	39 years	
<b>Commander's Flying Experience:</b>	112 hours (of which 8 were on type) Last 90 days - 12 hours Last 28 days - 3 hours	
<b>Information Source:</b>	AAIB Field Investigation

### Synopsis

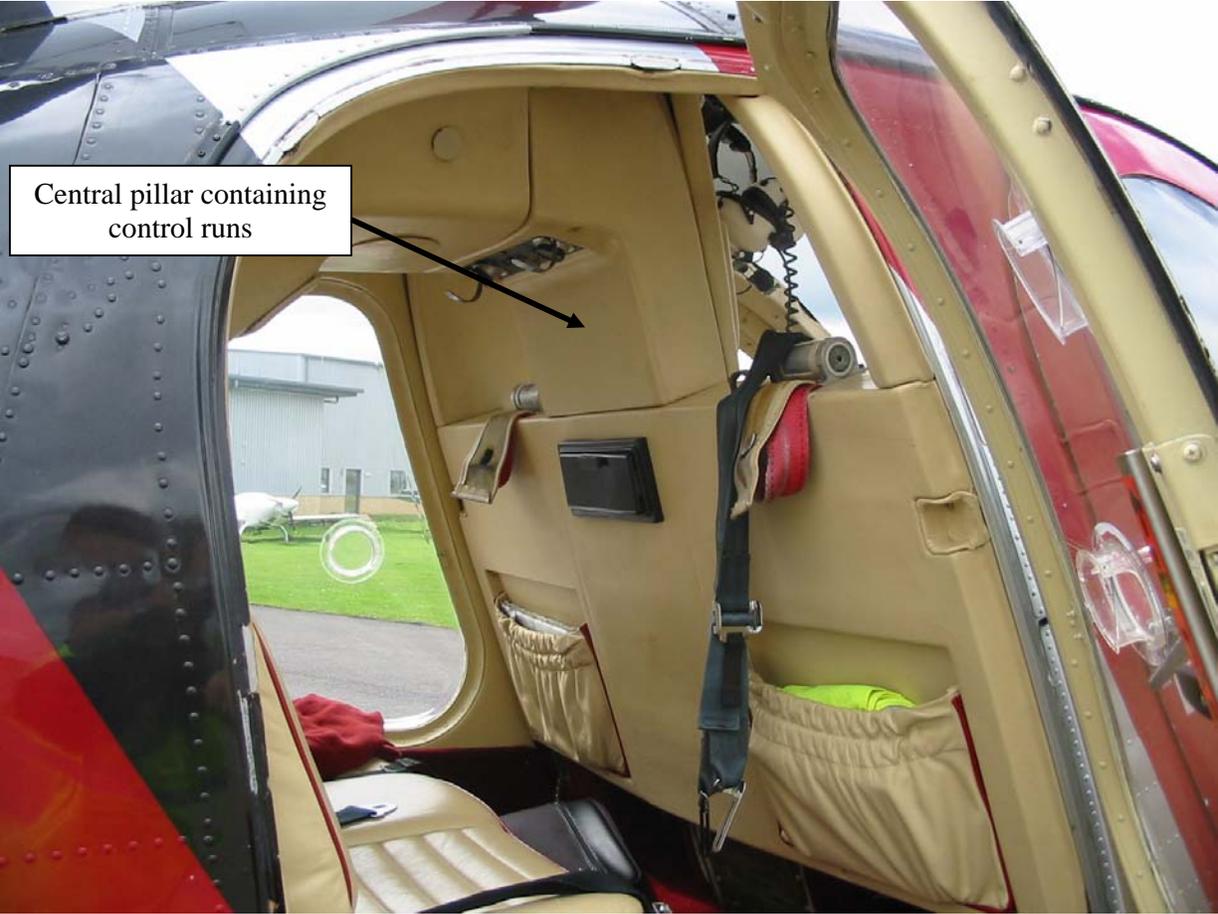
**Figure 1**  
(View from rear right seat – Hughes 369HS)

The helicopter had already been refuelled and repositioned outside the hangar by one of the helicopter operator's own pilots to make room for a Jet Ranger that was in the hangar, in which he and another pilot were about to depart. The pilot of the Hughes was seen by the crew of the Jet Ranger to carry out a pre-flight inspection on his aircraft before strapping his son into a child's car seat which had been secured in the rear left seat of the helicopter. The Jet Ranger then took off and departed before the pilot and his wife had boarded the Hughes. Subsequent evidence showed that the pilot flew the Hughes from the front left seat, as is normal for this type, and his wife sat in the rear right seat. From his position, the pilot would have had difficulty in seeing his wife, and vice versa because of the central pillar behind and between the two front seats which contained the main rotor control runs (see Figure 1). Also, he would have had at least as much difficulty in seeing his son who was sat directly behind him.

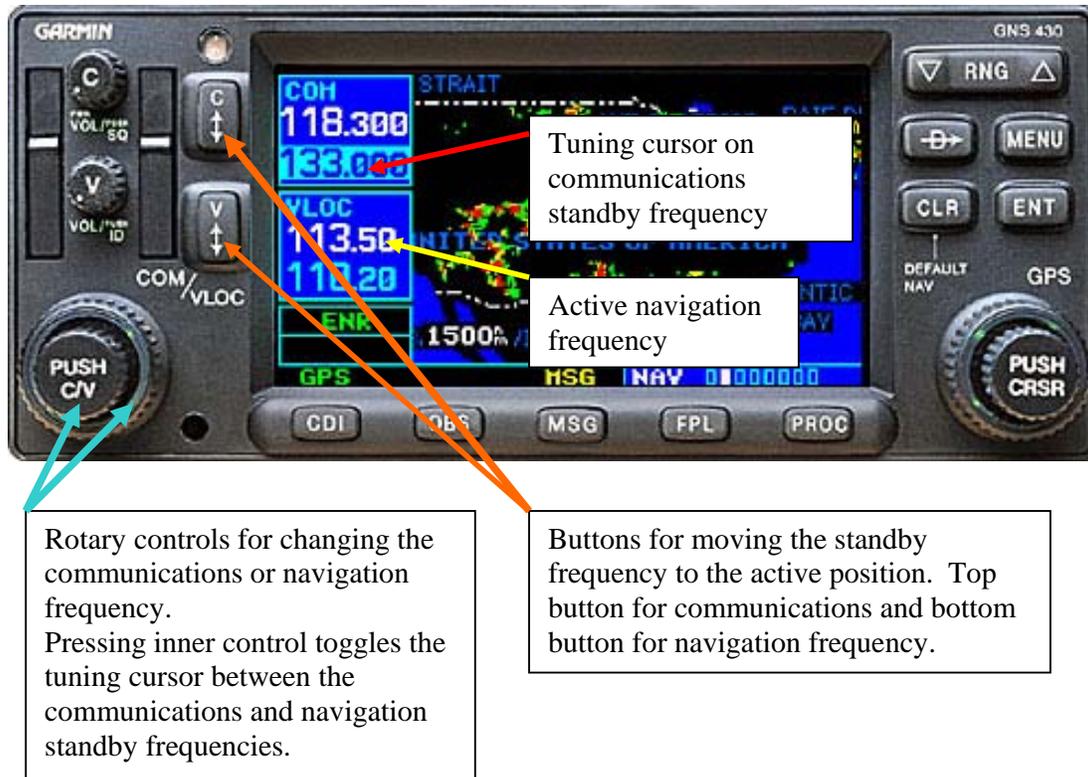
**Figure 3**  
(Garmin GNS 430)

The aircraft was fitted with the Garmin GNS 430, which combines VHF communications, navigation functions and moving map graphics on a single colour display (see Figure 3). The communications and navigation frequencies are both altered by means of the same co-located rotary knobs (one inner and one outer) situated on the bottom left hand corner of the combined control panel and display. Rotating the outer knob changes the MHz frequencies and the inner knob similarly changes the kHz frequencies. Momentarily pressing the inner knob toggles the tuning cursor between the communications and navigation standby frequency displays. It is possible to do this accidentally while changing the kHz part of the communications or navigation standby frequency. Both the communications and navigation displays show their respective active and standby frequencies. Pressing separate buttons for each facility moves the standby frequency to the active position.

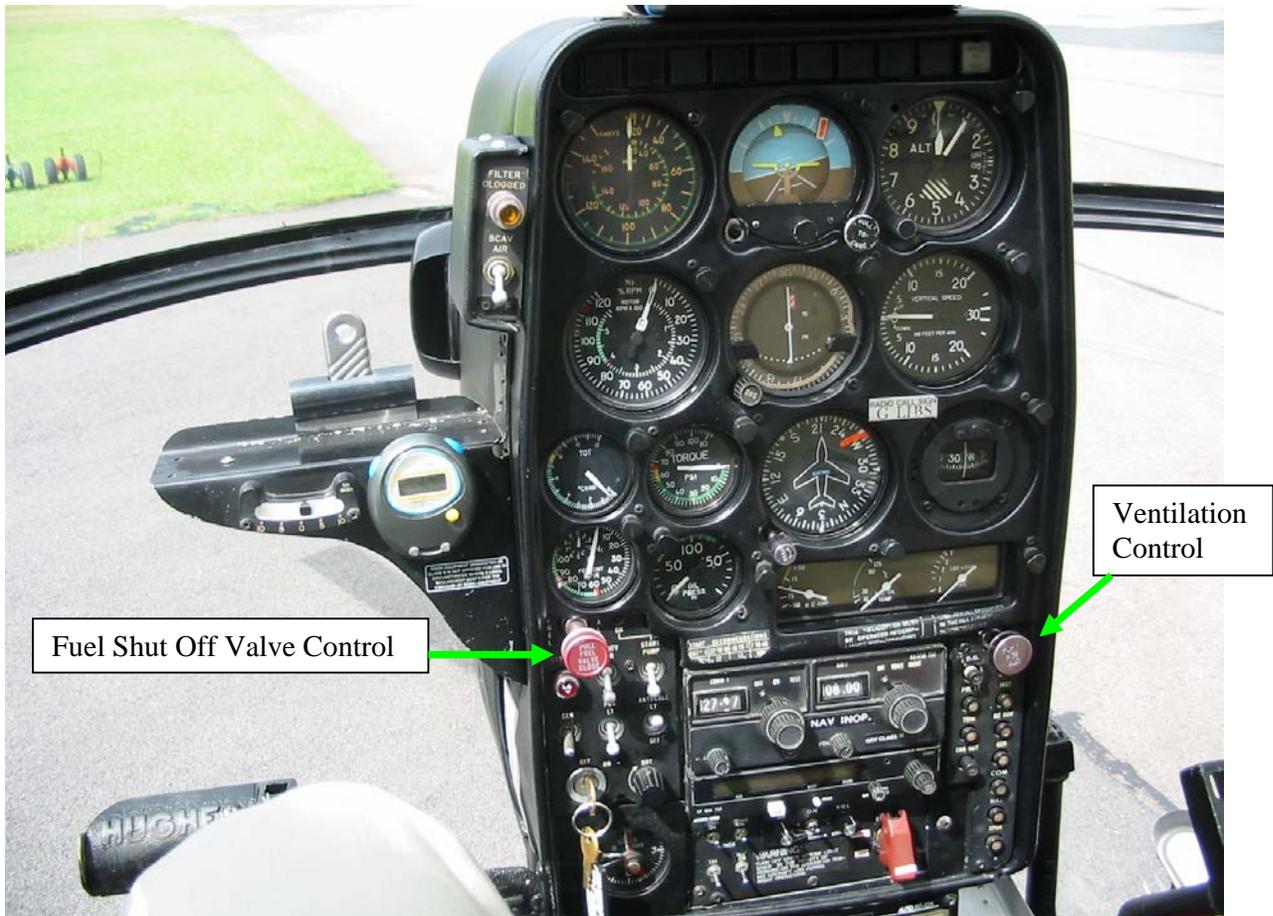
**Figure 4**  
(Instrument console – Hughes 369HS)

The fuel shut off valve is operated by a push-pull control on the left side of the instrument panel. The control, which is pulled out to close the valve, is in a similar but opposite position to the ventilation control on the right side of the panel (see Figure 4). In the Jet Ranger there are two ventilation controls and they are situated in comparable positions to the fuel shut off valve and the ventilation control in the Hughes (see Figure 5). Further, the shapes of the fuel shut off valve and the ventilation control in the Hughes are similar although the fuel shut off control is red in colour whereas the air vent control is black.

Consideration was given to the possibility that the pilot could, accidentally, have pulled and closed the fuel shut off valve, mistaking it for a ventilation control which is in a similar position in the Jet Ranger. It was a warm day and, even at that early stage in the flight, the temperature may have been rising uncomfortably, particularly for the pilot's wife and son who were sitting on the back seat. If that was the case, the pilot must have re-opened the fuel shut-off valve because the engine was producing power when the aircraft struck the ground. In addition, following such an unintentional slip, it is likely that the pilot would have been very conscious of the aircraft's proximity to the ground and, as it approached, he would probably have flared the aircraft to reduce both its rate of descent and forward speed, either to execute a forced landing or to avoid the ground. By contrast, witnesses stated that the aircraft pitched down just before striking the ground and the wreckage trail indicated that it had a high forward speed.
