Aircraft Type and Registration: Aerospatiale AS332L, G-TIGC

Date and Time (UTC): 26 June 1987 at 1155 hrs

Nature of Damage: Failed horizontal stabiliser spar

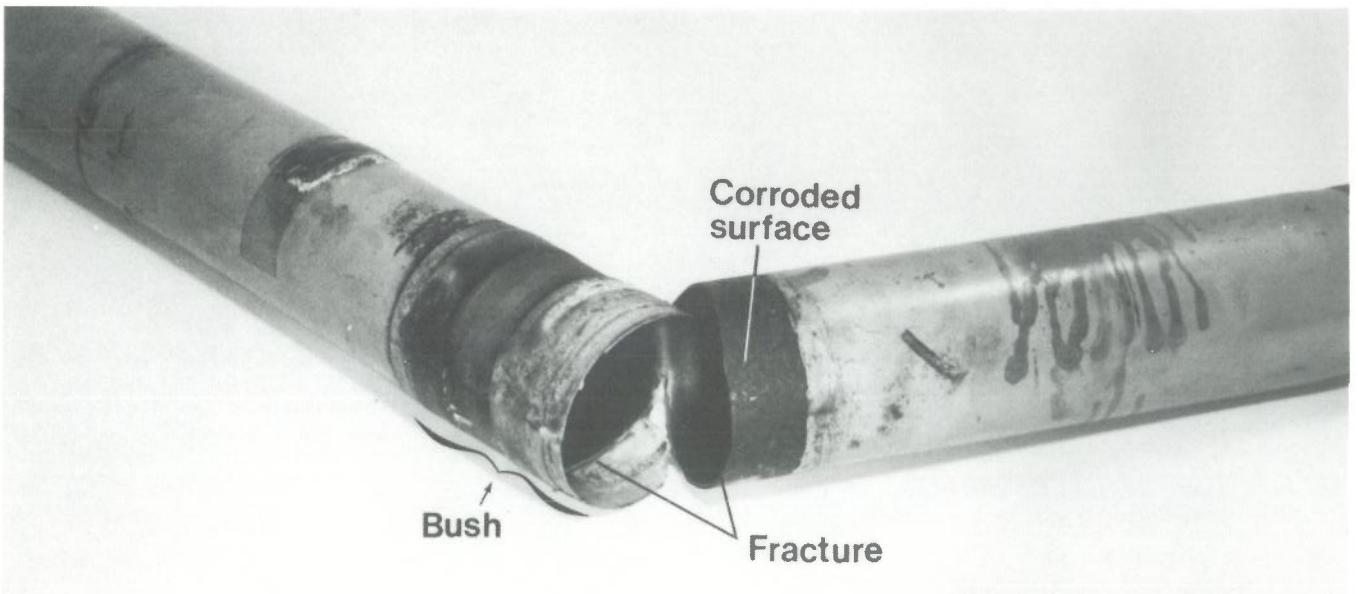
It was apparent that there had been a failure of the 80 mm diameter tubular steel spar within a glass fibre bush that covered that portion of spar bridging the gap between the horizontal and vertical stabiliser (See Figure). The fracture extended transversely around approximately 90% of the circumference. Metallurgical examination revealed a fatigue origin marked by corrosion staining and positioned some 60° aft of top dead centre. The fracture exhibited fatigue characteristics either side of the origin, extending to some 40% of the circumference, the remainder being fast fracture. The surface

of the tube adjacent to the fracture, that had been covered by the bush, was severely corroded over most of its area, and there was no evidence of any adhesive bond remaining between the bush and the spar. It was observed that the fatigue origin was associated with a corrosion pit of approximately 0.2 mm depth.

The bushes tend to wear in service and are thus periodically replaced. A new bush had been fitted to the subject spar. The method of replacement is detailed in the appropriate Maintenance Manual Work Card, with the surface preparation before bonding being the subject of a Standard Practice Card, both issued by the aircraft manufacturer. The Standard Practice Card directed that the passivated surface (on the cadmium plating of the spar) be removed by sanding with abrasive cloth of 180 to 200 grit size. This instruction would inevitably cause loss of the cadmium layer, the presence of which is not specifically mentioned. There was no instruction to subsequently replace the cadmium. Reprotection of the surface beyond the new bush was confined to a touch-up with primer and top-coat.

Fracture of spar within GFRP bush

Following the incident, the manufacturer issued a Service Telex calling for replating (with cadmium) of the affected area prior to bush replacement. However, the operator is currently removing the old bushes by means of a vacu-blast process which also obviates the requirement to use abrasive cloth to prepare the cadmium surface for subsequent bonding.
