Aircraft type and registration:	Boeing 747-100 N656PA (multi-jet public transport aircraft)	
Year of manufacture:	1971	
Date and time (GMT):	18 January 1984 at 1410 hrs	
Location:	London Heathrow Airport	
Type of flight:	Scheduled Passenger	
Persons on board:	Crew — 15	Passengers — 392
Injuries:	Crew — Nil	Passengers — Nil
Nature of damage:	Rupture to No 3 engine diffuser casing causing damage to the engine cowlings, pylon skin and adjacent leading edge flap	
Commander's Licence:	Air Transport Rating	
Commander's Age:	57 years	
Commander's total flying experience:	20,172 hours (of which 4,142 were on B 747 types)

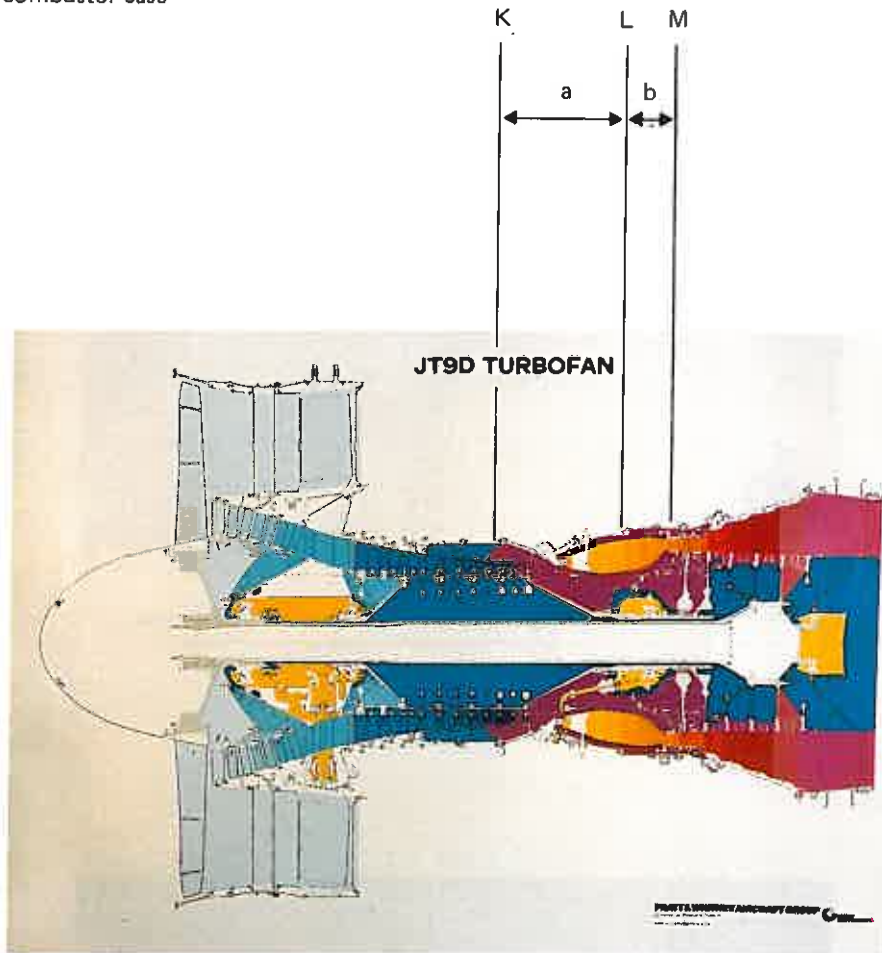
FIG 1 Colour cross-sectional diagram of JT9D with diffuser case and outer combustion case annotated in addition to flanges K, L and M

The damaged engine was transferred to the operator's overhaul facility for a detailed strip examination. This revealed that the primary failure had occurred in the diffuser module and that all other observed damage was consistent with having been caused by failure of the case, ref. Figure 1.

The rupture was confined to the diffuser case/outer combustor case area and extended from the high pressure compressor case/diffuser case mating flange (K) through the diffuser case/outer combustor case mating flange (L) and terminated at the outer combustor case/high pressure turbine case mating flange (M). The primary rupture had occurred over an axial distance of 33 inches at the 5-6 o'clock position (viewed

from the rear) with secondary circumferential ruptures occurring around the 2–10 o'clock position in the region of K flange. The widest separation of the case occurred at M flange and measured 15".

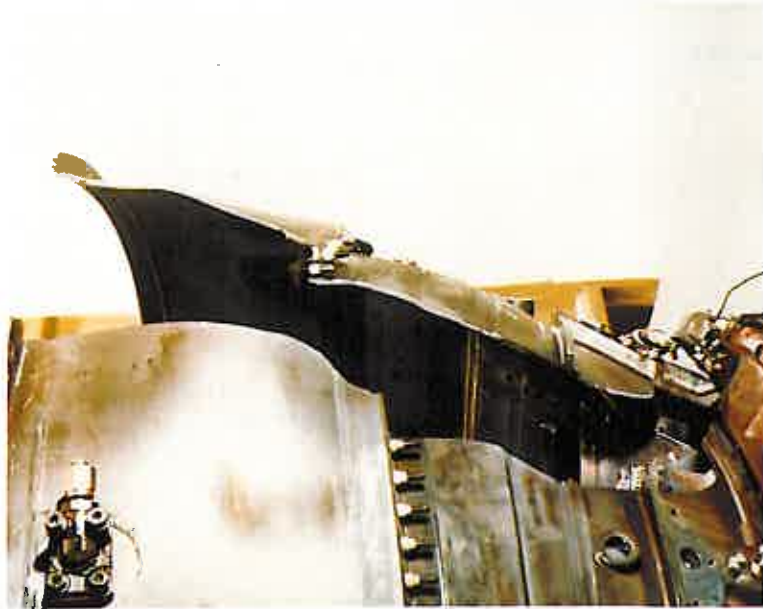
FIG 2 Colour reproduction of photo showing casing split, with discoloured area and rear rail indicated

The fracture surfaces exhibited a fresh greyish appearance throughout with the exception of an area in the vicinity of the diffuser rear rail;* adjacent to a boss at the engine 6 o'clock position. This area was discoloured a dull brown over a length of 4.80", which extended forward and aft of the rear rail. A previously welded crack repair was co-incident with a 2.8" section of the discoloured fracture surface, 1" of this being forward and 1.8" aft of the rear rail centre-line, ref. Figure 2.

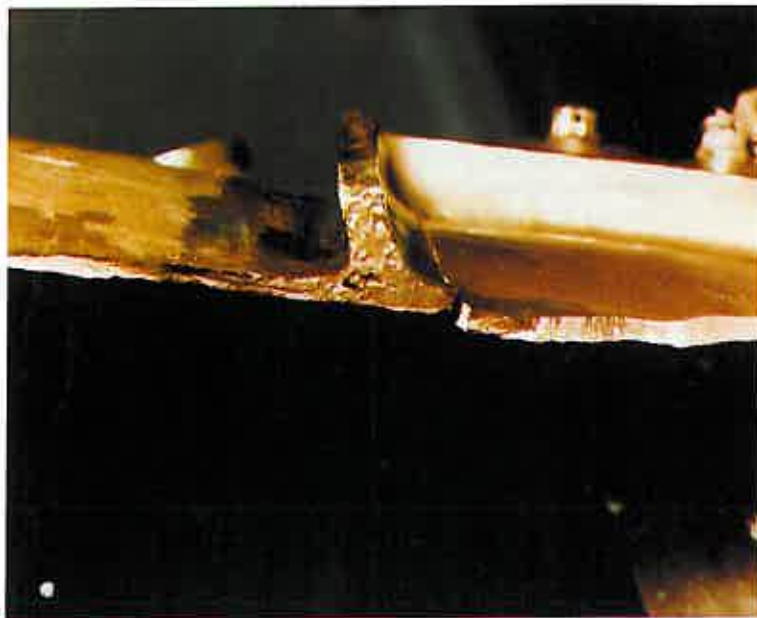
FIG 3 Colour reproduction of close-up photo of fatigue/weld area. Extent to fatigue highlighted

Metallurgical examinations of the fracture surfaces, conducted by the engine manufacturer and the AIB have determined that the 4.8" discoloured area exhibited evidence of fatigue, from multiple origins, whilst the remainder were consistent with having suffered failure from direct overstressing. It was apparent that the weld repair co-incident with the discoloration was sub-standard (ref. JT9D Engine Manual, Section 72-41-01), this being characterised by incomplete fusion of the weld, voids, cold shuts and poor surface finish, ref. Figure 3.

At the time of the accident the diffuser case had accumulated 35,153 hours/9646 cycles since being manufactured in 1970, 7462 hours/1352 cycles since its last inspection and repair at the operator's overhaul base. At that time a total of 21 cracks were detected and weld repaired. It did not prove possible from the available records, presented by the manufacturer and operator, to determine when and where the particular repair had been carried out.

Since the accident the engine manufacturer has recommended, amongst other checks, that a once off on wing inspection be carried out on all diffuser cases, with particular attention to be paid to the 6 o'clock boss location, using a flexible borescope. Both the operator and manufacturer of the engine have now shown this to be possible without the removal of any engine components.
