Beech 200 Super King Air, G-OWAX

AAIB Bulletin No: 7/2003	Ref: EW/G2002/07/35	Category: 1.2
INCIDENT		
Aircraft Type and Registration:	Beech 200 Super King Air, G-OWAX	
No & Type of Engines:	2 Pratt & Whitney Canada PT6A-41 turbine engines	
Year of Manufacture:	1977	
Date & Time (UTC):	23 July 2002 at 0700 hrs	
Location:	12 nm north-east of Clacton, Essex	
Type of Flight:	Public Transport (Passenger)	
Persons on Board:	Crew - 2	Passengers - 8
Injuries:	Crew - None	Passengers - None
Nature of Damage:	Damage to main cabin door	
Commander's Licence:	Airline Transport Pilot's Licence	
Commander's Age:	64 years	
Commander's Flying Experience:	15,100 hours (of which 3,114 were on type)	
	Last 90 days - 39 hours	
	Last 28 days - 16 hours	
Information Source:	Aircraft Accident Report Form submitted by the pilot and further enquiries by AAIB

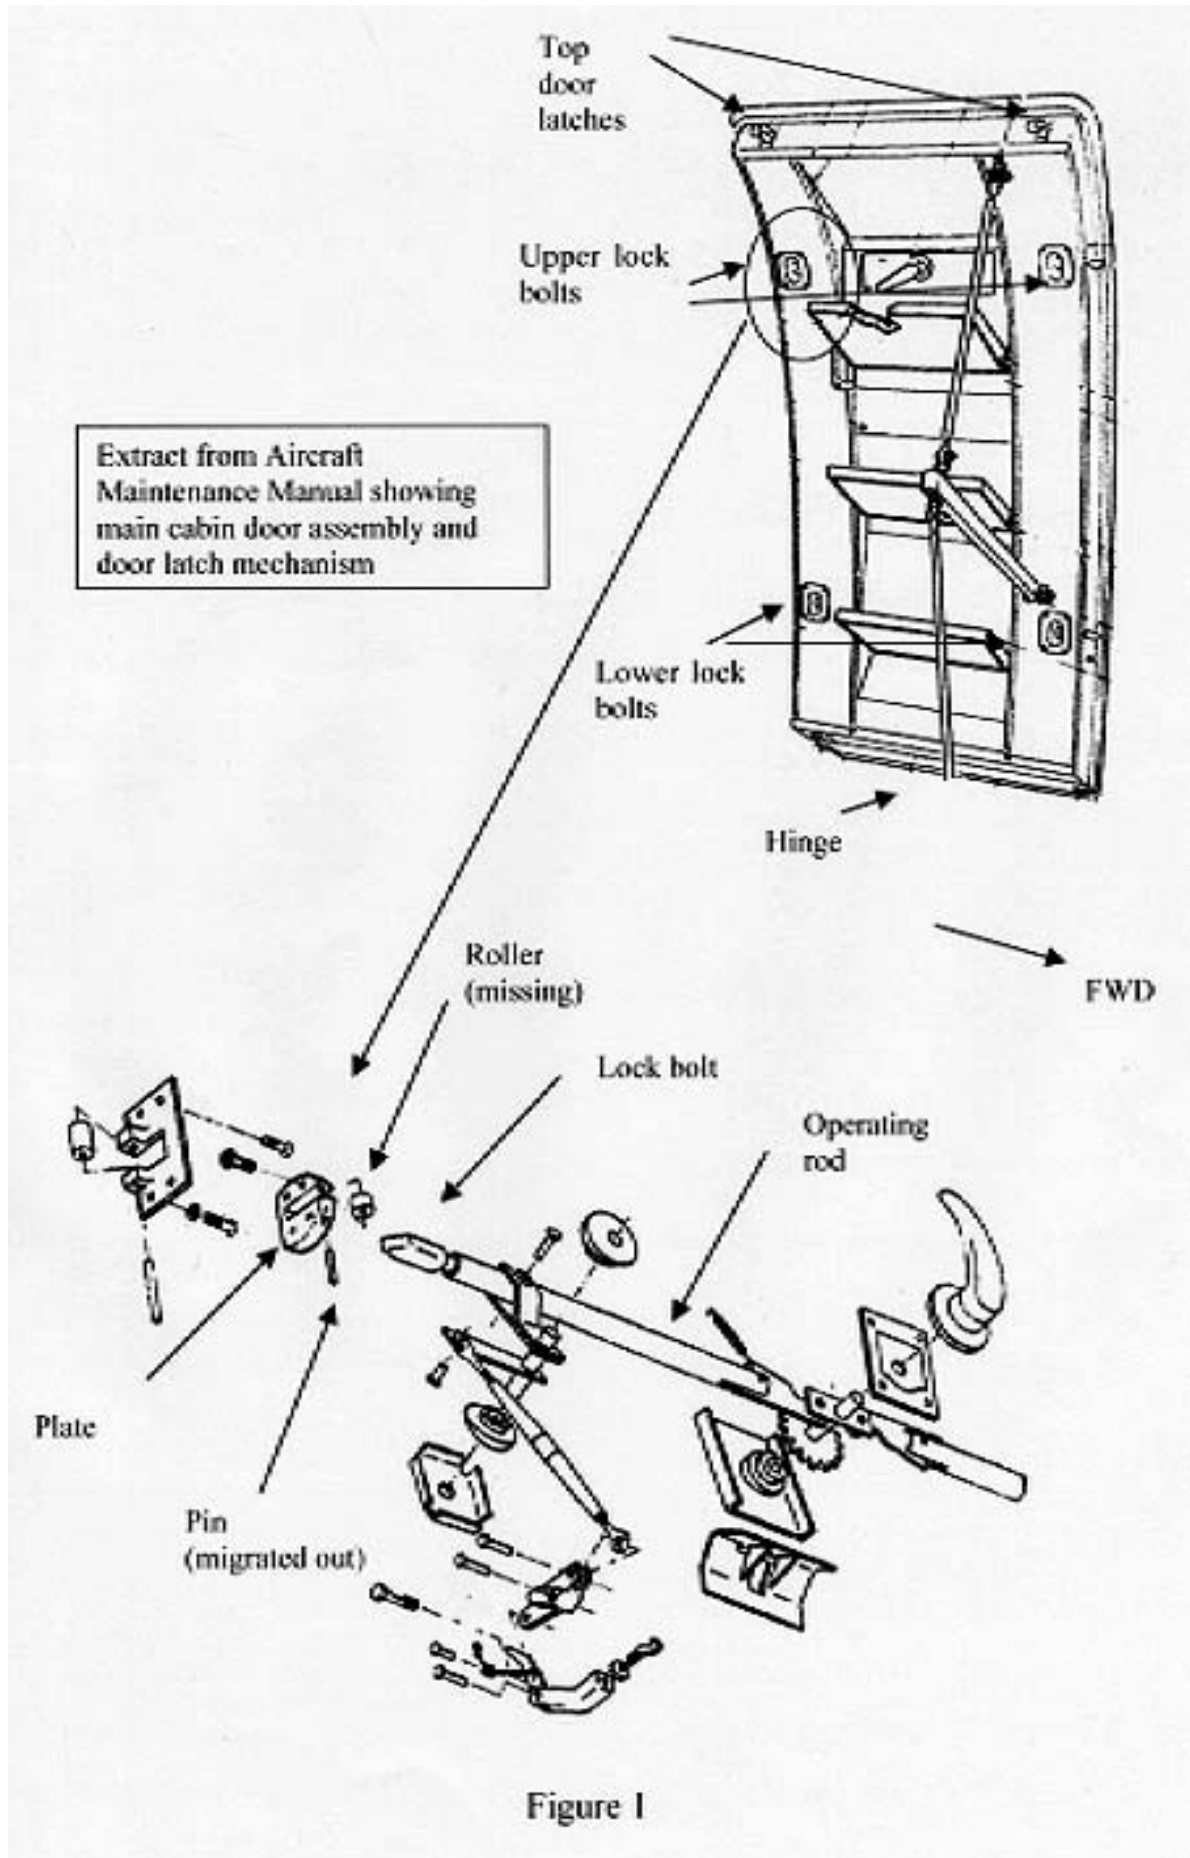
The main cabin door is hinged at the bottom and pivots downwards to provide a stairway for passenger and crew entry and exit. The locking mechanism (see Figure 1) is operated via a handle located centrally in the door. Rotation of the handle to the closed position causes two top door latches to hook into the top of the door frame and two upper (one each side) and two lower (one each side) lock bolts on the sides of the door to extend outwards into the door frame.

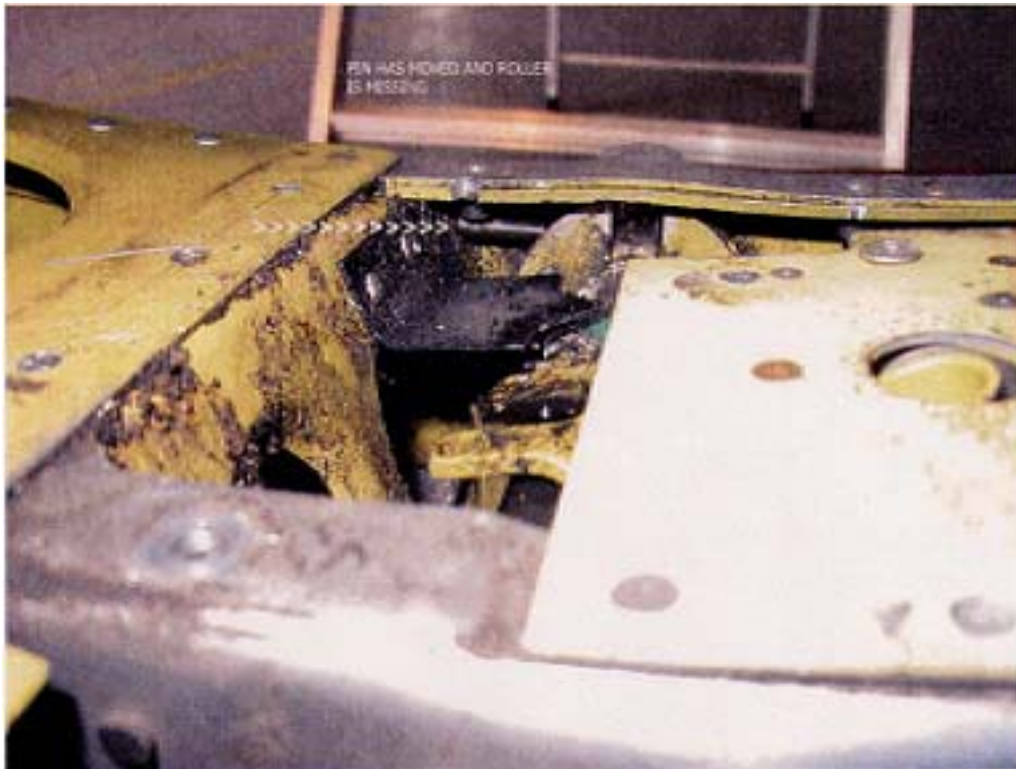
Figure 2 - Migration of pin

Subsequent examination of the cabin door by the repair organisation revealed that the pin from the rear upper roller had migrated from its position (see Figure 2). This had allowed the roller to come out of its position within the plate. The loss of the roller had removed the support from the lock bolt allowing cabin pressure to force the bolt into the surrounding structure (see Figure 3). This had allowed the door to open slightly and cause the loss of pressurisation. The roller was not recovered.

It is recommended that the Federal Aviation Administration, in conjunction with Raytheon Aircraft Company, review the method of securing, or the inspection requirements of, the main cabin door latch roller assembly on Beech 200 aircraft with a view to preventing roller retaining pin migration.

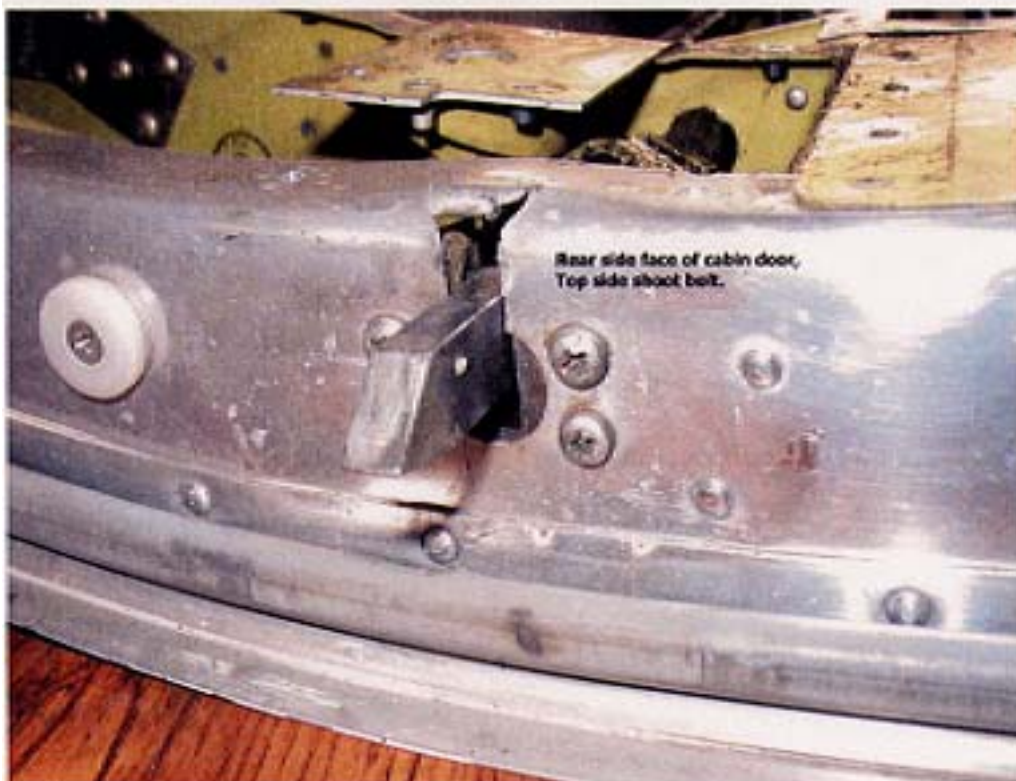
Figure 3 - Damage to door structure
(photographs courtesy Signature Aircraft Engineering)

The operating rod within the door structure attached to the lock bolt had become distorted during the depressurisation and prevented the mechanism from opening the main door after the aircraft had landed.

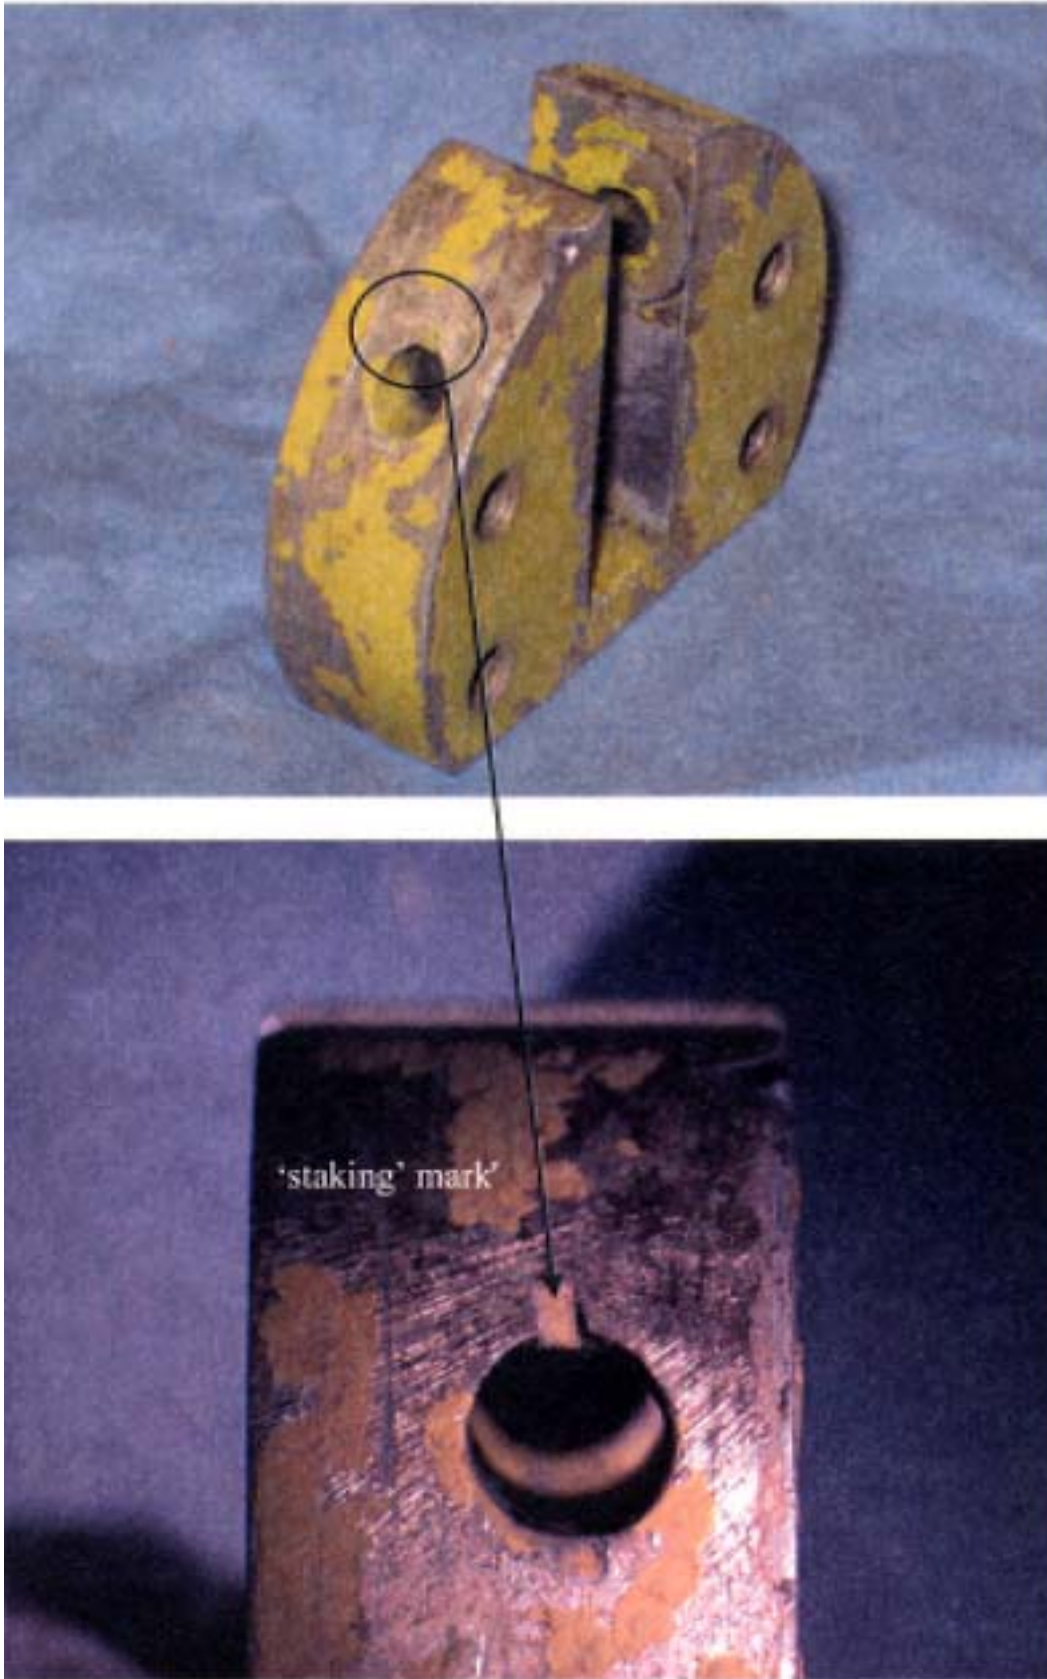
The components removed from the aircraft were returned to the AAIB for examination. There was evidence (see Figure 4) on the two upper plates of 'staking' marks. It was not possible to conclude when the pin had begun to migrate, though it is likely that this migration had occurred over a period of time. As soon as the movement of the pin was sufficient to release the roller the differential pressure within the cabin would have caused the door to move.

Figure 4 - upper rear plate showing 'staking' mark
