CONTENTS – APPENDICES AND FIGURES

ACCIDENT TO DAN - AIR B Ae 748, G-ASPL, AT NAILSTONE, LEICS. ON 26 JUNE 1981
CORRECTED F.D.R. READOUT

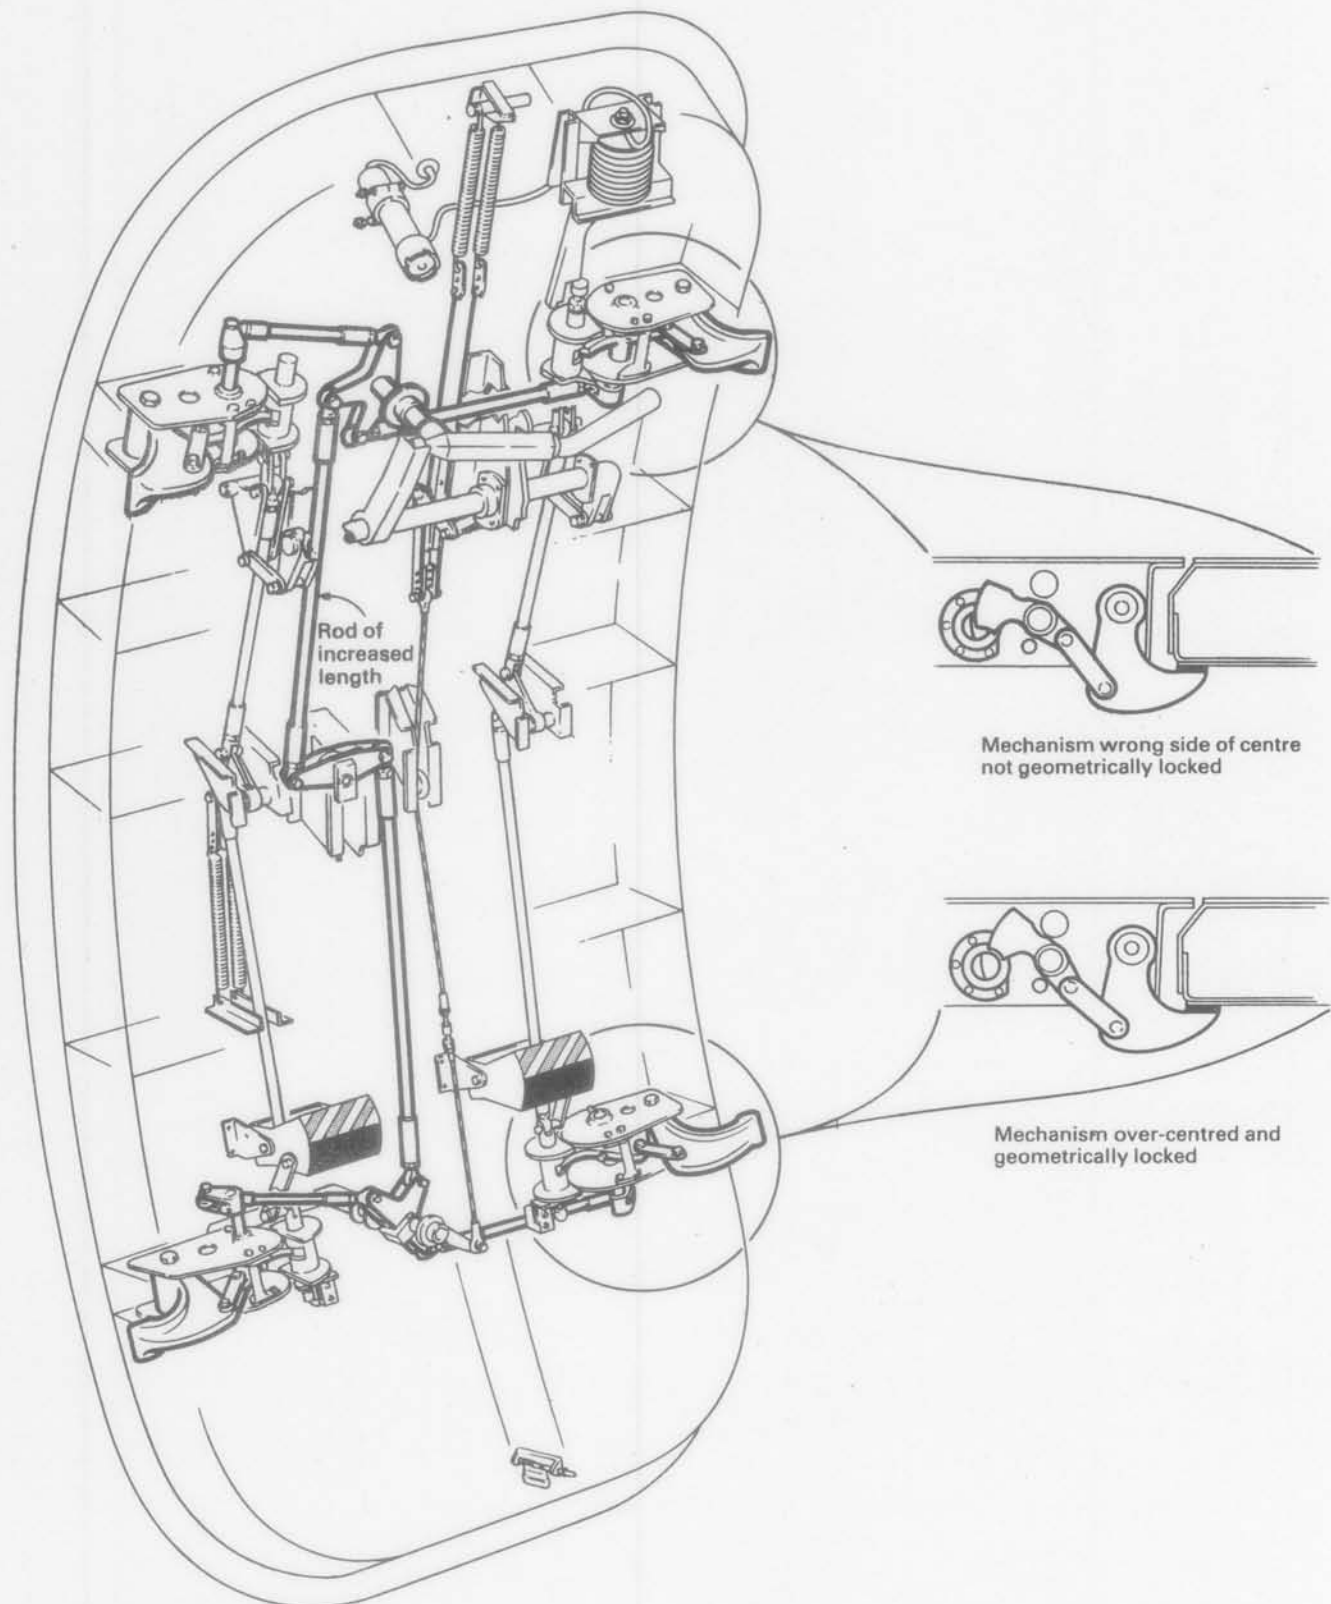
Figure 6

Diagram showing effect of variation of rod length on synchronisation of top and bottom pairs of claw catches. Movement of top rods and star lever exaggerated to emphasise effect of incorrect rod length. Inset diagrams show geometrically locked bottom claws and top claws with geometric lock not made as a result of incorrect rod length.

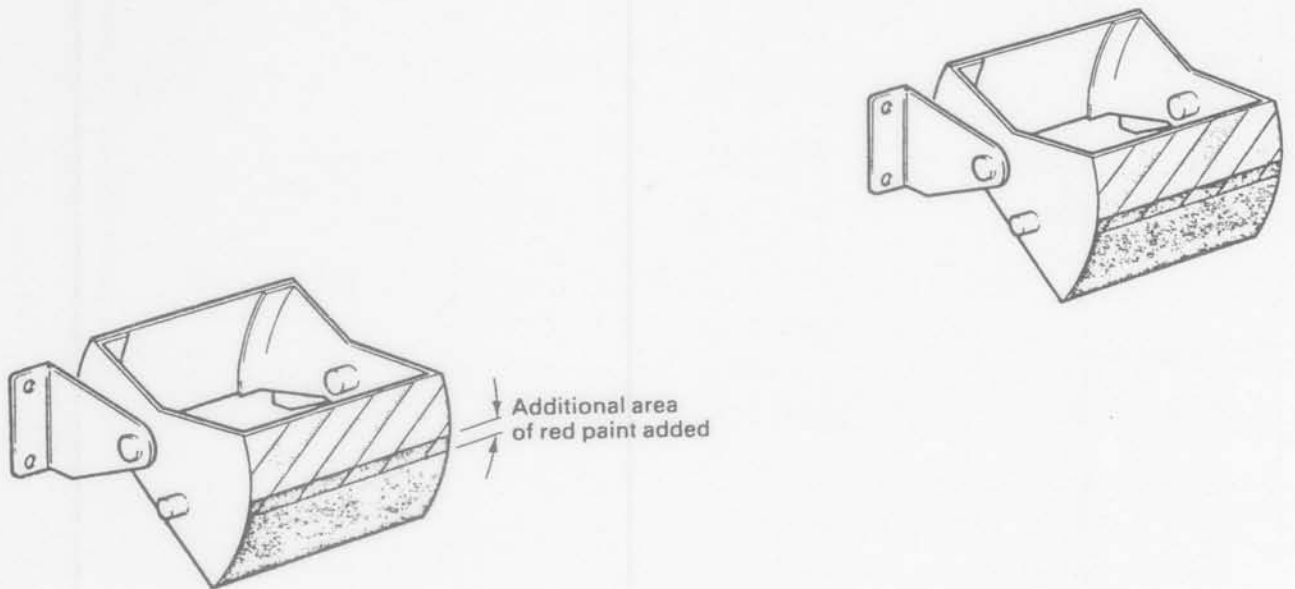
Figure 10 Drums with red over-painted and extended upwards (as applied at some time to G-ASPL)

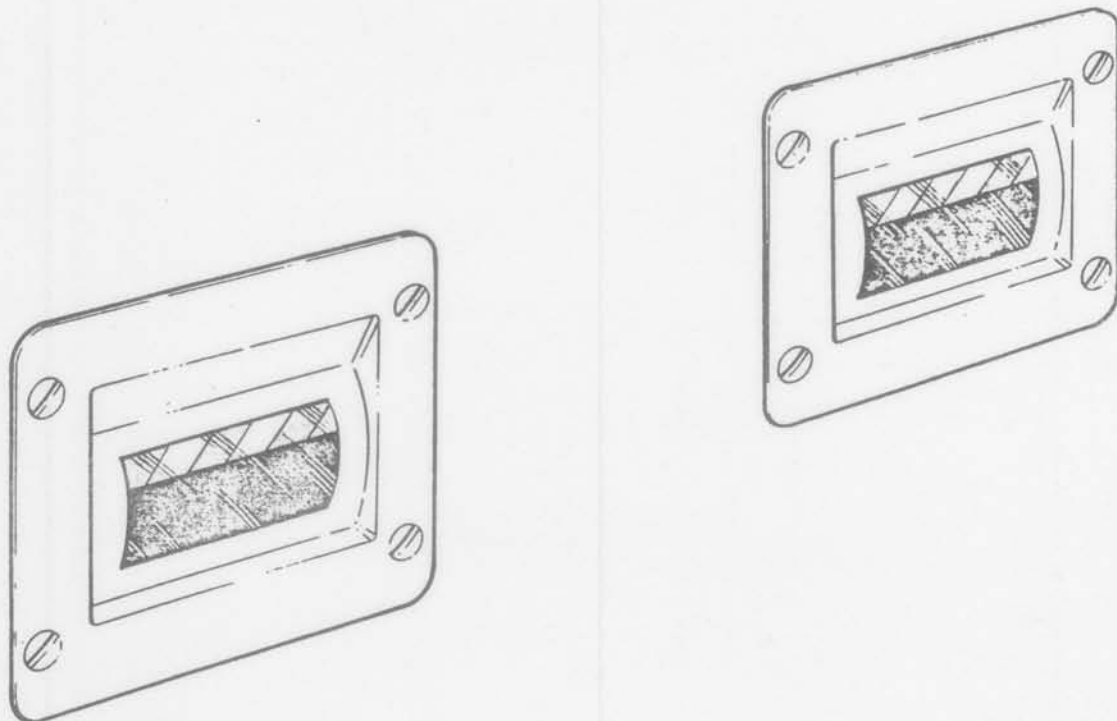
Figure 11 Approximate indication which would have been given by indicators with over-painting as in Fig. 10 when secondary mechanism is just disengaged.

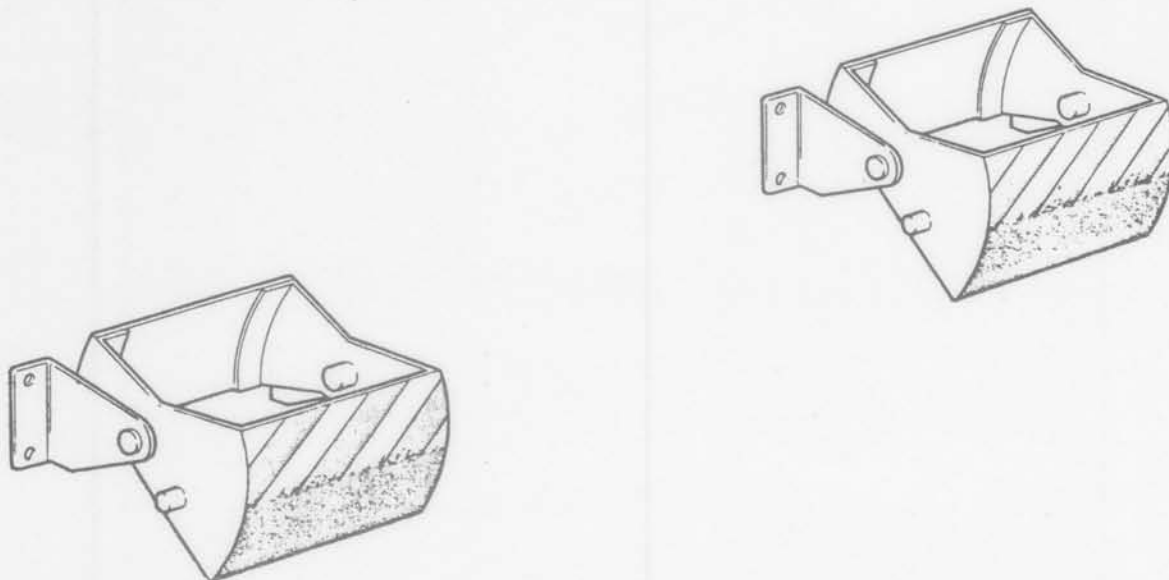
Figure 12 Drums with signs of red paint over green/yellow partly worn away, as found on G-ASPL

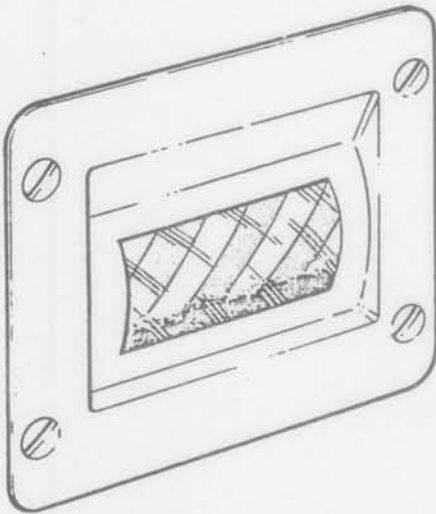
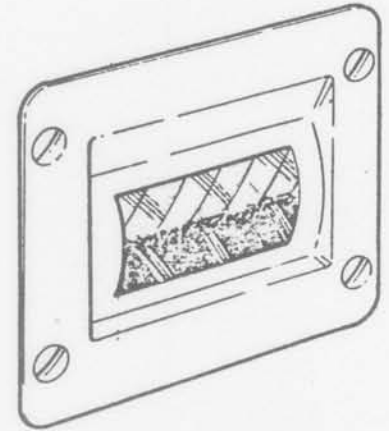
Figure 13 Effect of wearing away of over-painted layer on indication with mechanism in the same position as in Fig. 11

Note: Wearing away of red paint layer was unsymmetrical

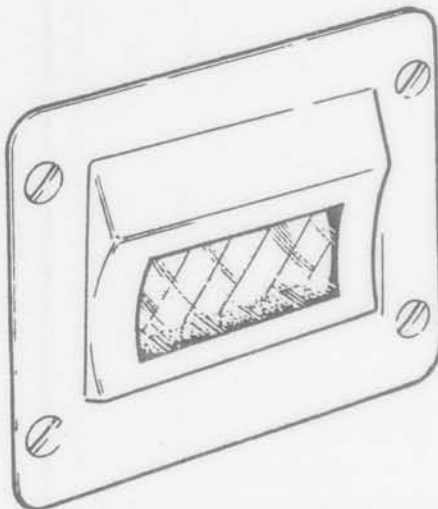
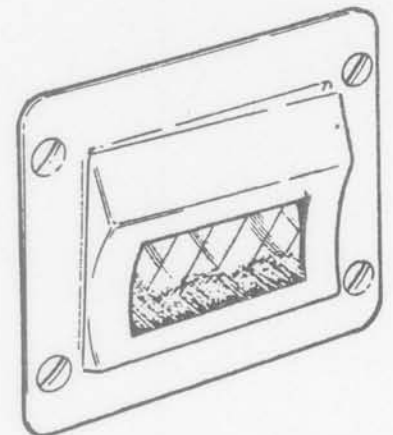
“BB In the course of an accident investigation an aircraft has been found with the window over the indicator drum reversed so that the window contour does not follow the contour of the drum. This can lead to the possibility of parallax errors giving misleading indication of the true state of the locking mechanism.

Figure 14 Additional effect brought about by incorrect fitting of windows as found on G-ASPL.

Note View of indicator drums in conditions as found, is affected by:

1. Parallax errors resulting from different eye positions i.e. standing close to door handle looking downwards or standing on other side of fuselage, adjacent to passenger door looking across to baggage door.
2. Backlash in indicator drum drive mechanism allowing drum to adopt a range of angular positions.
3. Shadows over lower half of concave window space can obscure red section under normal cabin lighting, leaving only green yellow colouring visible.

CC Within two days of the receipt of this telex all aircraft are to be inspected and if windows are found to be reversed they are to be removed and refitted correctly ensuring no foul between window and drum. Until this inspection and any necessary rectification has been accomplished the aircraft may not be despatched with any fault on the door unsafe warning light system (contrary to para 2A4 pre-flight checks of alert SB A52/90).

DD In the case of window part no 3N 1990 the transparent area within the painted surround must measure not less than one inch in height. In the case of window part no 20N 2651 ensure that the window has not been painted to restrict window height to less than one inch.

EE After refitting windows the relevant checks in para C1 of alert SB A52/90 are to be repeated.”
