**SERIOUS INCIDENT**

<b>Aircraft Type and Registration:</b>	ERJ 190-200 LR Embraer 195, G-FBEE	
<b>No &amp; Type of Engines:</b>	2 General Electric CF34-10E7 turbofan engines	
<b>Year of Manufacture:</b>	2007	
<b>Date &amp; Time (UTC):</b>	23 February 2010 at 1915 hrs	
<b>Location:</b>	Jersey Airport, Channel Islands	
<b>Type of Flight:</b>	Commercial Air Transport (Non-Revenue)	
<b>Persons on Board:</b>	Crew - 2	Passengers - None
<b>Injuries:</b>	Crew - None	Passengers - N/A
<b>Nature of Damage:</b>	No 2 engine cowling detached and leading edge slat on right wing damaged	
<b>Commander's Licence:</b>	Airline Transport Pilot's Licence	
<b>Commander's Age:</b>	54 years	
<b>Commander's Flying Experience:</b>	9,000 hours (of which 700 were on type) Last 90 days - 57 hours Last 28 days - 15 hours	
<b>Information Source:</b>	AAIB Field Investigation

**Synopsis**

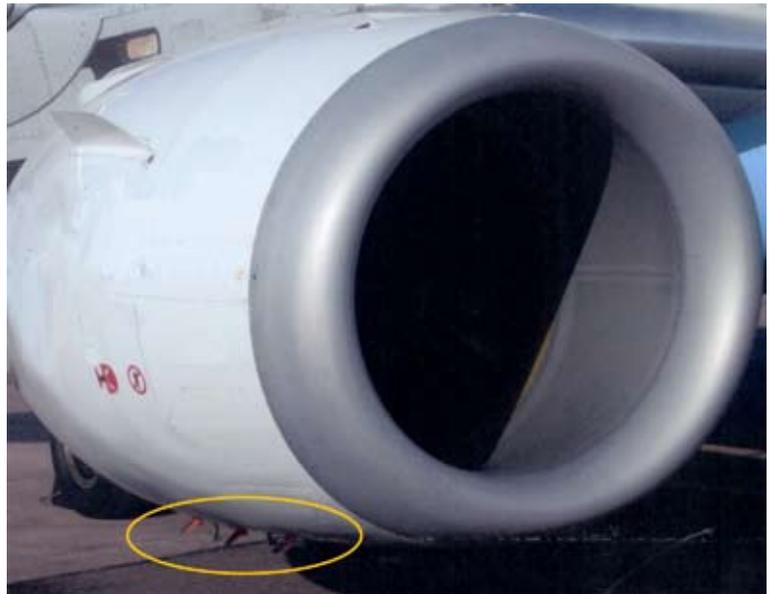
**Figure 1**

The engine cowl latches are underneath the engine (Figure 1) and were not explicitly included in the walk-round checklist. Having checked the technical log and noting that the rectification work and a daily

The fan cowls of the Embraer 195 aircraft comprise two ‘clamshell’ doors of composite material, hinged at their top edge. When closed and fastened, three over-centre clamps on the outboard cowl engage with hooks on the inboard cowl and, when locked, the clamps are flush with the surface. When unlocked, the clamp levers protrude and their edges are painted ‘dayglo’ red to make them more conspicuous (Figure 1).

Upon inspection, it was found that the fan cowls of the right engine had torn away from their hinges, leaving only a small portion of the upper structure still attached. Examination of the debris recovered from the runway showed that it comprised a substantial piece of each cowl door and numerous smaller pieces. The lack of any damage to the clamps and hooks indicated that they had not been engaged and that this was the most likely

reason for the detachment of the cowls. Damage to the airframe was limited to scuffing and denting of the leading edge slats and two punctures of the slat skin.

- A Notice to Aircrews was issued instructing them to include a check for security of the engine cowl fasteners during their pre-flight walk-round checks.
