INCIDENT

Aircraft Type and Registration:	VPM M16 Tandem Trainer, G-YRAT	
No & Type of Engines:	1 Arrow GT1000 2-stroke piston engine	
Year of Manufacture:	1993	
Date & Time (UTC):	21 January 1995 at 1540 hrs	
Location:	In-flight, landed at Windrush Airfield, Oxfordshire	
Type of Flight:	Private	
Persons on Board:	Crew - 1	Passengers - 1
Injuries:	Crew - None	Passengers - None
Nature of Damage:	Cracked and distorted fork component in flying control system	
Commander's Licence:	Private Pilot's Licence with Instructor Rating	
Commander's Age:	54 years	
Commander's Flying Experience:	250 hours (of which 235 were on type) Last 90 days - 20 hours Last 28 days - 10 hours	
Information Source:	AAIB Field Investigation

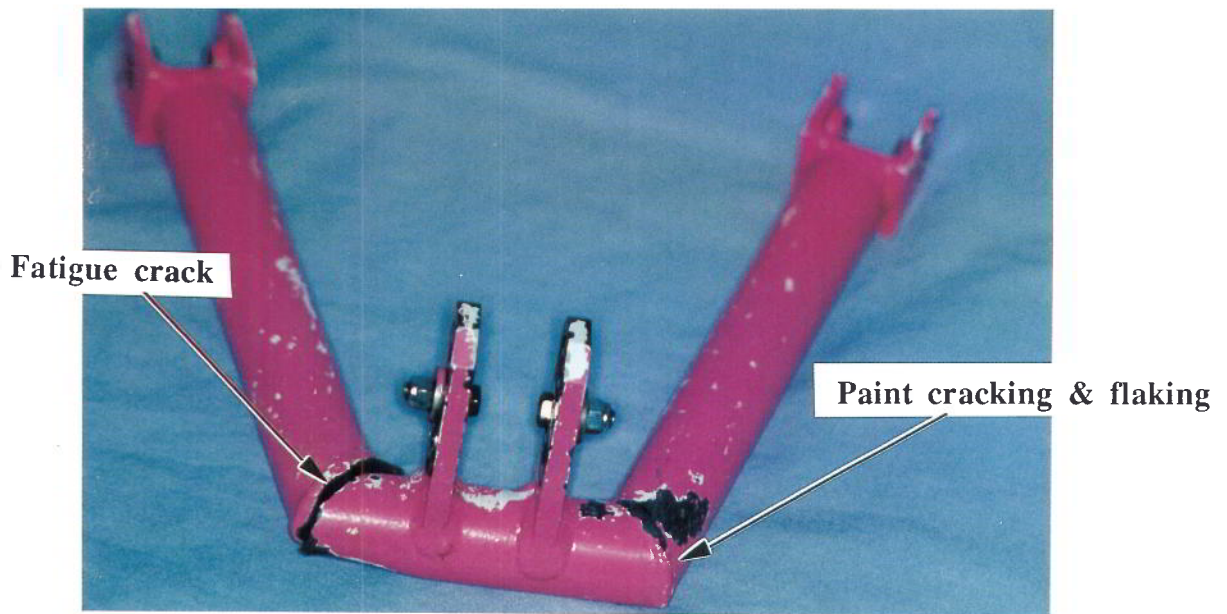
Figure 1 - Fork from flying control system of VPM M16, G-YRAT

In the VPM M16 design, the pitch and roll commands from the pilots' sticks are transmitted to the rotor head control rods by means of a welded steel fork (examples shown in Figures 1 and 2, the control layout shown in Figure 3). Examination of the fork from G-YRAT (Figure 1) after the incident showed that one arm had almost totally separated at the elbow weld and the resulting distortion had

caused the loss of control authority. The fork from G-YRAT was submitted for detailed metallurgical examination. An identical component from G-BVRD, the VPM M16 involved in an accident at Cranfield on 12 January 1995, was also submitted for examination at the same time.

The fork from G-YRAT (Figure 1) showed distinct plastic deformation around the elbow area and a large crack close to the weld bead on the 'port' side of the aircraft; the paint had also cracked and flaked from the corresponding area on the opposite ('starboard') side of the fork. Examination of the crack faces showed that the fracture was typical of that resulting from high-stress low-cycle fatigue and magnetic crack detection tests showed a small crack to be present adjacent to the corresponding weld bead on the opposite ('starboard') side of the fork.

From these examinations it is apparent that the damage to both forks had resulted from in-service loading of a high order, approaching, and periodically exceeding, the elastic limits of the tube material. The occurrence of these high loads on both forks was confirmed by the examination of the bearings in the control rod attachment arms, with heavy damage to the bearing raceways on the fork from G-YRAT and lighter damage in the same areas on the fork from G-BVRD.

Analysis of the normal in-flight loads in the flight control system indicate that they would not be large enough to cause the damage observed in the forks either in G-BVRD or G-YRAT. It is more likely, therefore, that the damage to the control fork from G-BVRD was caused during the dynamic flapping excursions which resulted in the accident to that gyroplane and that the initiation of the damage to the fork from G-YRAT was the result of a similar, but earlier, incident. As a result of these examinations the CAA has advised owners of VPM M16 gyroplanes that, before further flight, the fork should be subjected to an inspection including crack detection and that this should be repeated following any incidence of excessive blade flapping.

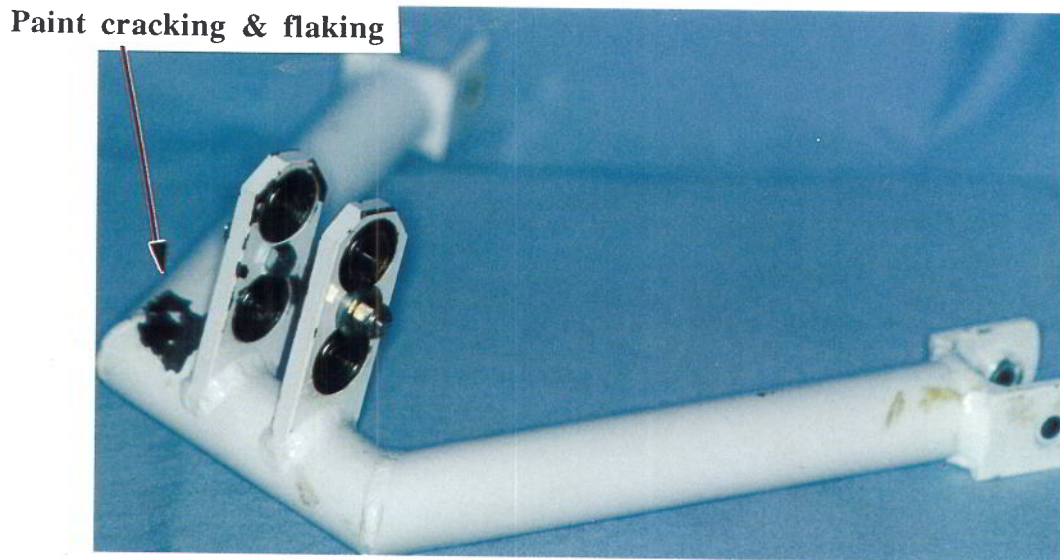
Figure 2 - Fork from flying control system of VPM M16, G-BVRD

Examination of the fork from G-BVRD (Figure 2) showed similar plastic deformation to that found in the fork from G-YRAT, including paint cracking and flaking, although to a lesser degree. In order to investigate the quality of the welding and the material strengths of the tubing, metallurgical sections from both forks were prepared and examined by microscope and microhardness test; this examination showed that the welding was of good quality and satisfactory form and strength.
