No: 1/91

Ref: EW/G90/10/14

**Aircraft Type and Registration:** Piper PA-32R-301, G-BSGO

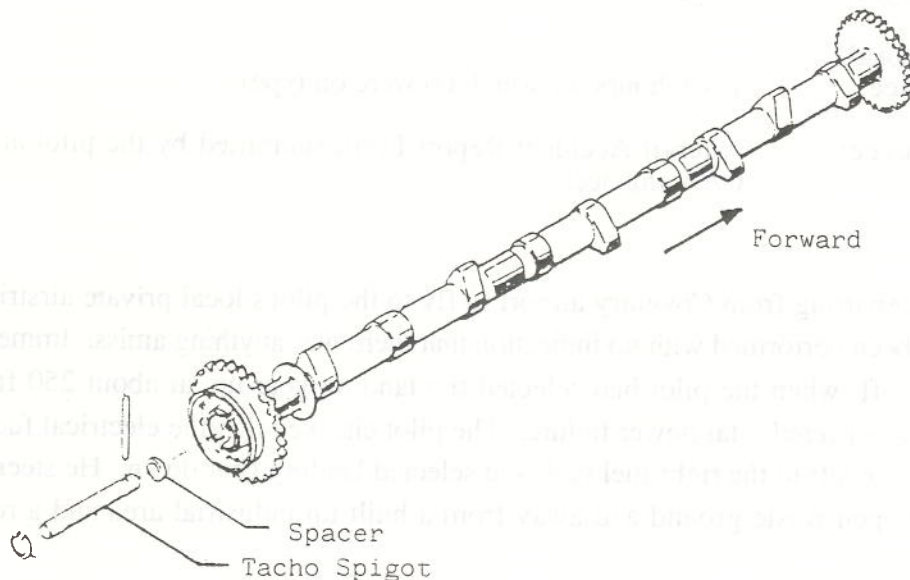
When the engine was stripped down it was found that all but one of the cam followers had suffered damage amounting in some cases to total destruction of the cam follower head. Amongst the debris in the crankcase were found fragments which proved to be parts of a phosphor-bronze spacer (PN

76118) normally located at the aft end of the camshaft supporting the tacho drive spigot. These particles could only have entered the crankcase, once the spacer had fractured and come out of its location, by migrating down the central bore of the hollow camshaft. The largest piece of the spacer was in fact found trapped in a crankcase cavity at the front end of the camshaft to where it had fallen out of the camshaft bore. It seemed most probable that debris from the spacer had found its way between some cams and their followers, damaging the followers and thus creating more debris which progressively damaged other cam followers.

The largest spacer fragment found, which had not migrated into the main crankcase cavities and had thus not been crushed under the cam followers, had however suffered heavy wear and polishing and no indication was found to explain why it had broken up or been released.

Camshaft and Related Parts
