AAIB Bulletin No: 7/94 **Ref:** EW/C94/4/1 **Category:** 1.2

Aircraft Type and Registration: Jet Provost T3A, G-BVEG

Information Source: AAIB Field Investigation

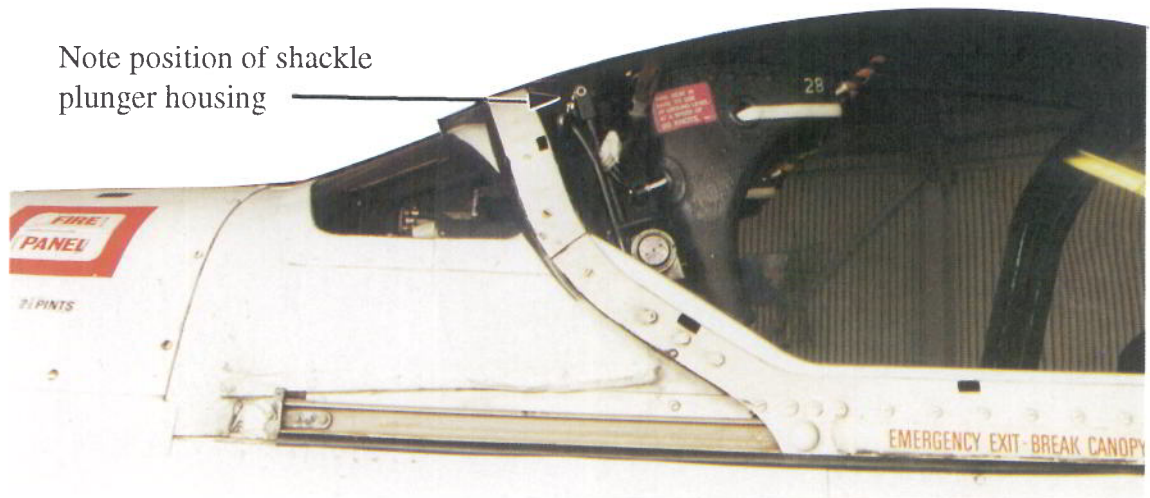
Plate 1 View of right side of rear of Jet Provost 3A cockpit canopy

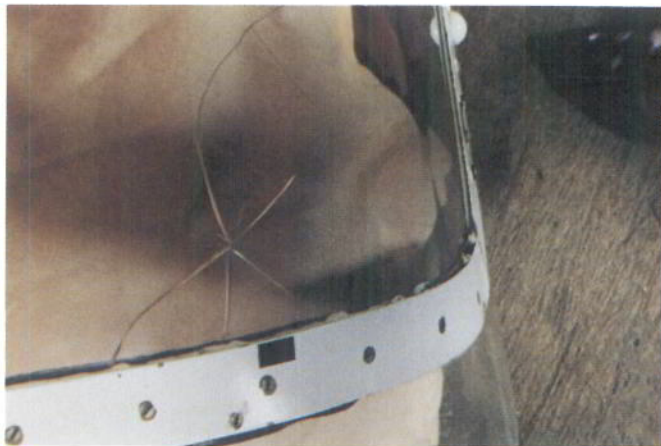
Inspection of the broken canopy which had been removed on 29 March 1994, after the training flights, showed that the centre of the cracking had been immediately above the scissor shackle locking plunger housing of the right seat. On the right seat, this housing is normally very close to the canopy glazing and is, by design, chamfered to give greater clearance (see Plates 1, 2 and 3). The seat structure, to which this housing is attached, cannot move perceptibly up and down on the guide rails if the top latch is properly engaged. Vertical adjustment of the seat pan height does not involve movement of the seat structure. No evidence of the canopy replacement appeared in the servicing documentation and, so far as can be established, no attempt was made to obtain a new Flight Release Certificate from an approved engineer.

Plate 2
Cracked canopy which was removed

94-18 The CAA should consider clarifying the wording of each Permit to Fly and its associated Operational Limitations such that the actions necessary to maintain the validity of the Permit are clear.

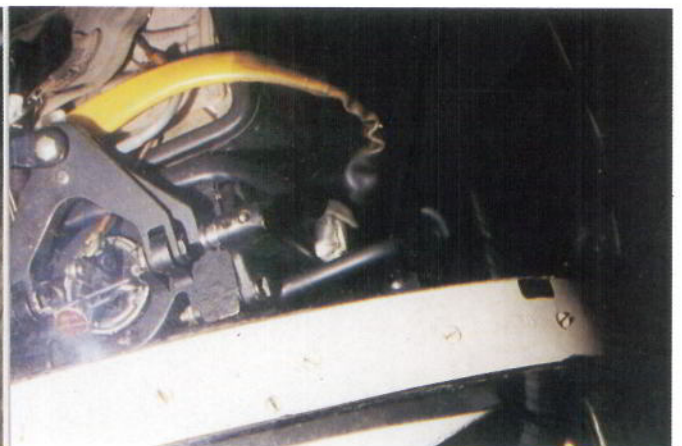
Plate 3
Position of plunger housing on intact canopy from similar angle

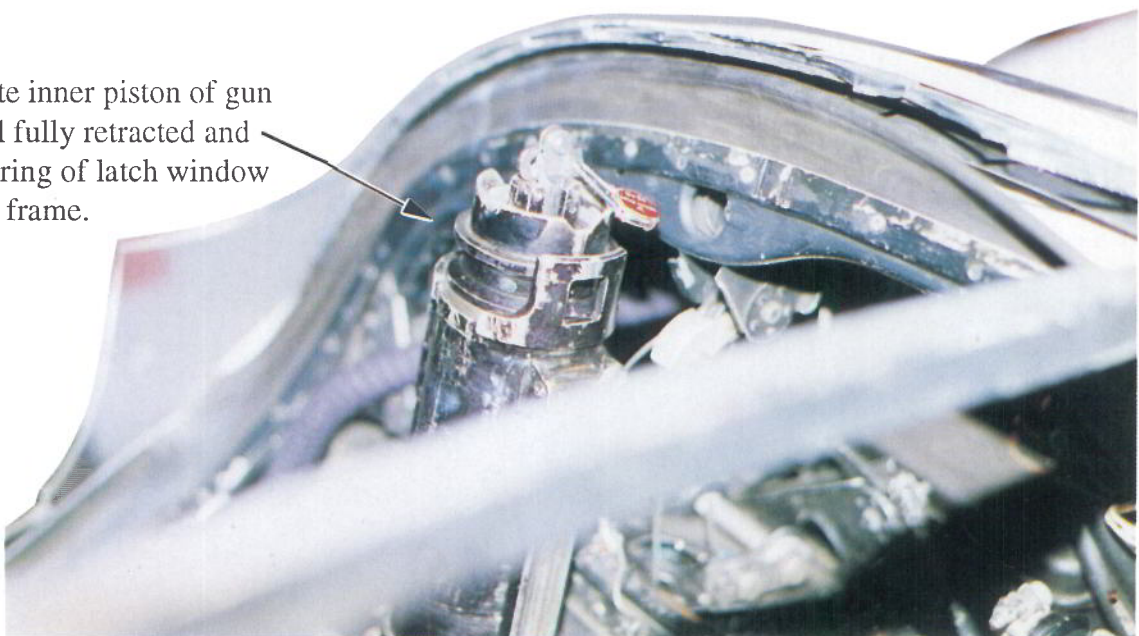
Note inner piston of gun still fully retracted and scoring of latch window top frame.

Plate 4 Right seat ejection seat gun in situ. (closer view of latch window at Plate 5)

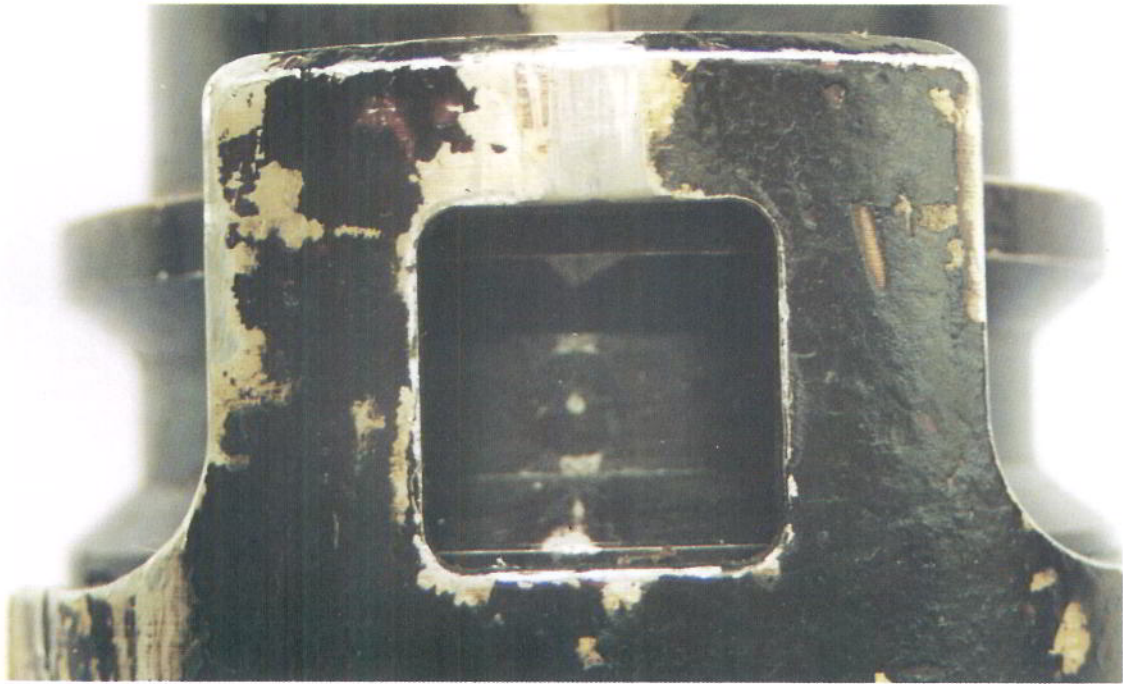
Plate 5 Latch window of right seat ejection gun
Note heavy scoring of top frame member and rounding of its edge
Note also position of latch groove relative to window.

Compare with latch window from left seat gun

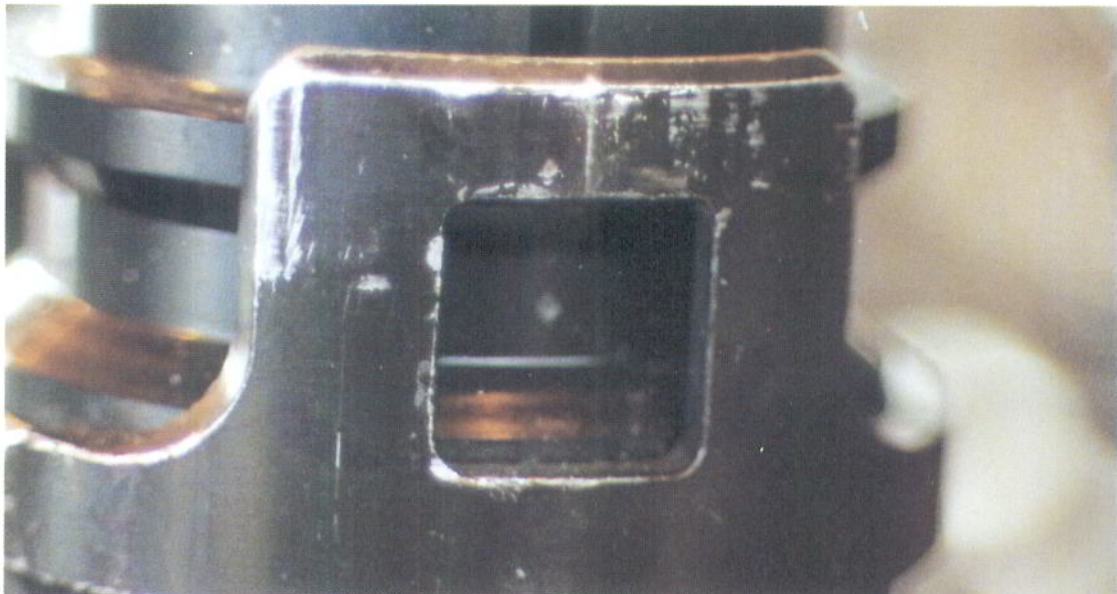
Plate 6 Latch window of left seat ejection gun

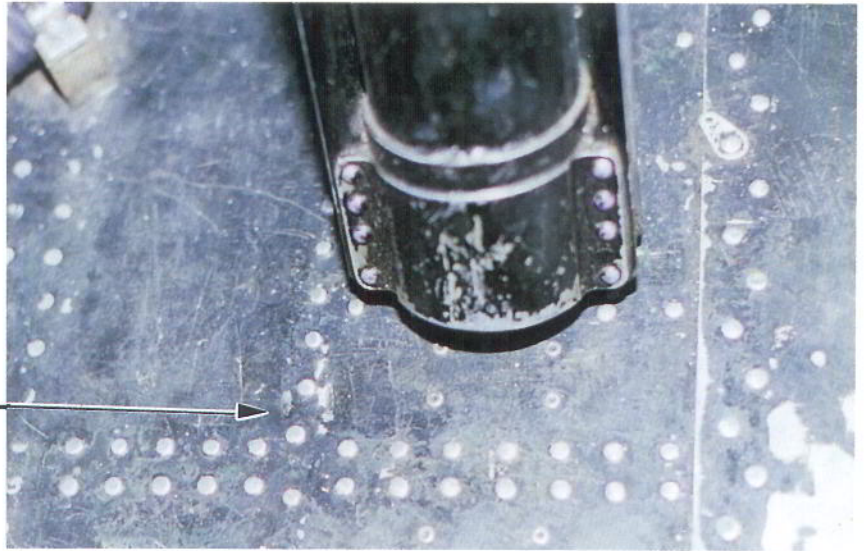
Plate 7 View of base of ejection gun and cockpit floor.

Note dents on floor

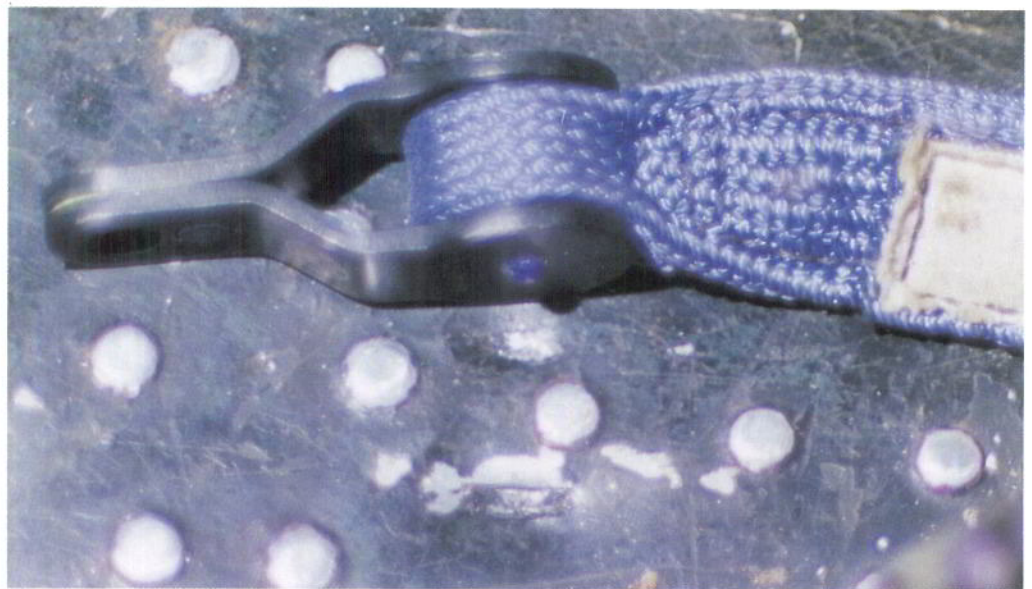
Plate 8 Dents on cockpit floor with leg restraint floor attachment fitting held beside it.

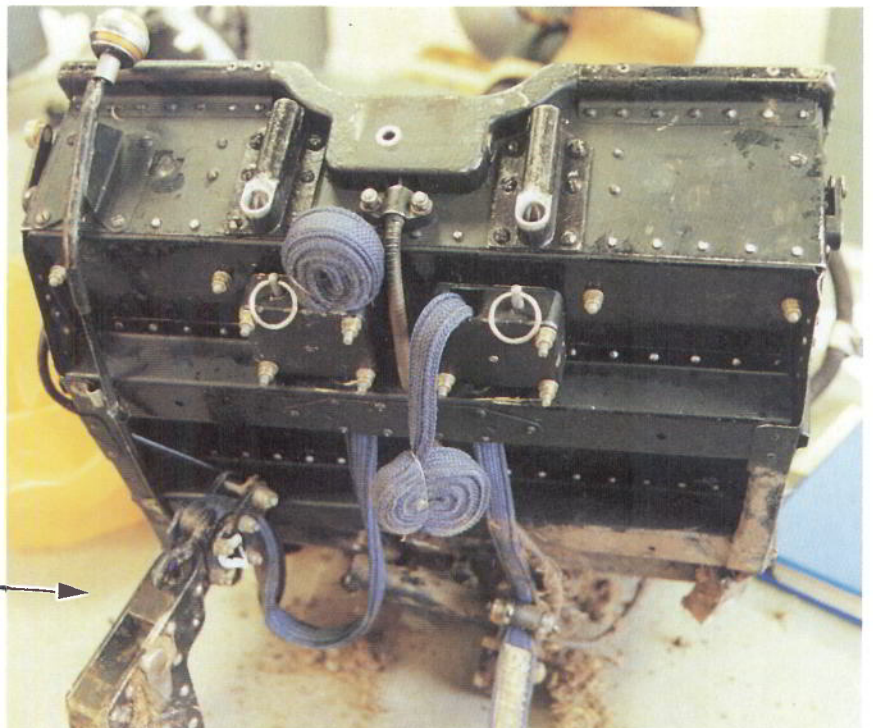
Examination of the seat showed that its leg restraint lines had been coiled in an identical manner to those already noted on the left seat (see Plate 9). The floor attachment fittings of both the leg restraint lines showed clear evidence of being crushed and the frangible shear rivet of one, broken, this evidence being more severe on the fitting attached to the right main seat beam. Examination of the seat mechanisms showed that the spring-powered barostatic time delay release mechanism had operated normally after the seat had left the aircraft, and thereby released the passenger's harness from his seat.

Plate 9 View of underside of seat with leg restraint lines still in snubbers and wirelocked into coils.

Note line passing behind roller on bottom of seat beam.

Bottom of seat beam on left of picture has been broken off but is still tethered to seat by leg line.

94-12 The CAA should require all operators of aircraft fitted with inerted Martin-Baker ejection seats to take the seats out of the aircraft in order to remove completely the leg restraint lines from the seats. Before refitting the seats they should ensure that the cockpit floor in the area below the seat is completely free of obstructions.

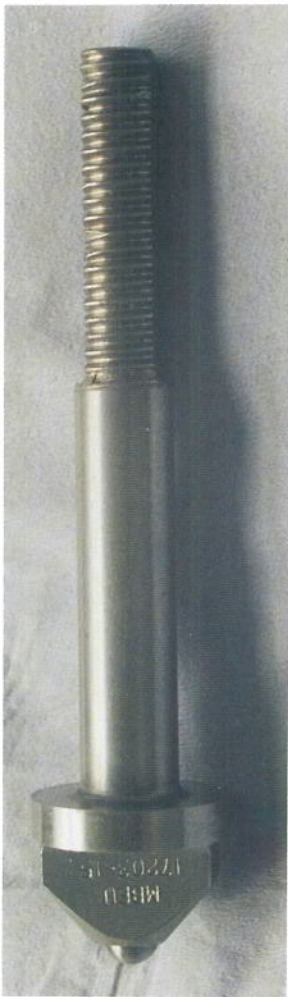
Plate 13
Side view of plunger

←
Brass extraction tool
fits on threads on
top portion of plunger

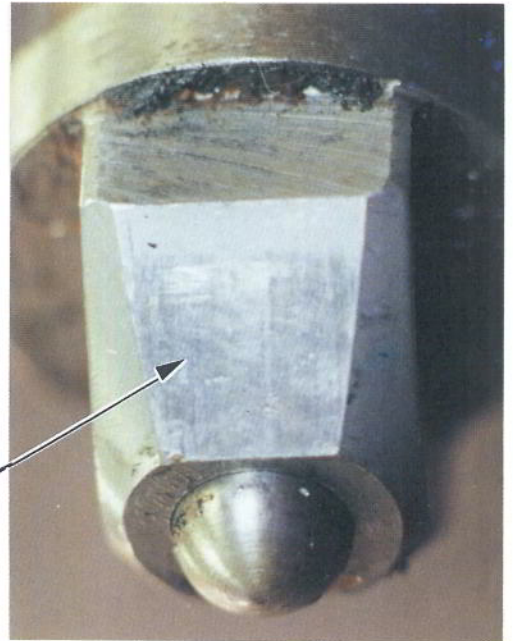
Examination of the top latch plunger assembly showed unusual signs of wear on the two angled faces of the engaging end of the plunger, one side being more severely worn (see Plates 10 to 12 and Fig 1). This wear was in a position which was consistent with the latch being only partially engaged, with the angled face of the plunger in contact with the upper edge of the top latch window on the ejection gun (see Plate 5). It also revealed that the threads at the visible end of the plunger, on which the seat extraction tool is fitted to remove the seat, had been damaged at a regular spacing as if the latch had been 'prised out' by a series of levering actions (see Plates 13 and 14). The latch engagement spring and the latch safety indication system were undamaged and working correctly.

Plate 11 →
Plunger
angled face

Note heavy abrasion
on this face

94-13 The CAA, in conjunction with Martin-Baker Aircraft Co Ltd, should establish set procedures by which each particular ejection seat installation may be rendered inert if such action is desired and acceptable.

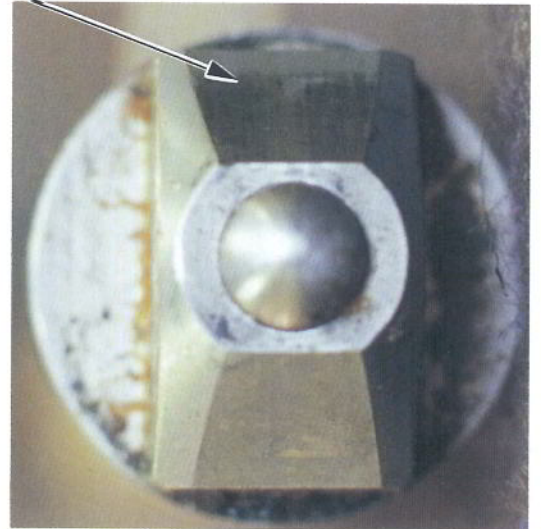
Plate 10 →
Plunger end &
angled faces

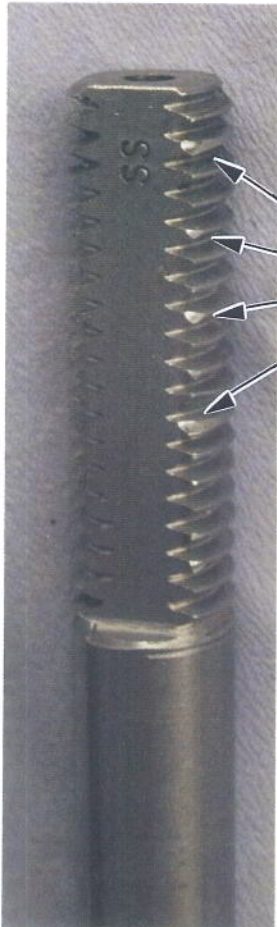
Plate 14
←
View of plunger threads
showing intermittent
damage to threadform

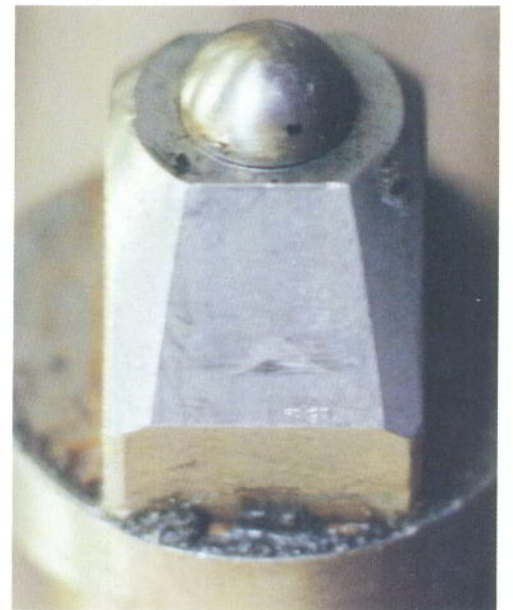
Plate 12 →
Plunger
angled face

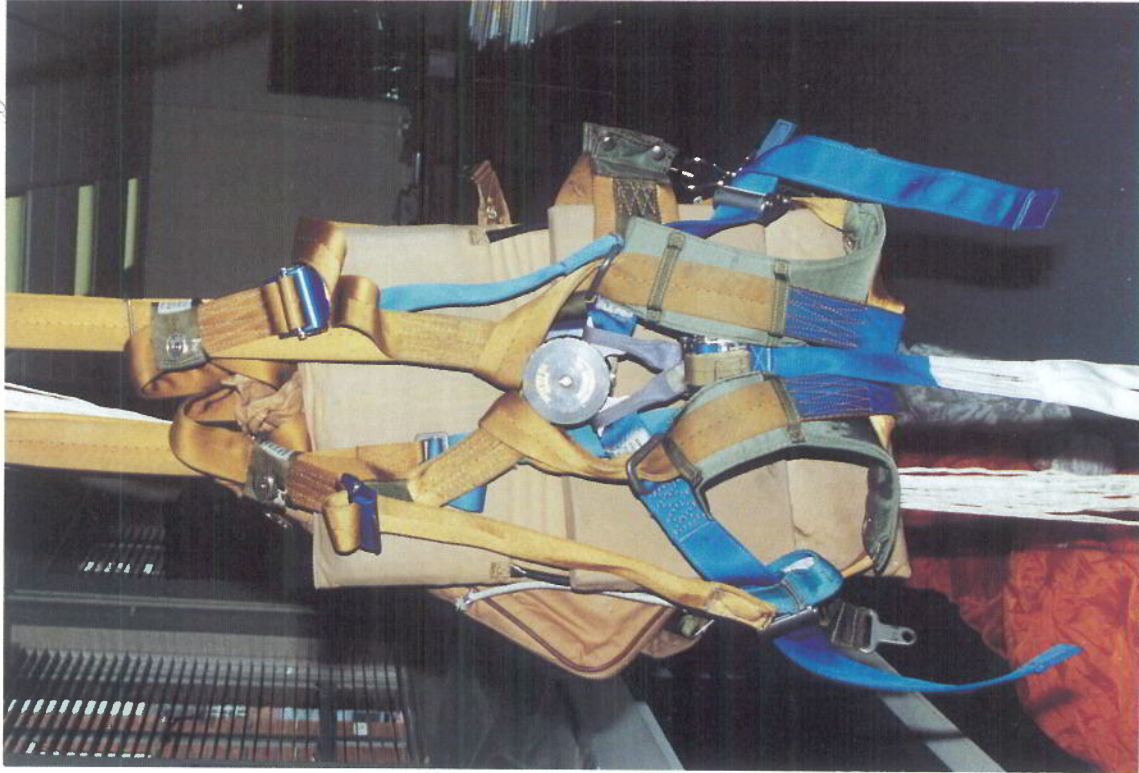
The ejection seat's spring-powered barostatic time delay release mechanism had operated normally and thereby released the passenger's harness from the seat. After pulling the parachute ripcord, the parachute canopy inflated fully and correctly. Unfortunately, the passenger was not properly strapped into the parachute because the crotch straps had been not been correctly routed through rings on the seat lap straps and over the shoulder harness lugs. This allowed the harness to ride up the passenger's body after deployment and he was restrained by the waist strap and lap straps which rose to his armpits. His breathing was restricted by tension in these straps and by the harness Quick Release Box which was pressing on his throat. The attached diagrams show the correct and incorrect fitting of the parachute harness to a volunteer who was not involved in the accident (see Plates 15 and 16).

Plate 16 Parachute harness correctly fastened.
 (shown without wearer to show straps more clearly)
 Note crotch straps coming from base of back pad
 and looped into both lap and upper torso harnesses.

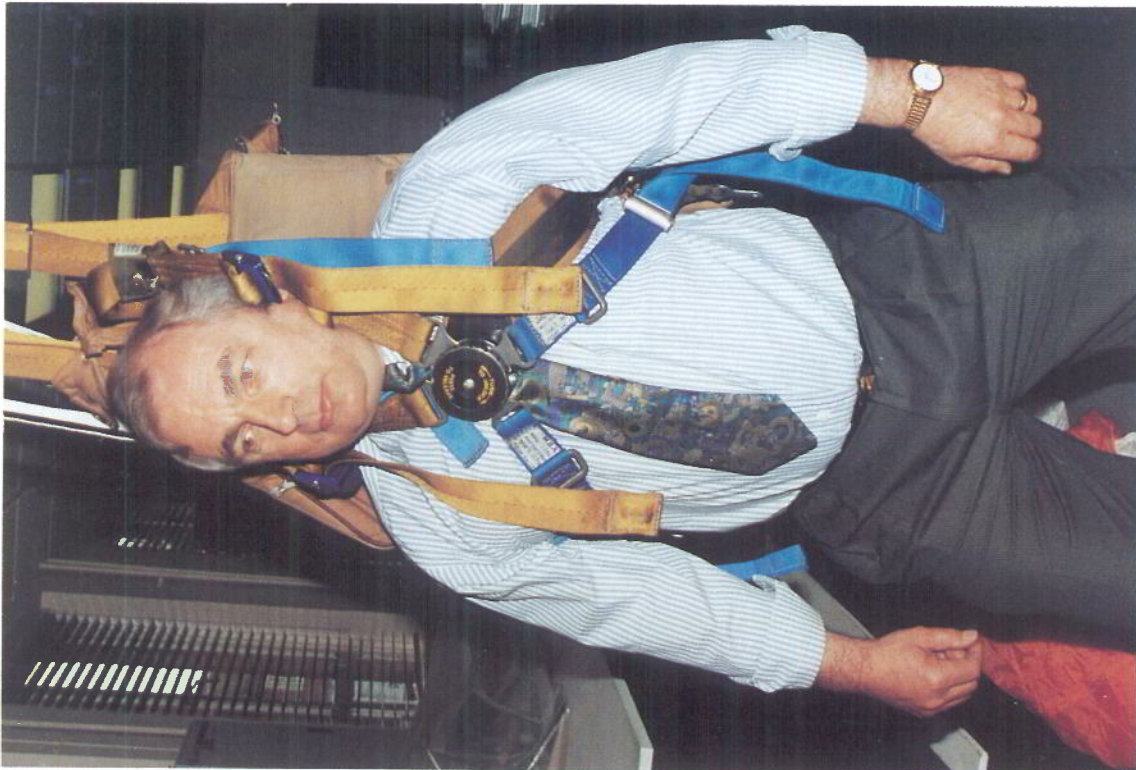
Plate 15
 Demonstration of how parachute harness will rise
 under armpits if the crotch straps are not fastened.

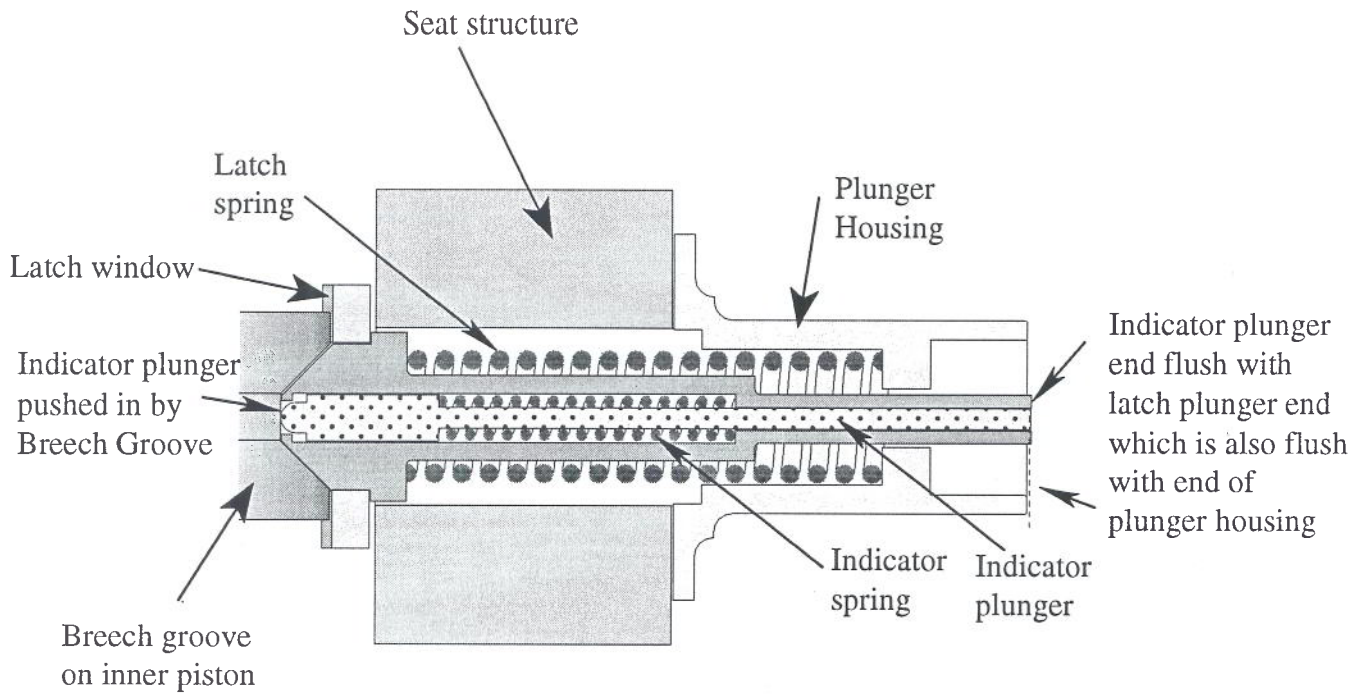
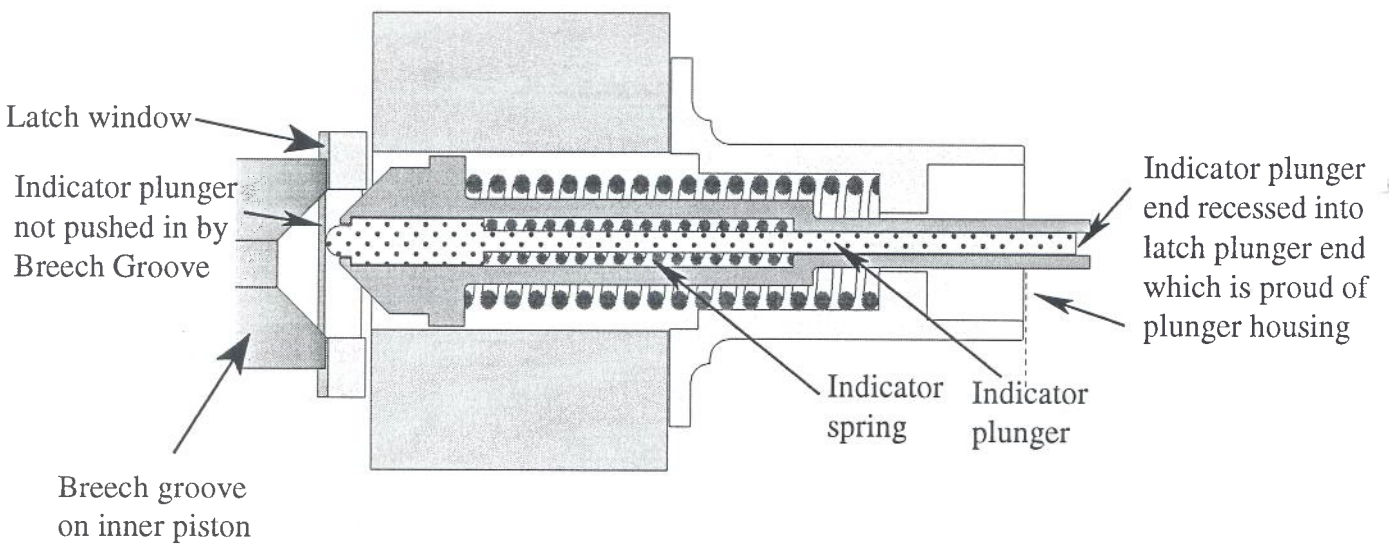
Fig 1 Cross section through Top Latch mechanism showing both safe and unsafe indications

a Safe

b Unsafe
