INCIDENT

Aircraft Type and Registration:	Embraer 190-200, G-FBEH
No & Type of Engines:	2 General Electric CF34-10E7 turbofan engines
Year of Manufacture:	2007
Date & Time (UTC):	15 January 2009 at about 0740 hrs
Location:	Overhead Edinburgh
Type of Flight:	Commercial Air Transport (Passenger)
Persons on Board:	Crew - 5 Passengers - 40
Injuries:	Crew - None Passengers - None
Nature of Damage:	None
Commander's Licence:	Airline Transport Pilot's Licence
Commander's Age:	40 years
Commander's Flying Experience:	6,250 hours (of which approximately 100 were on type) Last 90 days - 137 hours Last 28 days - 33 hours
Information Source:	AAIB Field Investigation

Synopsis

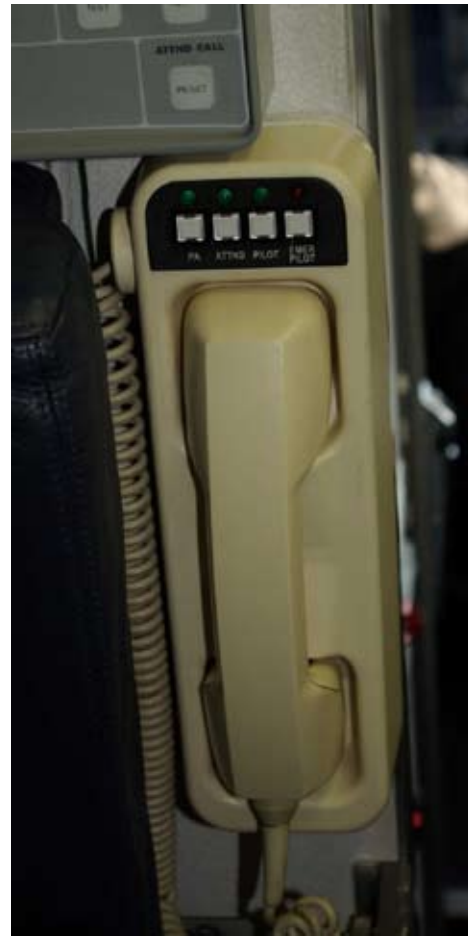
Figure 1

The SCCM attempted to call the flight crew on the cabin interphone system, by pressing the PILOT call button. The green light above the button (Figure 1) illuminated, but the flight crew did not answer. Despite repeated attempts, using handsets in both the forward and rear galleys, the SCCM could not establish communication with the pilots in this way.

Cabin interphone handset at front galley

normally. However, if a PILOT call is initiated from either handset in the cabin, the green light above the pushbutton illuminates and a single chime is heard in the flight deck, but the pushbuttons on the pilots' audio panels do not illuminate, and voice communication cannot be established.

The PILOT function of the interphone system seemed, to the cabin crew, to indicate that it was functioning normally. However, the CAB pushbutton in the flight deck did not illuminate, and no voice contact was possible. The cabin crew did not attempt to use the EMER PILOT function, as this would involve an emergency call, which differed (in the cabin crewmembers' perception) from the normal

The 'false positive' indication of the PILOT call was crucial to the incident; had the PILOT call not appeared to function correctly, it is probable that the cabin crew, instead of contemplating incapacitation of the flight crew or serious emergency on the flight deck, would have attempted to establish communication using the EMER PILOT call.

It is recommended that Embraer (Empresa Brasileira de Aeronautica SA) immediately notify all operators, of the Embraer 190 family of aircraft, to inform their flight and cabin crew of the functioning of the interphone system when the aircraft is supplied only with emergency electrical power.

It is recommended that Embraer (Empresa Brasileira de Aeronautica SA) modify the functioning of the interphone systems of Embraer 190 family aircraft to provide crew with the facility to make both normal and emergency calls when the aircraft is supplied only with emergency electrical power.

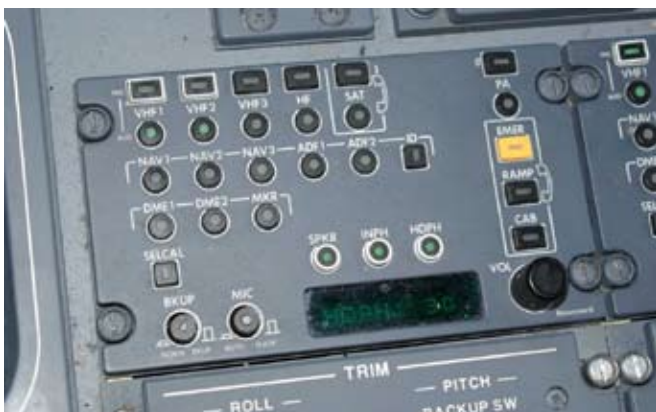
Figure 2

Pilot's audio panel in flight deck
