AAIB Bulletin S5/2012

SPECIAL

ACCIDENT

Aircraft Type and Registration:	EC225 LP Super Puma, G-REDW
No & Type of Engines:	2 Turbomeca Makila 2A1 turboshaft engines
Year of Manufacture:	2009 (Serial no: 2734)
Date & Time (UTC):	10 May 2012 at 1114 hrs
Location:	20 nm east of Aberdeen
Type of Flight:	Commercial Air Transport (Passenger)
Persons on Board:	Crew - 2 Passengers - 12
Injuries:	Crew - None Passengers - 2 (Minor)
Nature of Damage:	Salt water immersion
Commander's Licence:	Airline Transport Pilot's Licence
Commander's Age:	40 years
Commander's Flying Experience:	3,060 hours (of which 2,740 hours were on type)
Information Source:	AAIB Field Investigation

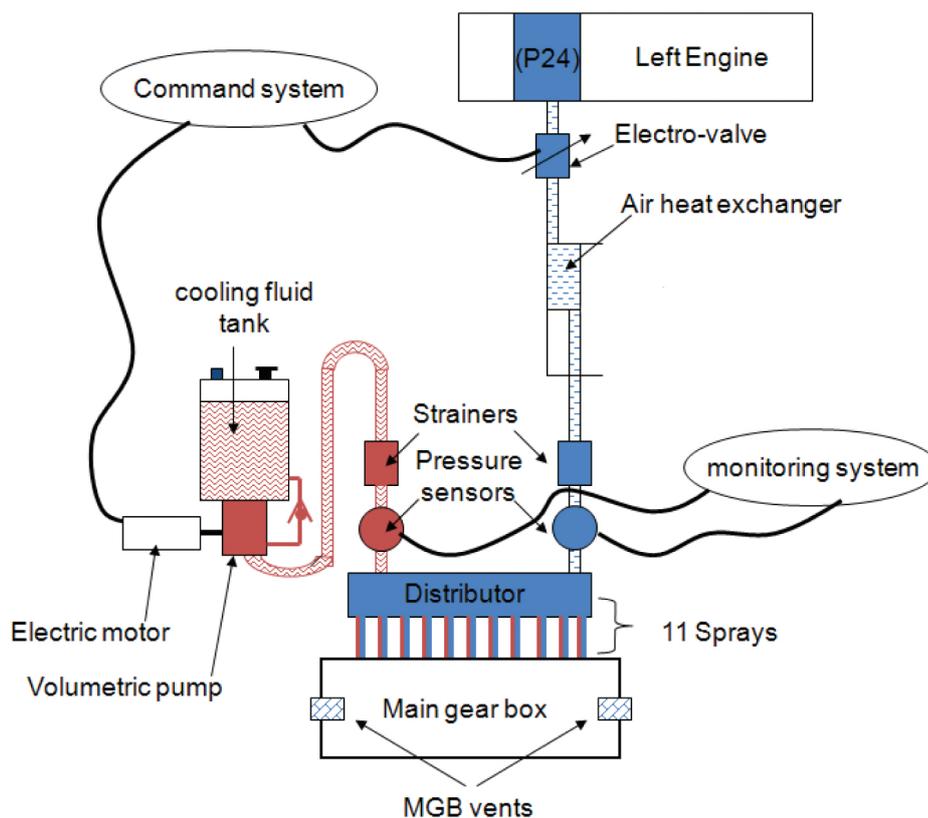
Figure 1

The MGB lubrication system includes two mechanically-driven oil pumps and a crew-activated emergency lubrication system (see Figure 1). The latter comprises: a bleed air supply from the left engine, a Hydrosafe 620 supply from an 11 litre reservoir, a series of small pipes around and inside the MGB, to deliver the Hydrosafe 620 in a spray, and monitoring and command systems on a dedicated Printed Circuit Board (PCB).

When the emergency lubrication system is activated an electro-valve, called the P2.4 valve, opens and bleed air from the left engine enters the system, after passing through an air heat-exchanger. At the same time, an electric pump supplies Hydrosafe 620 from the reservoir. There are two similar sensors that monitor the pressure in the Hydrosafe 620 pipes and bleed air lines; these sensors are mounted on the MGB. A MGB EMLUB caption will illuminate if low pressure is detected in either the Hydrosafe 620 pipes or the bleed air lines. This warning is inhibited for approximately 30 seconds after the system is activated, to allow the system to reach a steady state.

Schematic of the Emergency Lubrication System
