**ACCIDENT**

<b>Aircraft Type and Registration:</b>	Boeing 737-804, G-GDFJ	
<b>No &amp; Type of Engines:</b>	2 CFM56-7B26 turbofan engines	
<b>Year of Manufacture:</b>	2000 (Serial no: 28229)	
<b>Date &amp; Time (UTC):</b>	19 October 2012 at 0638 hrs	
<b>Location:</b>	Glasgow Airport	
<b>Type of Flight:</b>	Commercial Air Transport (Passenger)	
<b>Persons on Board:</b>	Crew - 6	Passengers - 187
<b>Injuries:</b>	Crew - None	Passengers - 1 (Serious) 15 (Minor)
<b>Nature of Damage:</b>	None	
<b>Commander's Licence:</b>	Airline Transport Pilot's Licence	
<b>Commander's Age:</b>	36	
<b>Commander's Flying Experience:</b>	7,600 hours (of which 2,200 were on type) Last 90 days - 227 hours Last 28 days - 69 hours	
<b>Information Source:</b>	AAIB Field Investigation

**Synopsis**

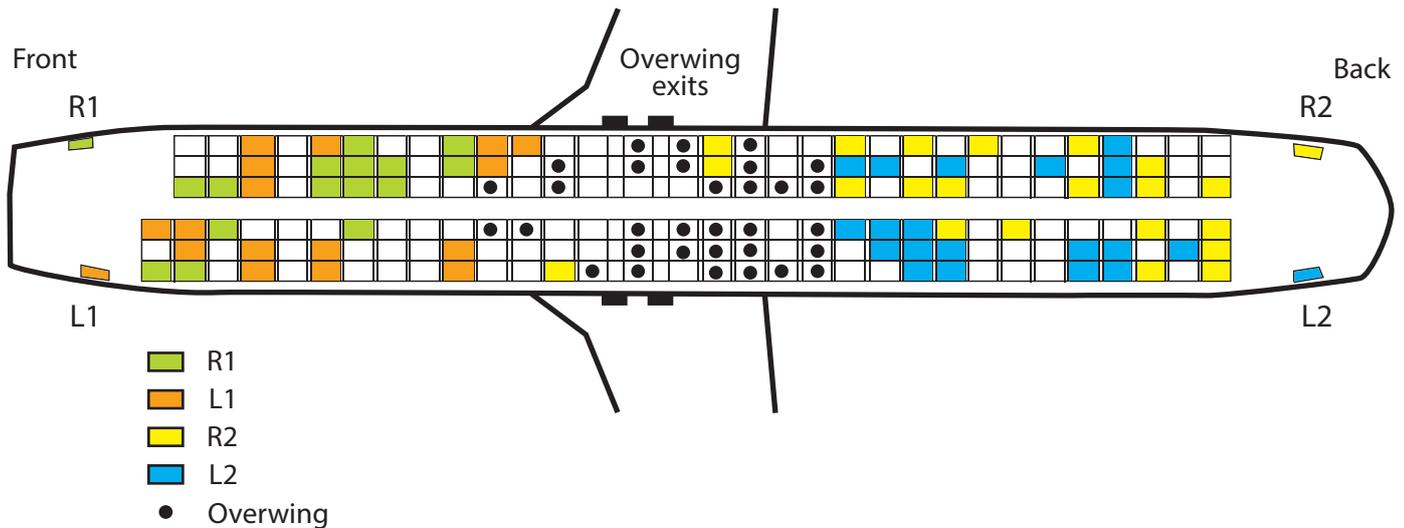
**Figure 3**

When all the passengers had cleared the cabin, the cabin crew left the aircraft and tried to gather the passengers together. The aircraft commander walked the length of the cabin and, having ensured all passengers had evacuated, the co-pilot, followed by the commander, exited the aircraft. Figure 3 shows the exits used by those passengers who returned questionnaires.

Cabin diagram showing the exits used by passengers

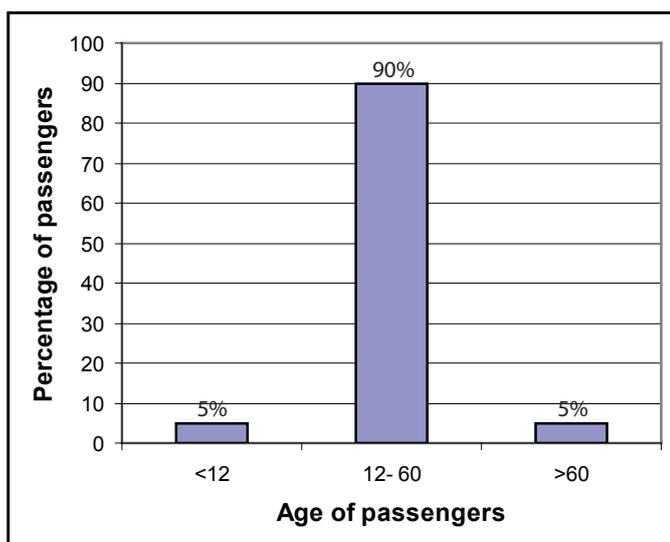
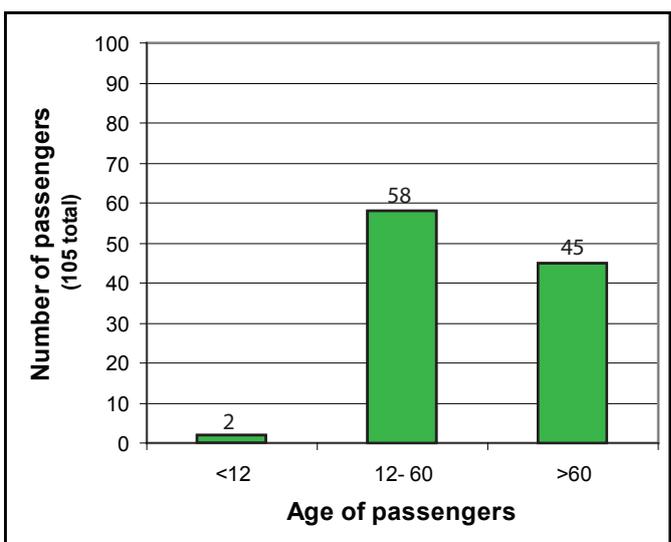
**Figure 4**  
Certification and accident age distribution

The age group requirements for the demonstration, by percentage, are shown in Figure 4. They are compared with the actual age distribution in the accident, obtained from the 105 questionnaires returned.

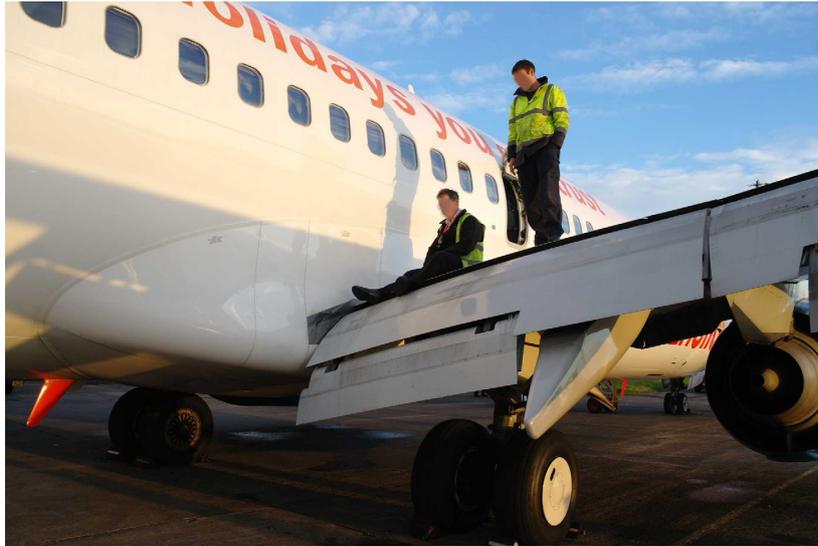
**Figure 5**

Showing the flaps in the fully lowered position.

height of the lowest part of the flap trailing edge with the flap fully lowered (see Figure 5) is 42 inches.

The injuries suffered were as a result of the evacuation, due to passengers bumping into each other on the slides or being knocked to the ground. In the case of the over-wing exits, sliding six feet to the ground off a wet flap can be a daunting experience but the aim is to escape from the aircraft and, as such, carries a degree of risk.

In addition, the operator has re-issued the on-board Safety Card to reflect the need for passengers, evacuating via the overwing exits, to slide down the trailing edge of the wing. Also, the verbal briefing given to passengers occupying seats adjacent to the overwing exits has been amended to stress the requirement to turn aft, immediately after evacuating through the exit, and to slide down the trailing edge of the wing.

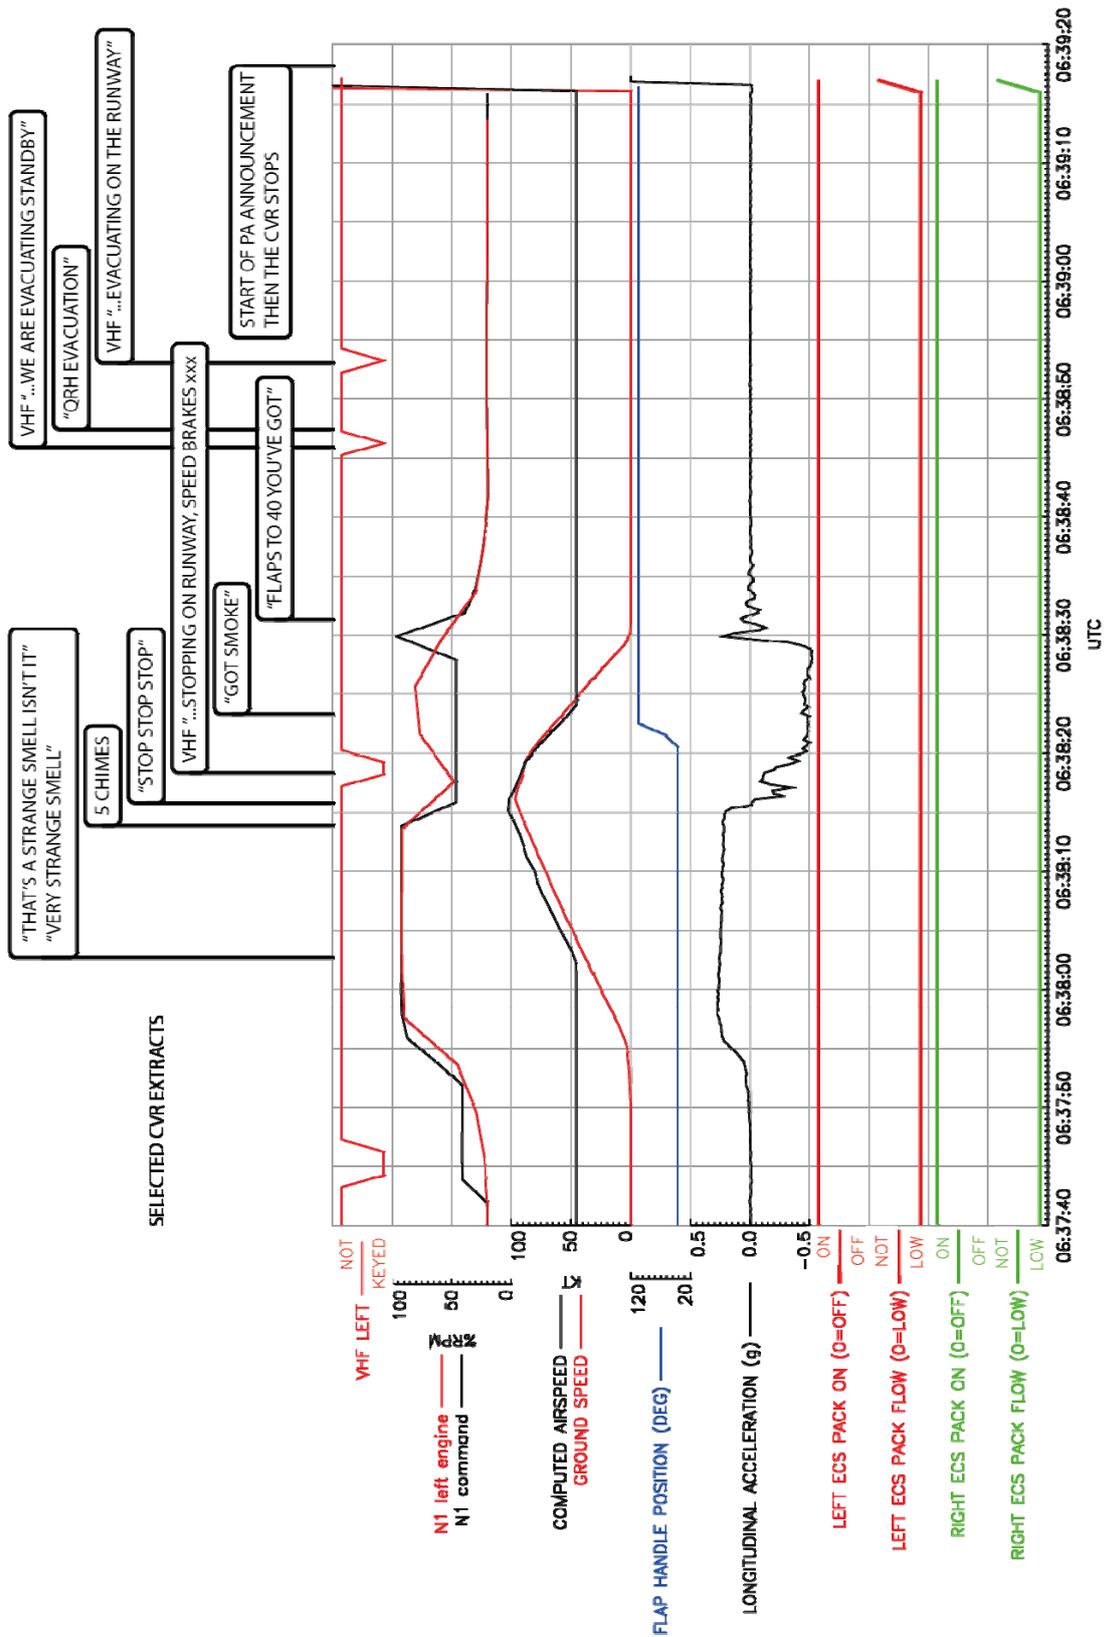
Figure 6

The recordings show that the pilots identified a "STRANGE SMELL" approximately five seconds after the engines reached their takeoff power. The flight crew did not make reference to any visual signs in the cockpit. Eleven seconds after the flight crew first commented on the smell, the cabin crew alerted the flight crew to a problem in the cabin. This was identified as smoke. There was no reference to heat or breathing problems.

Pertinent FDR parameters and CVR extracts

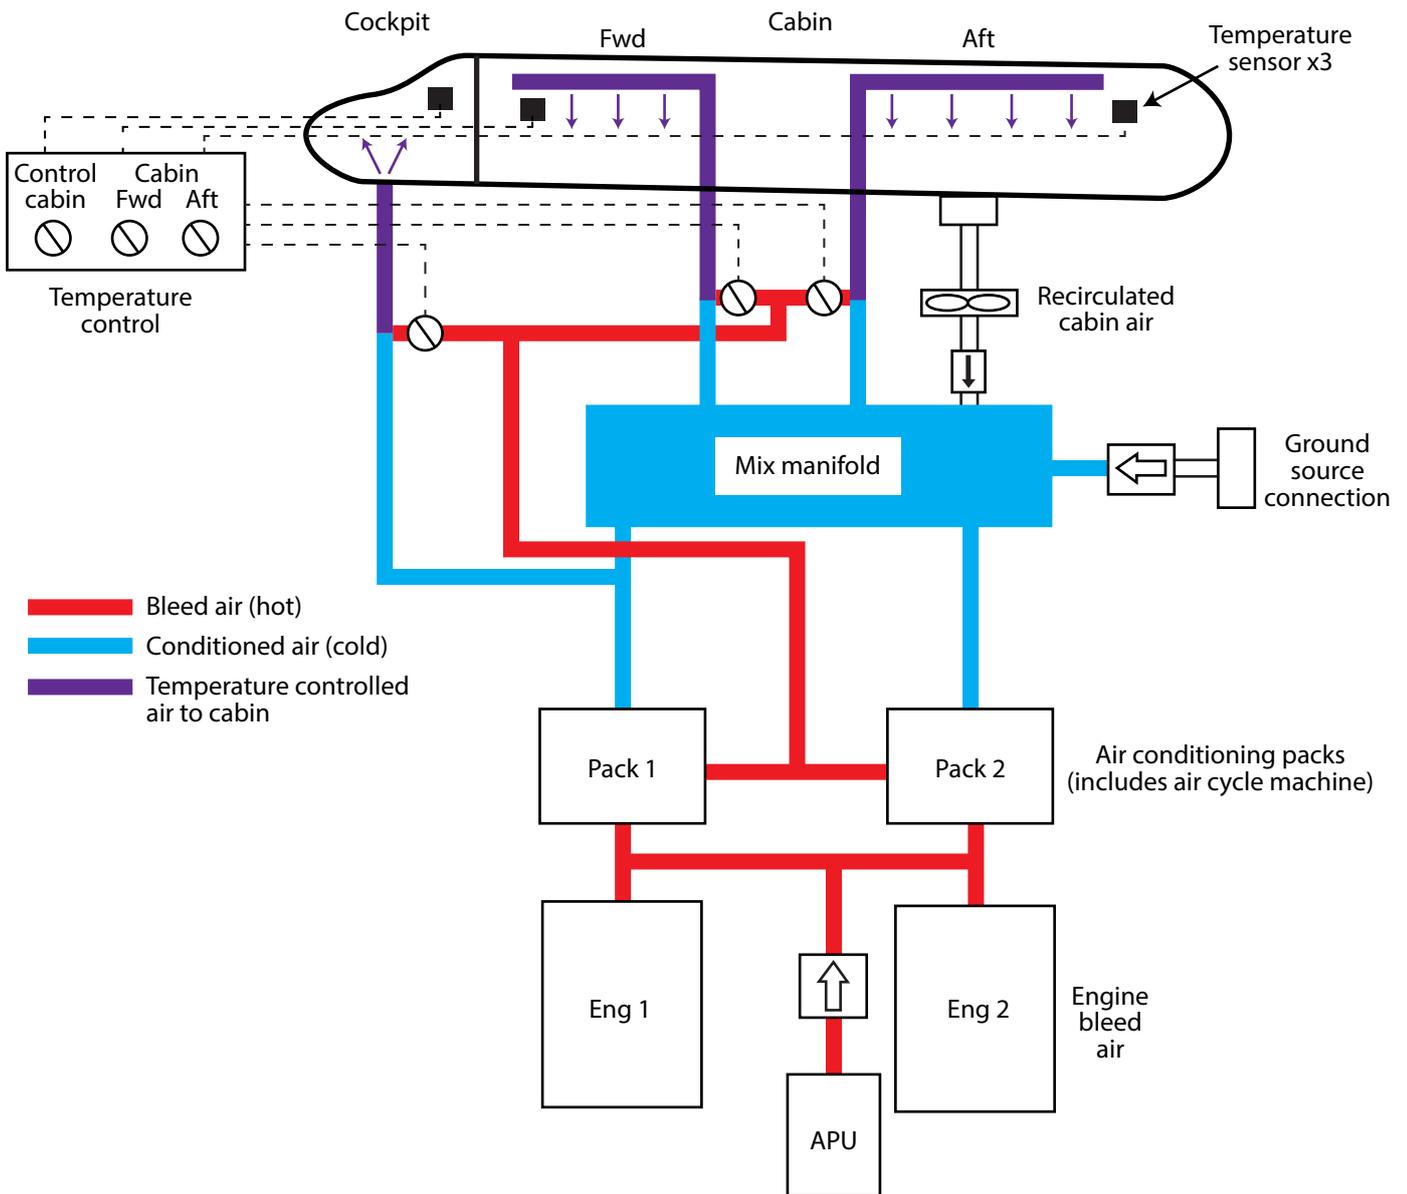
**Figure 7**

Simplified Schematic of Air Conditioning System

At the beginning of the flight, the air conditioning packs were selected ON after engine start, in accordance with the standard operating procedures, but later than on the other flights sampled. This, combined with the short taxi time, may have meant that the cabin was slightly warmer than usual by the time the takeoff commenced. The ambient conditions on the day meant the air was humid, with the temperature and dew point only one degree apart. As engine power was increased for takeoff, more air was available for air conditioning and the air conditioning system was able to supply colder air to the cabin to achieve the selected temperature. As the cabin was warm and humid, this sudden influx of cold air, potentially down to 1.7°C, could have caused the formation of mist or fog in the cabin which, in the low lighting conditions, could have given the appearance of smoke or fumes.

No reason for the acrid burning smell could be found and it did not recur at any time during ground tests or subsequent flights. There was no residual smell in the cabin or on people's clothing and none of the aircraft occupants reported any negative effects. It is possible that this smell may have been due to excessive moisture in the pneumatic system, vaporising from the ducting as it heated up to its normal operating temperature.

Excessive moisture in the air conditioning ducting was a possible factor in this event. Consequently, the operator has directed its maintenance personnel, by Quality

*'The following shall be carried out for all engine runs after maintenance. In addition to the minimum idle of 5 minutes without load (as per AMM task 71-00-00), both air conditioning packs shall be run using engine bleed (as per AMM task 21-00-00) with cabin temperature selectors in the mid position for a further 5 minutes prior to engine shut down.'*
