**ACCIDENT**

<b>Aircraft Type and Registration:</b>	Schempp-Hirth Flugzeugbau GMBH Discus B, G-CHOM	
<b>No &amp; Type of Engines:</b>	None	
<b>Year of Manufacture:</b>	1985	
<b>Date &amp; Time (UTC):</b>	9 July 2009 at 1552 hrs	
<b>Location:</b>	West of Gransden Lodge Airfield, Cambridgeshire	
<b>Type of Flight:</b>	Private	
<b>Persons on Board:</b>	Crew - 1	Passengers - None
<b>Injuries:</b>	Crew - 1 (Fatal)	Passengers - N/A
<b>Nature of Damage:</b>	Aircraft destroyed	
<b>Commander's Licence:</b>	BGA Gliding Certificate with Bronze Badge and Cross-Country Endorsement	
<b>Commander's Age:</b>	64 years	
<b>Commander's Flying Experience:</b>	19,600 hours (of which 2 hours were on type) Last 90 days - 15 hours (gliders) Last 28 days - 8 hours (gliders)	
<b>Information Source:</b>	AAIB Field Investigation

**Synopsis**

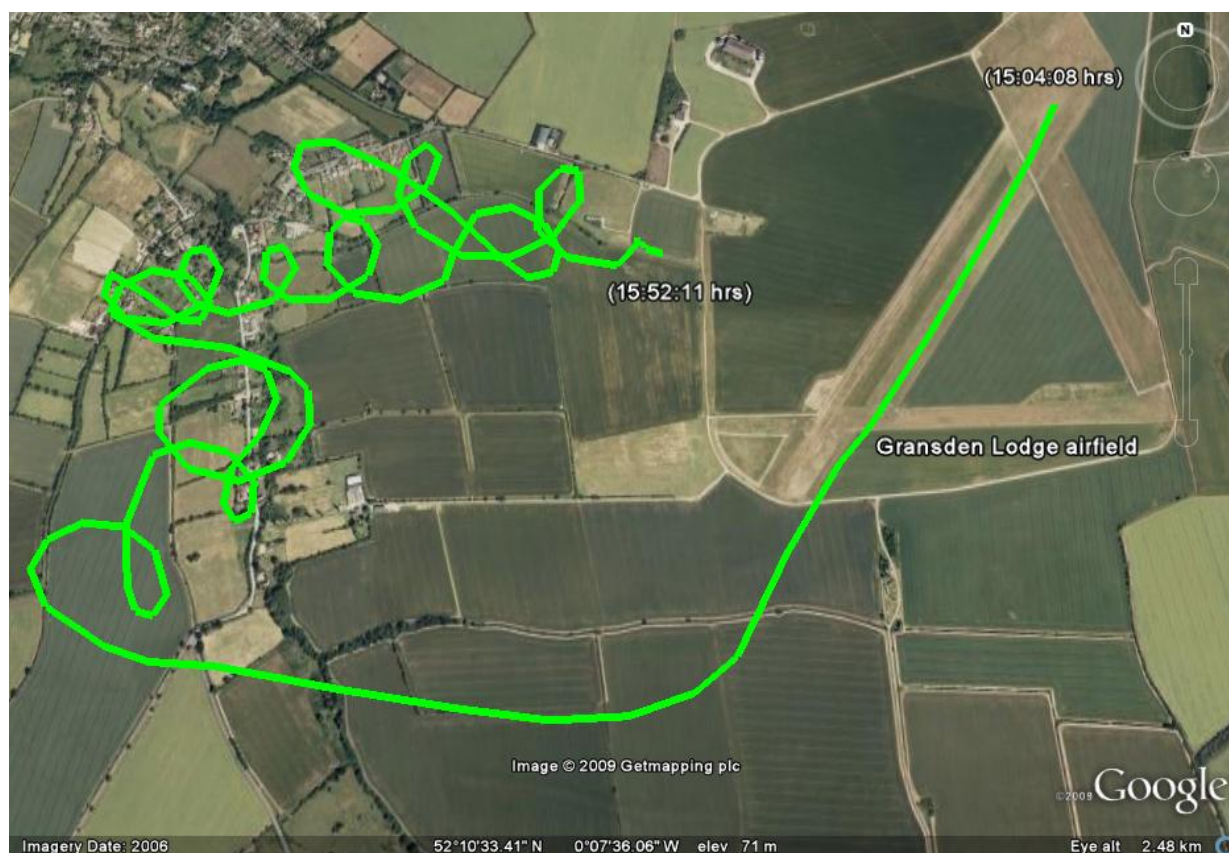
**Figure 1**  
GPS track of G-CHOM

Figure 1 shows the GPS track for G-CHOM, which is consistent with the glider soaring. The accident site was very close to the last recorded GPS position. The indications were that the aircraft's track at the point of impact was approximately 170°M.

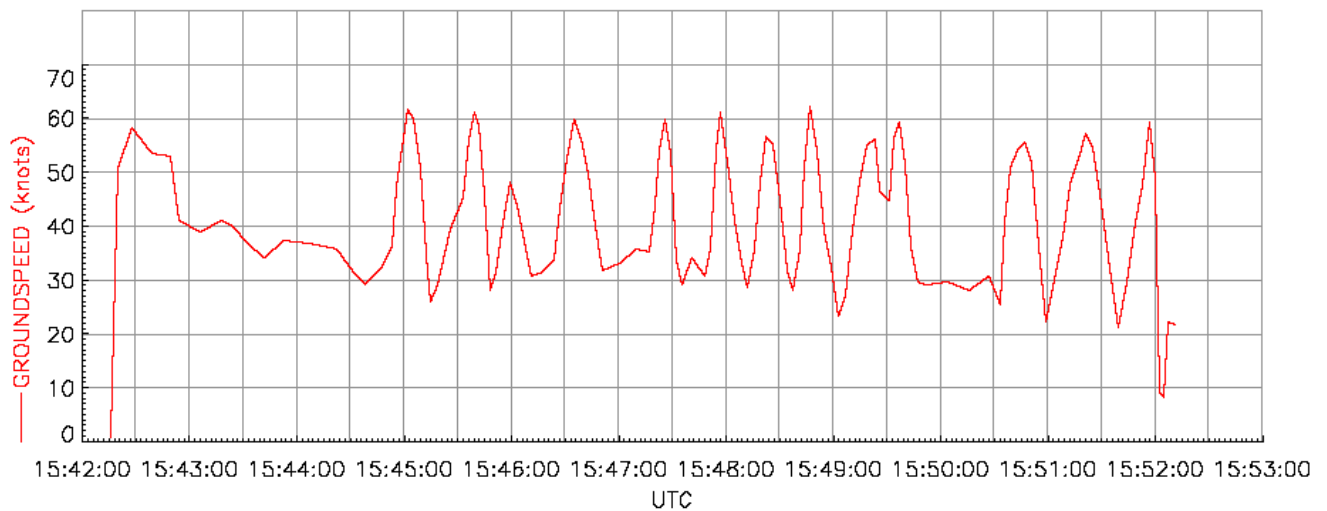
**Figure 2**

The average groundspeed between each GPS track point is presented in Figure 2 and shows that the groundspeed during the majority of the flight oscillated between 30 and 60 kt. The wind at 1552 hrs at 1,000 ft, 1,500 ft and 2,000 ft agl was estimated to

Speed of G-CHOM over the ground
