ACCIDENT

Aircraft Type and Registration:	Yak-52, G-LENA	
No & Type of Engines:	1 Vedeneyev M-14P piston engine	
Year of Manufacture:	1983	
Date & Time (UTC):	22 July 2006 at 1846 hrs	
Location:	Bournemouth Airport, Dorset	
Type of Flight:	Private	
Persons on Board:	Crew - 1	Passengers - 1
Injuries:	Crew - 1 (Fatal)	Passengers - 1 (Fatal)
Nature of Damage:	Aircraft destroyed, with post crash fire	
Commander's Licence:	Airline Transport Pilot's Licence	
Commander's Age:	49 years	
Commander's Flying Experience:	2,500 hours (of which 34 were on type) Last 90 days - 8 hours Last 28 days - 2 hours	
Information Source:	AAIB Field Investigation

Synopsis

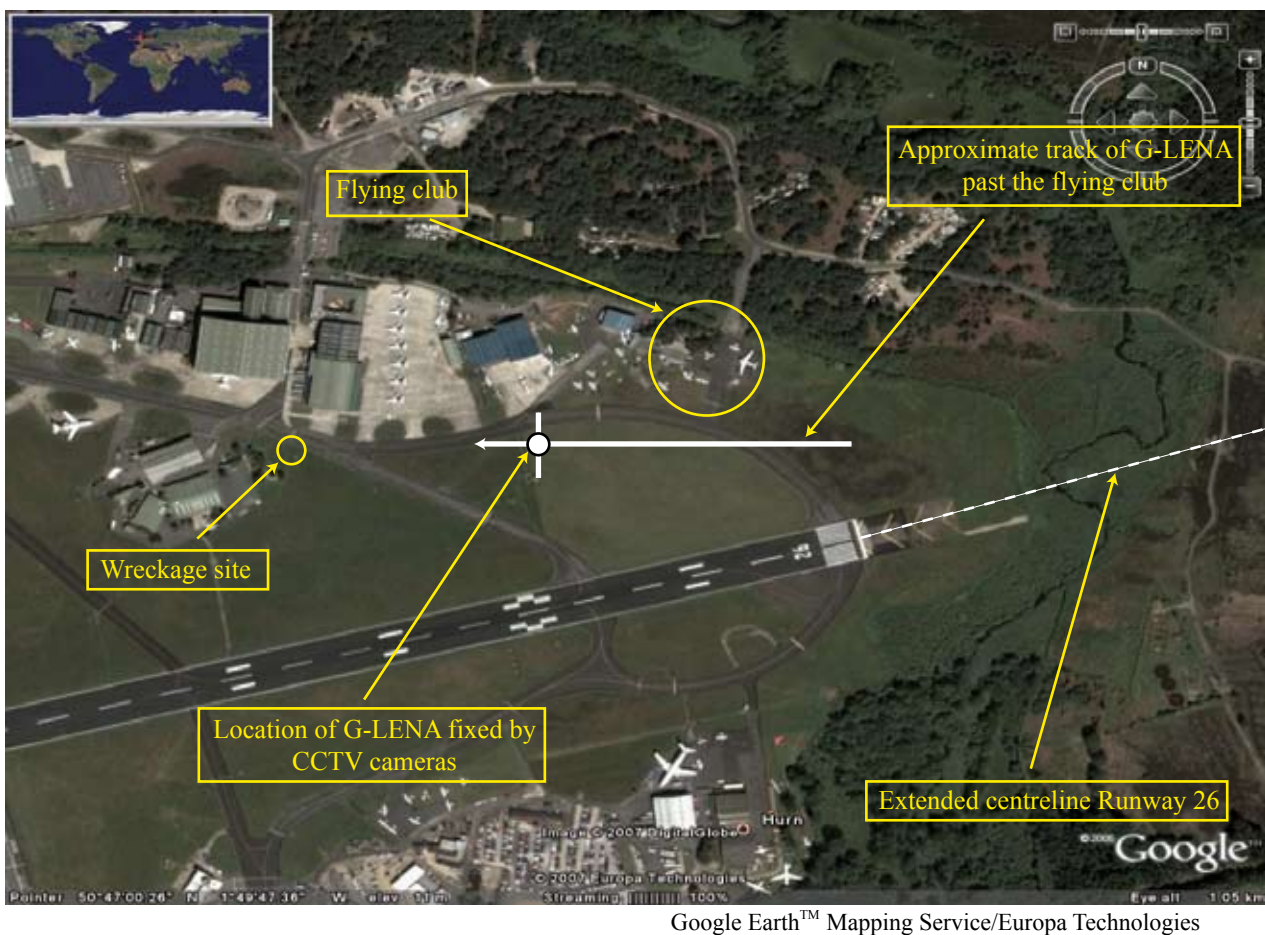
Figure 1

position over the ground was determined at one point, illustrated in Figure 1, when two images from different cameras were captured at the same time; this supported witness information that the aircraft was to the north of the runway centreline as it flew past the flying club.

Diagram illustrating accident site location, Runway 26 threshold area, estimated track of G-LENA and location of the flying club in relation to the accident site

The wreckage of G-LENA was examined on-site both on the night of the accident and the following day. The aircraft had struck the ground on a grassed area between a taxiway and some commercial buildings, Figure 1.

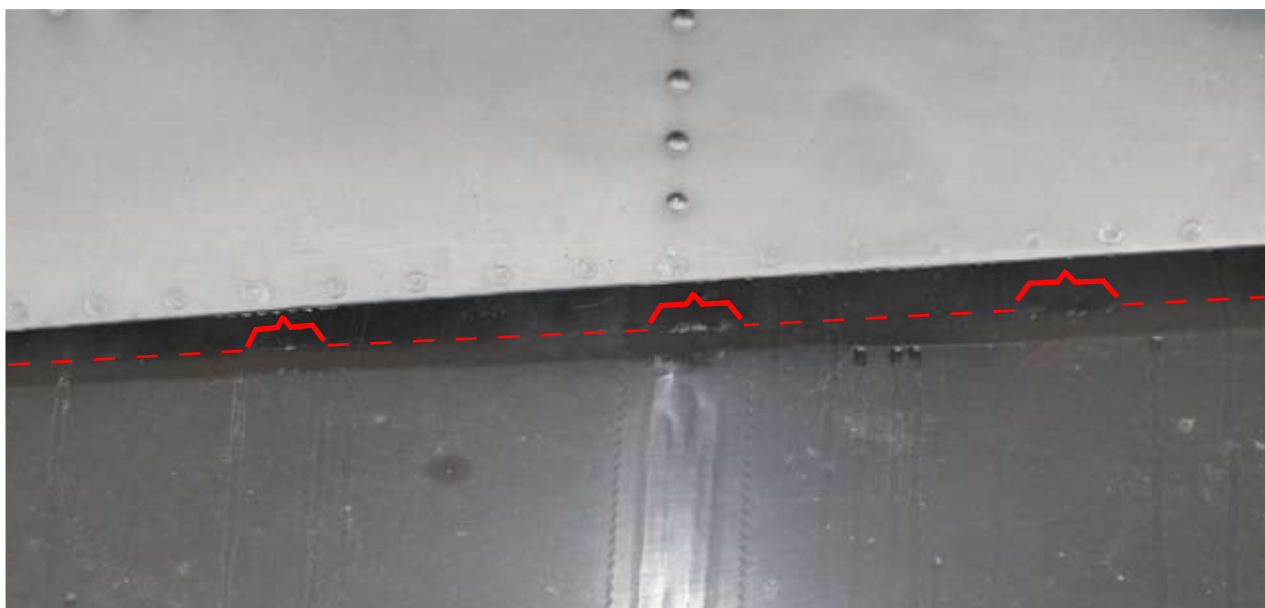
Figure 2

disconnections was found. However, close examination of the roll control system in the wings revealed indicators consistent with the right aileron being in the trailing edge up position and the left aileron in the down position at the time of impact, ie a roll input to the right. Several of these indicators are shown in Figures 2 to 5.

Witness marks on top surface of right aileron from shroud edge made when aileron trailing edge was up

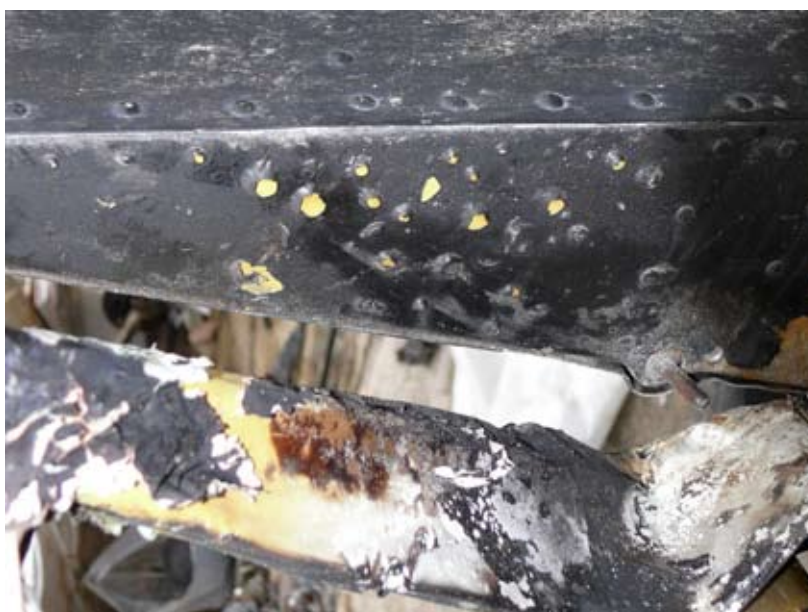
Figure 3

Witness marks of right aileron inboard edge against wing structure with right aileron trailing edge up

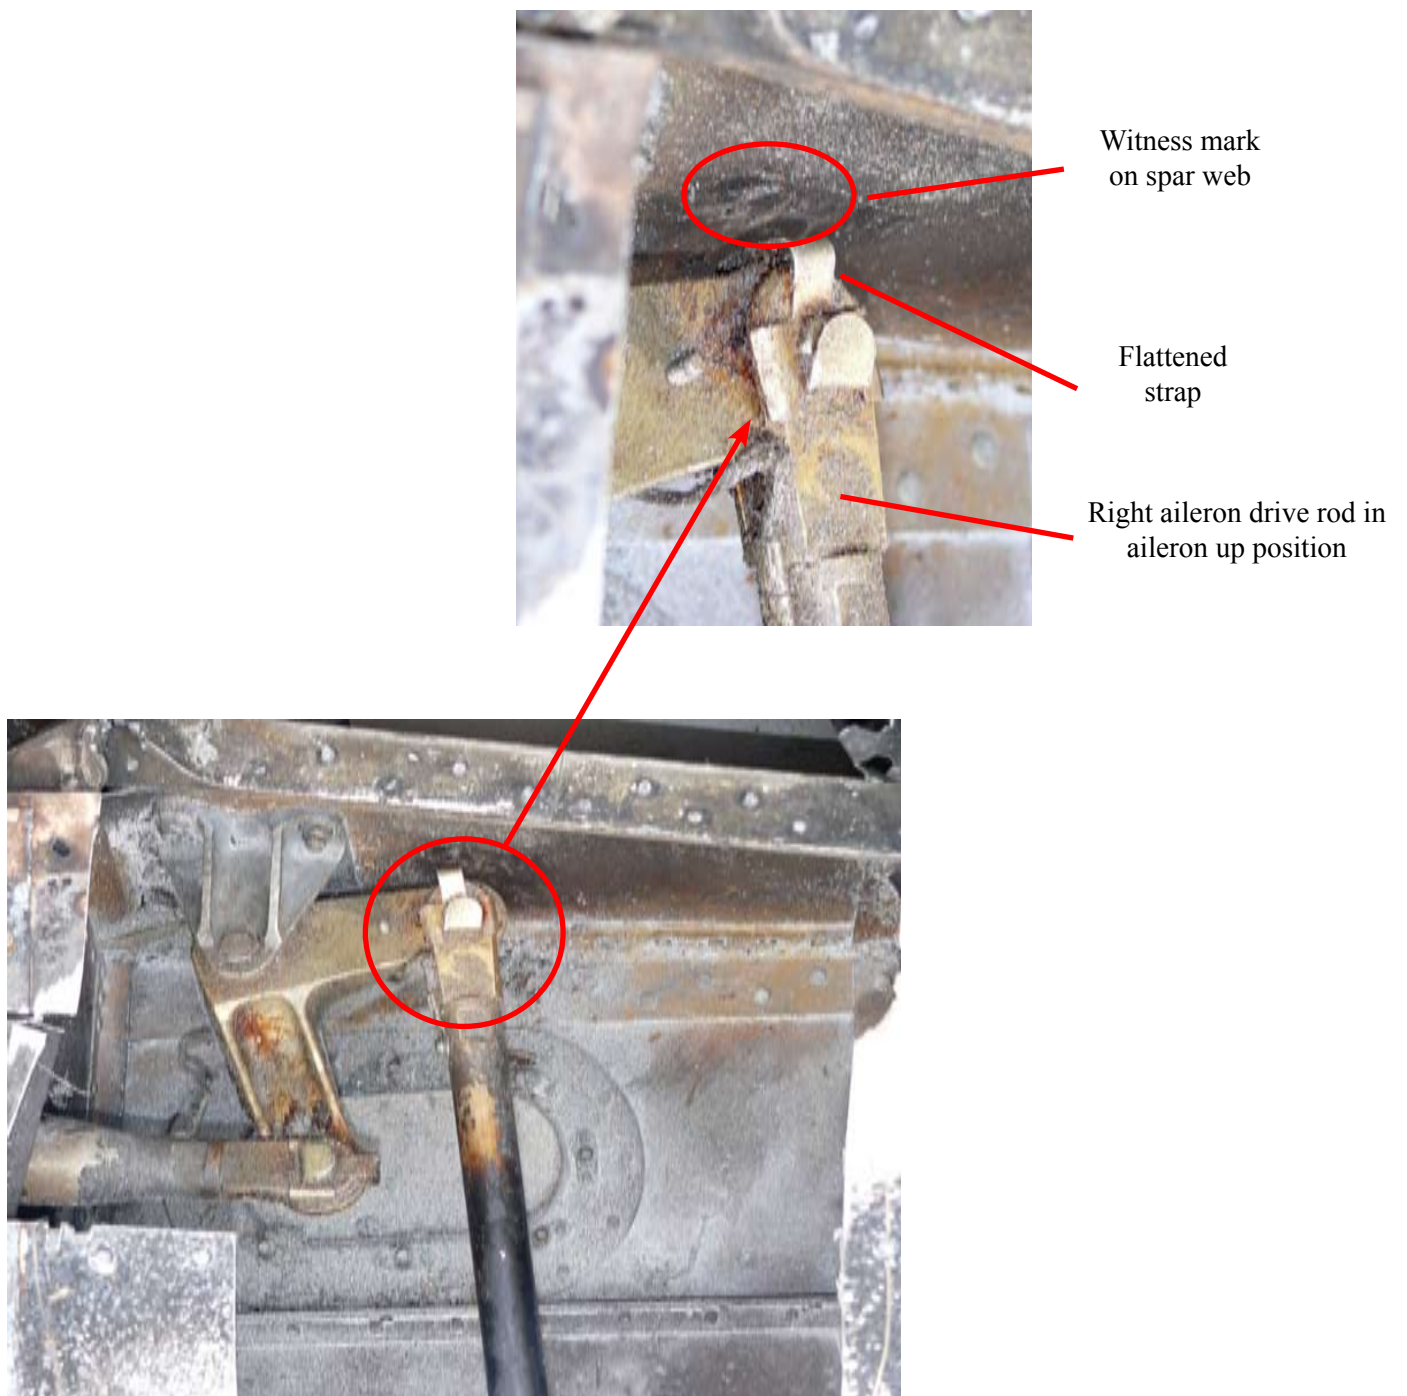
Figure 4

Right aileron drive bellcrank in aileron trailing edge up position.
Note witness marks against rear face of the wing spar and flattening of safety strap (inset picture)

The aileron control linkages in the wings, shown in Figures 4 and 5, were locked in the right roll position by crush damage in the fuselage.

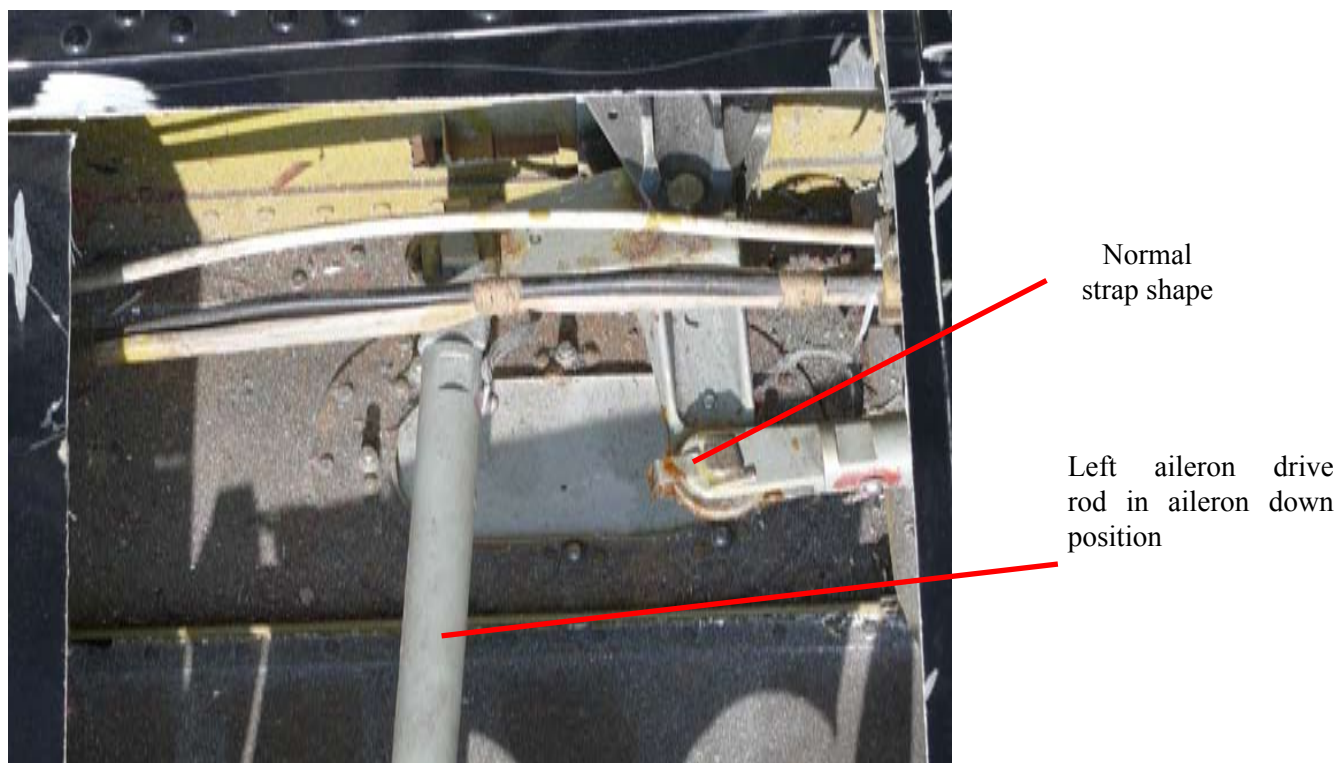
Figure 5

Left aileron drive bellcrank in aileron trailing edge down position

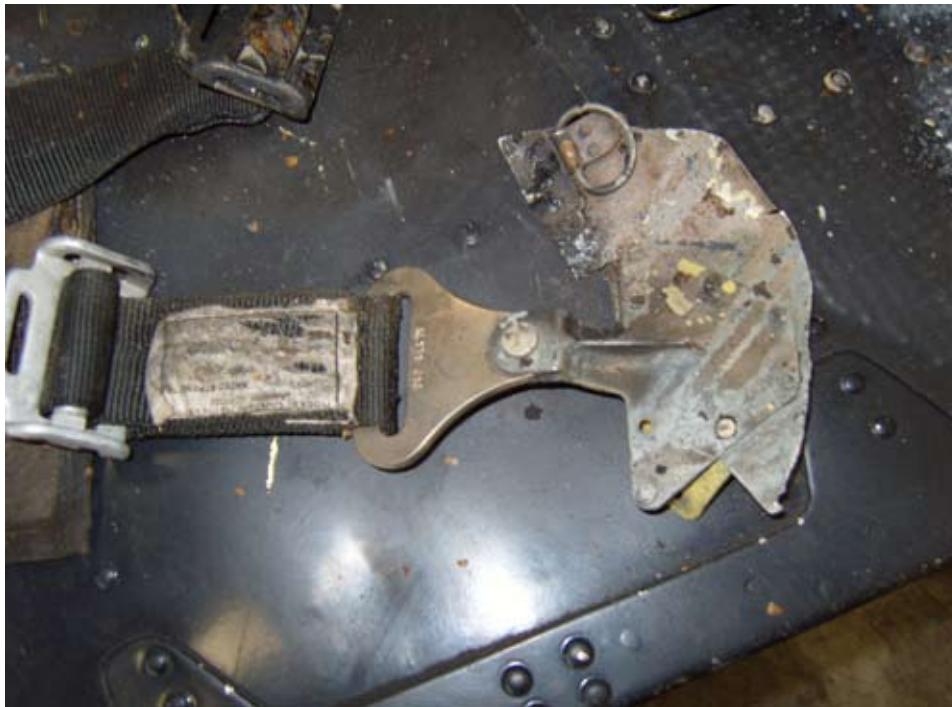
Figure 6

Several of the harness attachment points to the aircraft's structure, in both cockpits, were found to have failed in overload; these failures were consistent with being occasioned during the impact, Figure 6.

Example of seat belt attachment overload

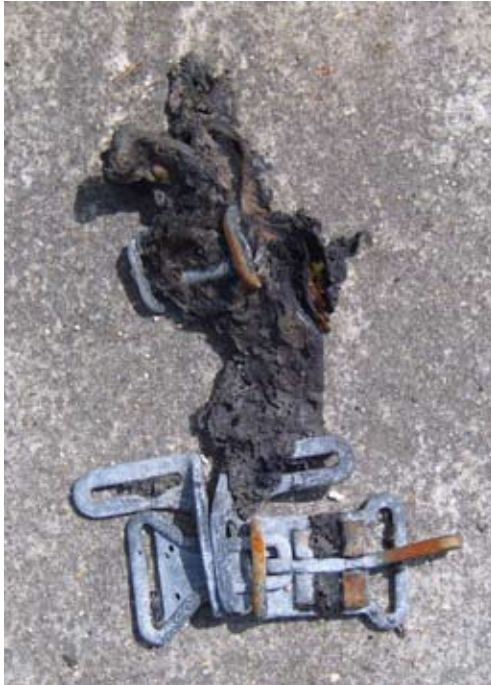
Figure 7

The front cockpit harness fittings were found indicating that the lap straps and the shoulder straps were in place, Figures 7. The crotch strap had not been used.

Front cockpit upper lap strap fittings, as found, showing shoulder straps secured to the lap strap

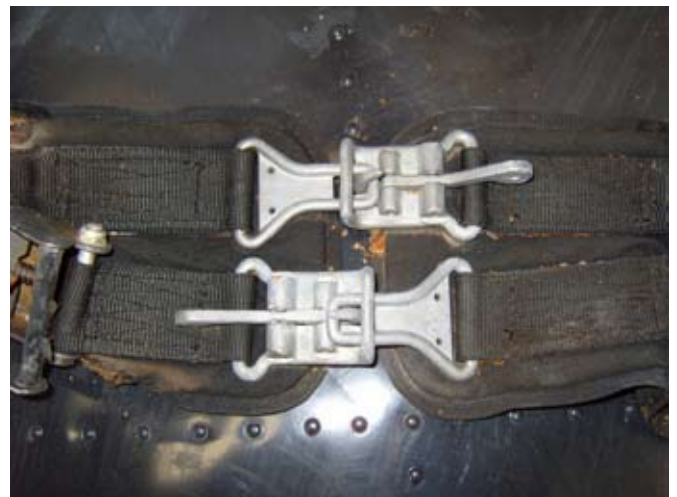
Figure 8

The harness in the rear cockpit, however, was found with the two lap belts fastened, but neither the two shoulder straps nor the crotch strap had been inserted, Figure 8.

Rear cockpit dual lap-strap buckles, as found

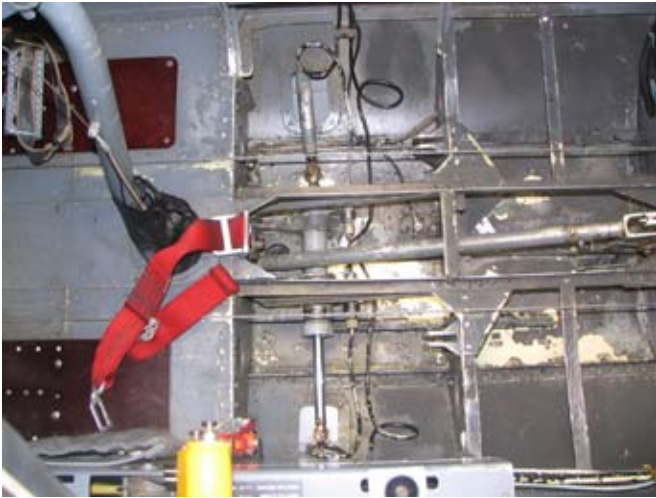
Figure 9

However, further testing demonstrated that it was possible for the buckle on an unsecured crotch strap to interfere with the roll control mechanism beneath the rear seat, as a significant gap exists between the aft end of the rear cockpit floor and the seat. Here, it is possible and relatively easy for the strap buckle to become trapped between the pitch control rod⁵ and fixed structure, and jam the control when either a right or left roll signal is applied, Figures 9 and 10. This jam has the potential to maintain a right or left roll input to the ailerons and prevent the input being cancelled or reversed. A gap also exists in the front cockpit, but tests showed that it would be significantly more difficult for the crotch strap to migrate to the flight control linkage area below the front seat. However, there was a potential for the strap to interfere with the controls in this area.

View of structure beneath rear seat position of a similar aircraft to G-LENA showing controls with right roll applied

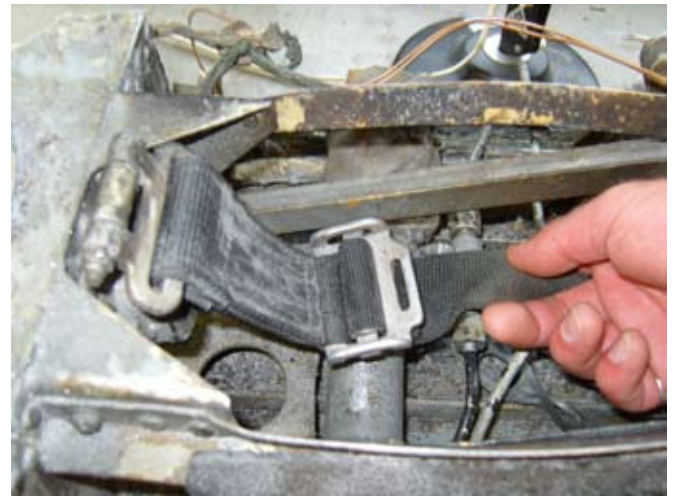
Figure 11

Detailed examination of this area in G-LENA revealed co-incident areas of damage and minor scuffing to the paint of the structural members and the pitch control rod, in the location that the strap buckle naturally adopts, should it migrate to this area, Figures 11 and 12.

Crotch strap from G-LENA positioned in a similar manner to that shown in Figure 10. Paint damage was present to the upper and lower edges of the longitudinal structural member and on the upper section of the flap actuator casing. (Pitch control rod omitted)

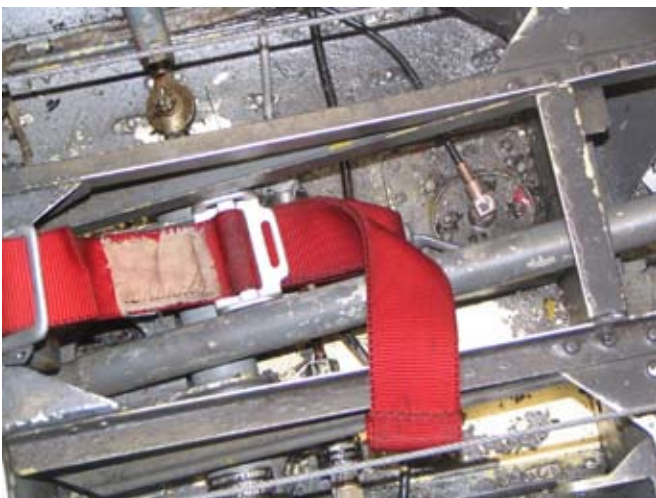
Figure 10

View showing crotch strap buckle jammed between the pitch control rod and fixed structure on a similar aircraft to G-LENA, with left roll being demanded but with the control stick positioned to the right

Safety Recommendation 2007-053

It is recommended that the Civil Aviation Authority review their response to AAIB Safety Recommendation 2003-71 with the intention of minimising the possibility of loose articles becoming jammed in any of the flight controls of Yak-52 aircraft on the UK register.

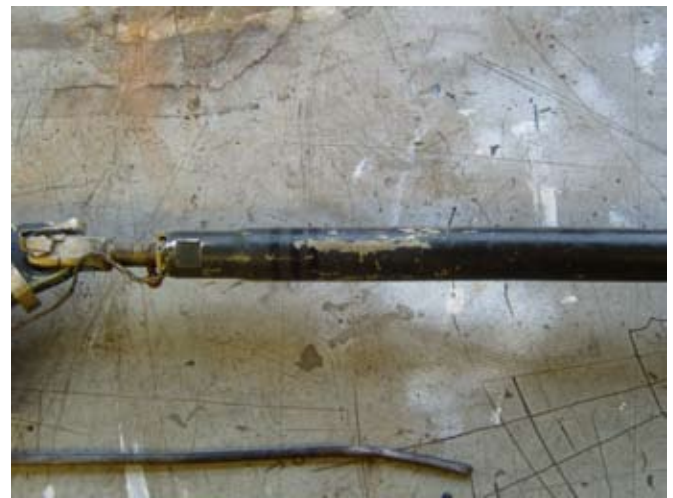
Figure 12

Paint damage to the pitch control rod in the area co-incident with the buckle location shown in Figure 11
