ACCIDENT

Aircraft Type and Registration:	Yak-52, G-LENA	
No & Type of Engines:	1 Vedeneyev M-14P piston engine	
Year of Manufacture:	1983	
Date & Time (UTC):	22 July 2006 at 1846 hrs	
Location:	Bournemouth Airport, Dorset	
Type of Flight:	Private	
Persons on Board:	Crew - 1	Passengers - 1
Injuries:	Crew - 1 (Fatal)	Passengers - 1 (Fatal)
Nature of Damage:	Aircraft destroyed, with post crash fire	
Commander's Licence:	Airline Transport Pilot's Licence	
Commander's Age:	49 years	
Commander's Flying Experience:	2,500 hours (of which 34 were on type) Last 90 days - 8 hours Last 28 days - 2 hours	
Information Source:	AAIB Field Investigation

Synopsis

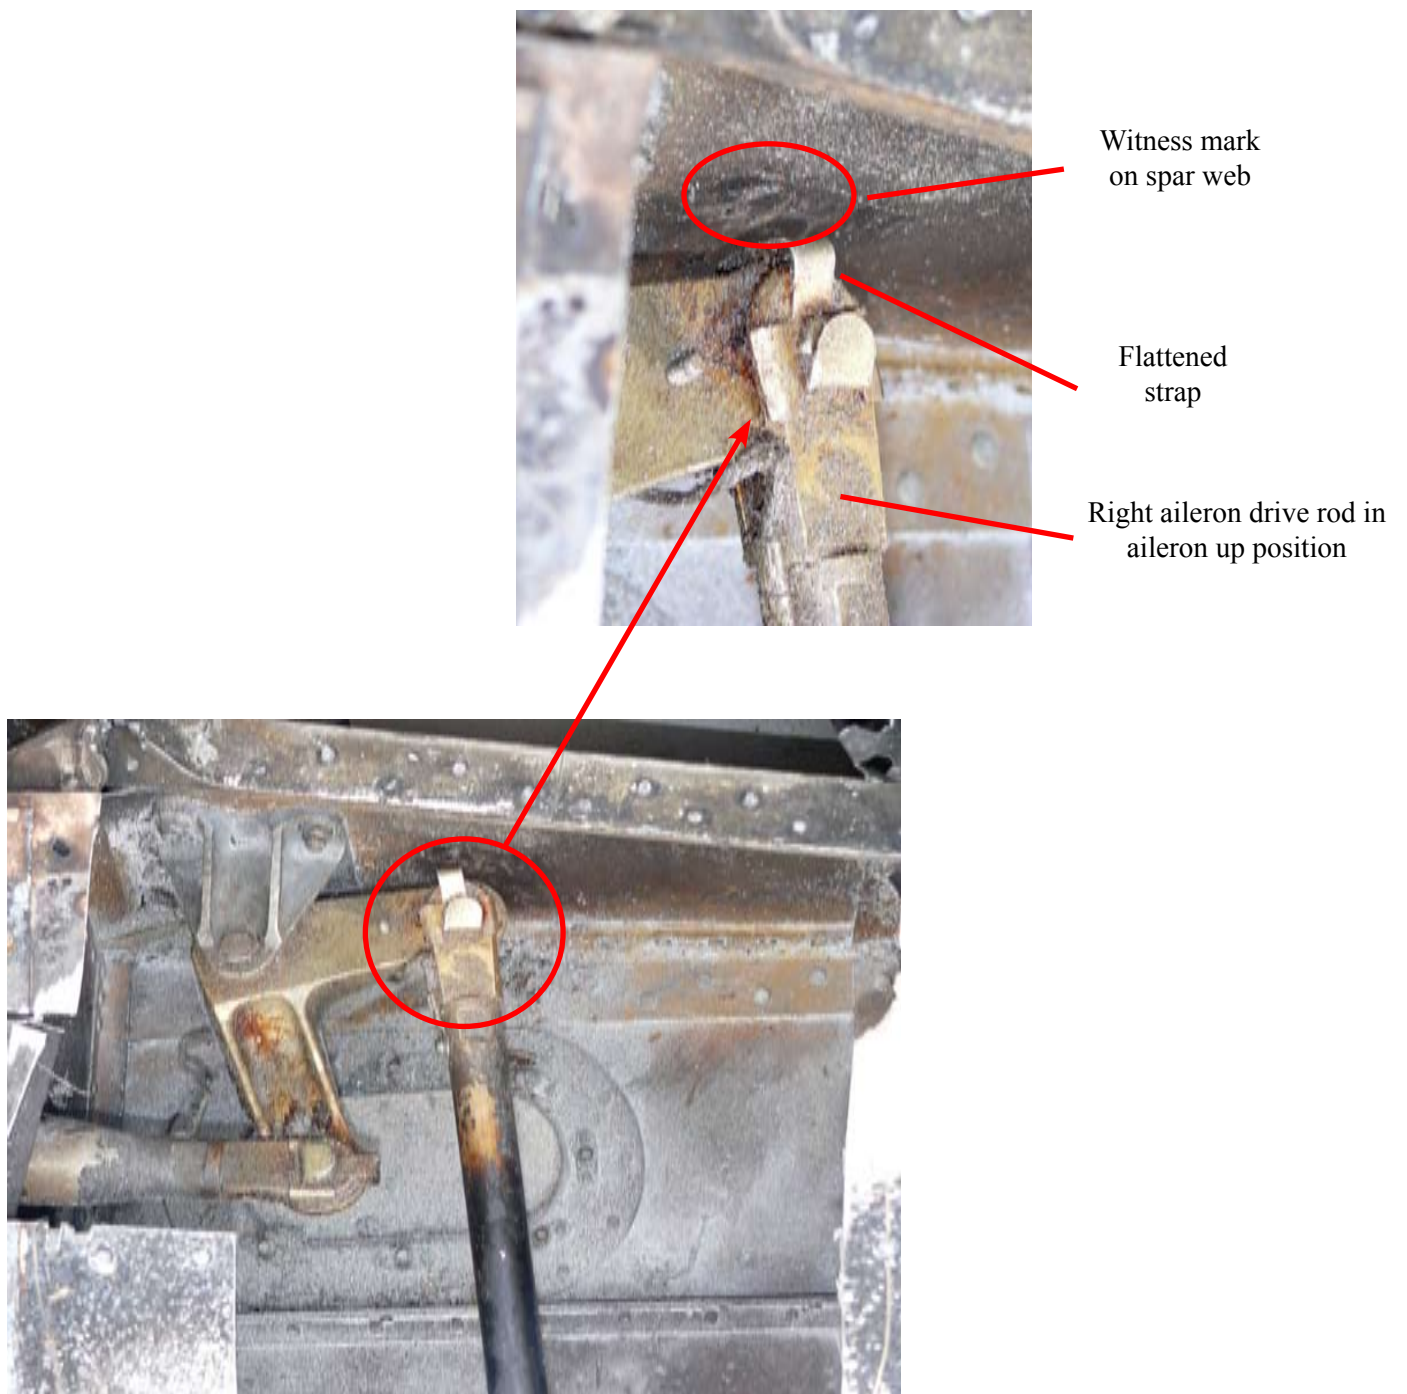
Figure 4

Right aileron drive bellcrank in aileron trailing edge up position.
Note witness marks against rear face of the wing spar and flattening of safety strap (inset picture)

The aileron control linkages in the wings, shown in Figures 4 and 5, were locked in the right roll position by crush damage in the fuselage.

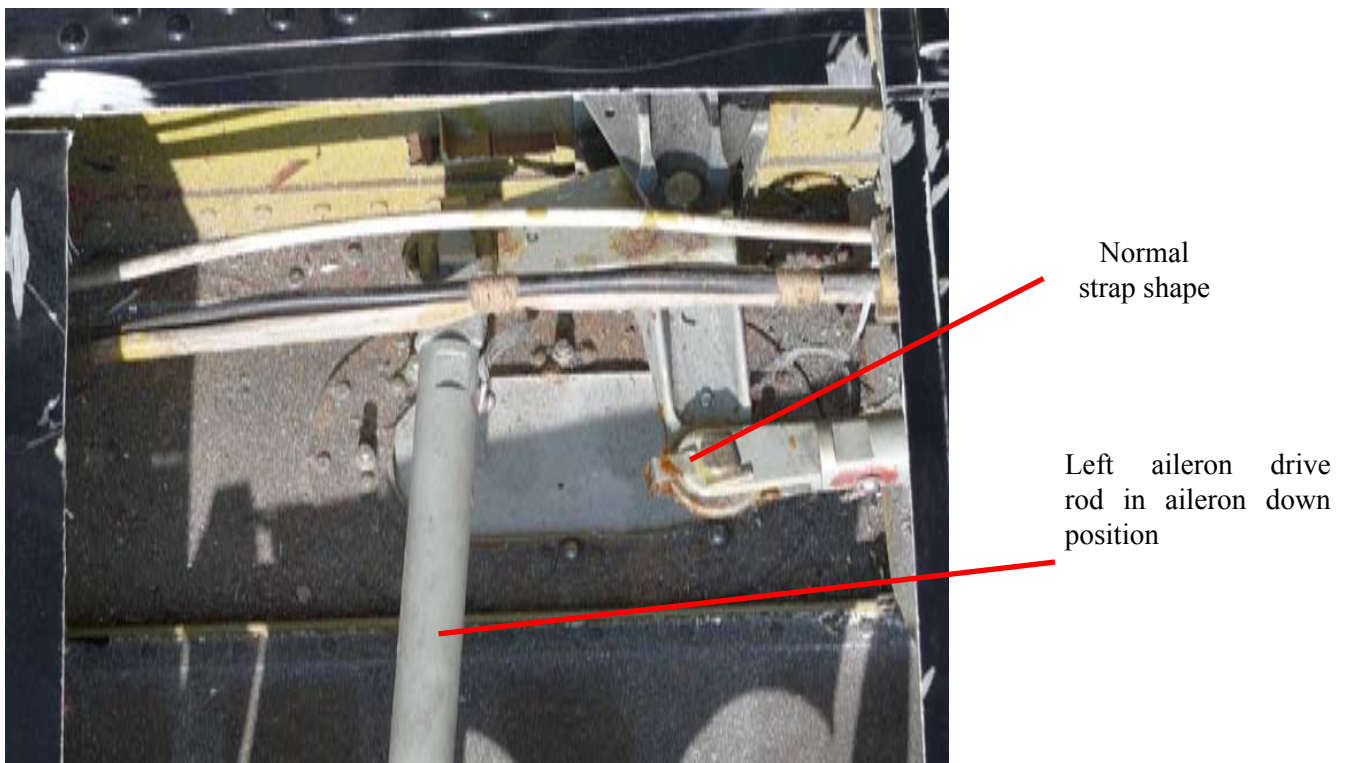
Figure 5

Left aileron drive bellcrank in aileron trailing edge down position

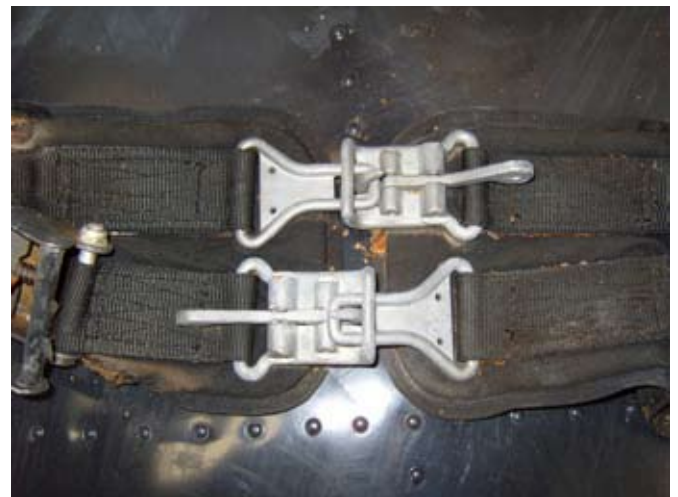
Figure 8

The harness in the rear cockpit, however, was found with the two lap belts fastened, but neither the two shoulder straps nor the crotch strap had been inserted, Figure 8.

Rear cockpit dual lap-strap buckles, as found

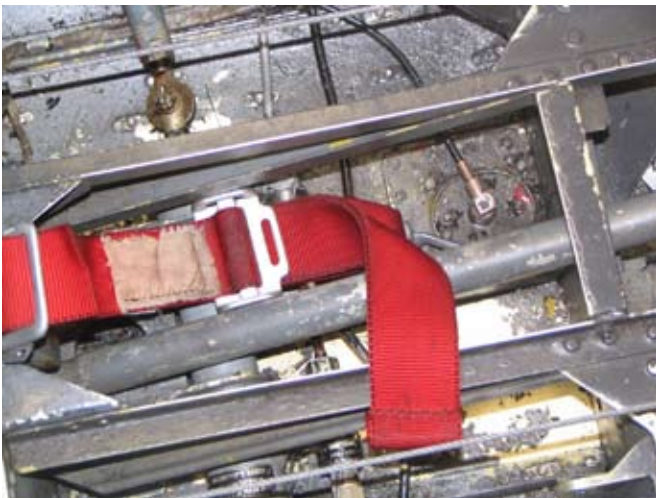
Figure 10

However, further testing demonstrated that it was possible for the buckle on an unsecured crotch strap to interfere with the roll control mechanism beneath the rear seat, as a significant gap exists between the aft end of the rear cockpit floor and the seat. Here, it is possible and relatively easy for the strap buckle to become trapped between the pitch control rod⁵ and fixed structure, and jam the control when either a right or left roll signal is applied, Figures 9 and 10. This jam has the potential to maintain a right or left roll input to the ailerons and prevent the input being cancelled or reversed. A gap also exists in the front cockpit, but tests showed that it would be significantly more difficult for the crotch strap to migrate to the flight control linkage area below the front seat. However, there was a potential for the strap to interfere with the controls in this area.

View showing crotch strap buckle jammed between the pitch control rod and fixed structure on a similar aircraft to G-LENA, with left roll being demanded but with the control stick positioned to the right

Safety Recommendation 2007-053

It is recommended that the Civil Aviation Authority review their response to AAIB Safety Recommendation 2003-71 with the intention of minimising the possibility of loose articles becoming jammed in any of the flight controls of Yak-52 aircraft on the UK register.

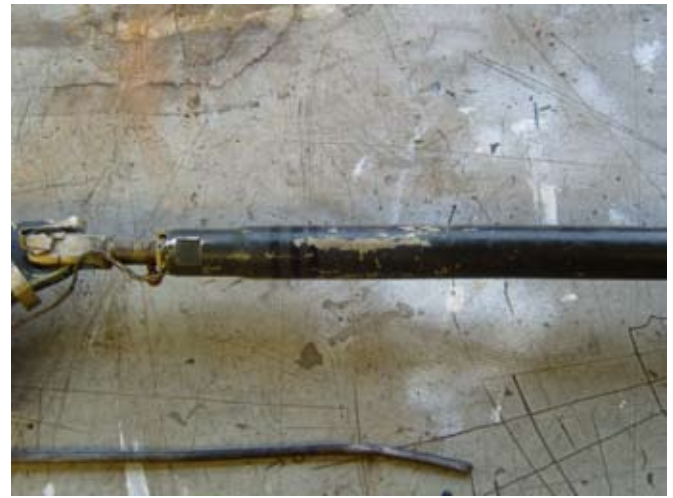
Figure 12

Detailed examination of this area in G-LENA revealed co-incident areas of damage and minor scuffing to the paint of the structural members and the pitch control rod, in the location that the strap buckle naturally adopts, should it migrate to this area, Figures 11 and 12.

Paint damage to the pitch control rod in the area co-incident with the buckle location shown in Figure 11
