ACCIDENT

Aircraft Type and Registration:	Piper PA-23-250 Aztec, G-BGTG	
No & Type of Engines:	2 Lycoming IO-540-C4B5 piston engines	
Year of Manufacture:	1979	
Date & Time (UTC):	19 July 2007 at 1615 hrs	
Location:	Guernsey Airport	
Type of Flight:	Private	
Persons on Board:	Crew - 1	Passengers - 1
Injuries:	Crew - None	Passengers - None
Nature of Damage:	Scratch on the lower side of the right wing tip and aileron, damage to the right landing gear door, damage to footstep	
Commander's Licence:	Private Pilot's Licence	
Commander's Age:	58 years	
Commander's Flying Experience:	1,171 hours (of which 12 were on type) Last 90 days - 16 hours Last 28 days - 5 hours	
Information Source:	Aircraft Accident Report Form submitted by the pilot, plus AAIB examination of a failed door actuating cylinder

Synopsis

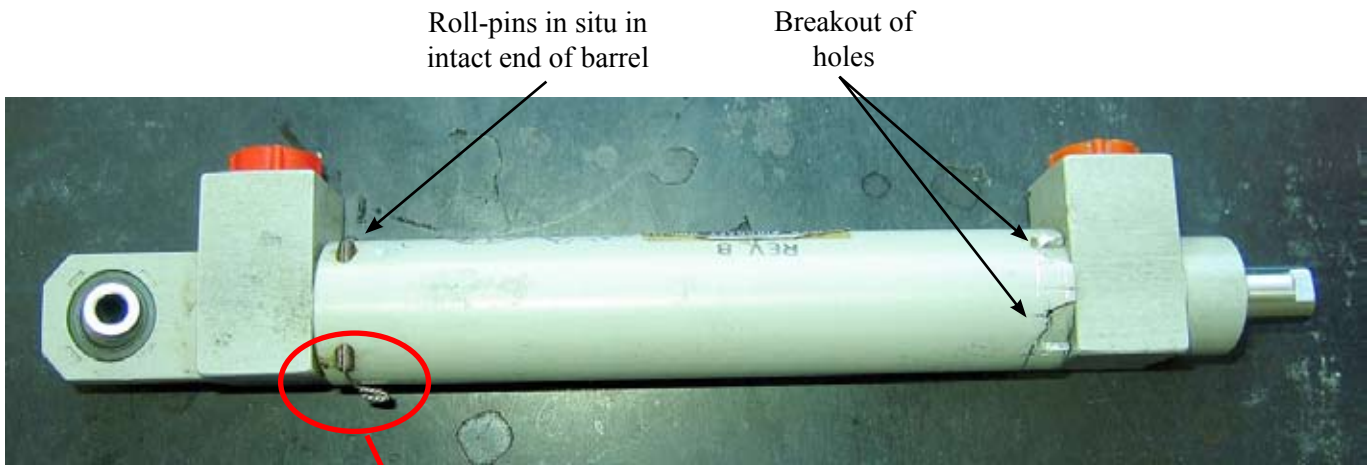
Figure 1 (above)

Examination of the aircraft after the accident revealed that the barrel of the right main landing gear door actuator had failed in such a manner as to allow the end-cap of the cylinder to detach. This caused a total loss of hydraulic fluid and consequent failure of the retraction actuating system. The AAIB examined the failed actuator and it was apparent that the end-cap had separated because of a 'breakout' of material around holes in the barrel of the cylinder. These holes provided location for a pair of roll pins that passed tangentially through the barrel and the cylinder end plug, on opposing sides of the cylinder housing, fixing the former to the latter (Figure 1).

Failed actuator, showing broken-out roll-pin holes (end plug re-inserted in barrel)

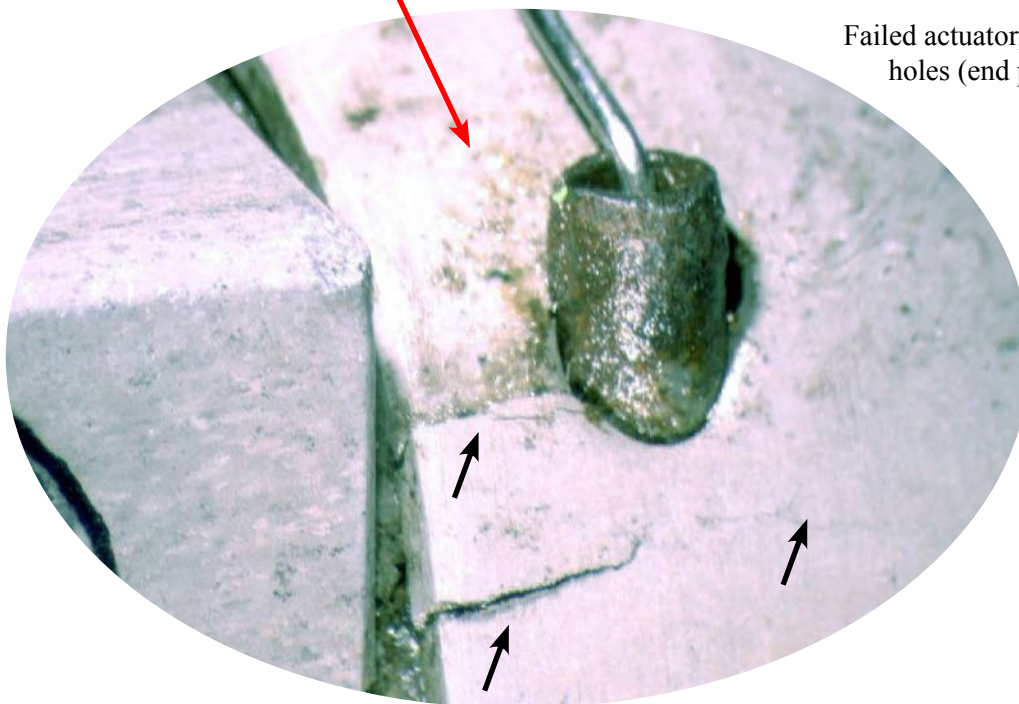
Figure 2

In addition to the fractures associated with the breakout a series of longitudinal cracks of varying length and width were also apparent at other locations around

each of the roll-pin holes in the barrel. This occurred both at the end which had failed and also around similar roll-pin holes in the opposite end of the barrel, which had not failed (Figure 2). It was evident that the breakout which had allowed the end plug to detach, resulted from exploitation of these pre-existing cracks, which gave the appearance of having been caused by stress-corrosion or a related mechanism.

The failed unit was subjected to detailed metallurgical examination, which included scanning electron microscopy. It was established that the cracks were indeed intergranular, probably caused by corrosion, which was widely apparent. Corrosion products had fully penetrated the grain boundaries, consistent with exposure to a marine environment. Cracks appeared to have been initiated by intergranular fissures in the surface of the barrel during manufacture, prior to the component being anodised, resulting in penetration of these fissures by anodic products (oxides). Additionally, the anodic coating of the barrel was unusually thin, being no more than 3 microns. This appeared to be not thick enough to prevent exploitation of these fissures subsequently by corrosion in service. The final overload fractures were ductile, suggesting that the material itself was not particularly embrittled, but Energy Dispersive X-Ray (EDX) analysis suggested the material was a copper/aluminium alloy, a type that generally offers poor resistance to corrosion.

Typical cracks at hole in *intact* end of barrel
