ACCIDENT

Aircraft Type and Registration:	Robinson R22 Beta, G-BXUC	
No & Type of Engines:	1 Lycoming O-320-B2C piston engine	
Year of Manufacture:	1988 (Serial no: 908)	
Date & Time (UTC):	22 September 2011 at 1500 hrs	
Location:	Gloucestershire Airport	
Type of Flight:	Training	
Persons on Board:	Crew - 1	Passengers - None
Injuries:	Crew - None	Passengers - N/A
Nature of Damage:	Tailboom and supporting structure damaged	
Commander's Licence:	Private Pilot's Licence	
Commander's Age:	26 years	
Commander's Flying Experience:	n/k hours (of which n/k were on type) Last 90 days - n/k hours Last 28 days - n/k hours	
Information Source:	Aircraft Accident Report Form submitted by the pilot

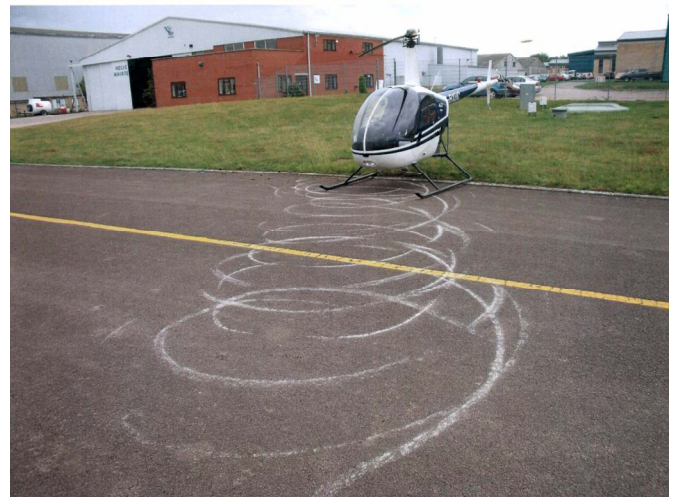
Figure 1

After landing the pilot hover-taxed the helicopter to the apron close to the helicopter operator's facilities. He then attempted to throttle back but inadvertently increased the engine power this, combined with a left yaw pedal input which had been applied during the landing, caused the helicopter to rotate rapidly to the left. It completed approximately six horizontal rotations before the pilot was able to regain control. The helicopter came to rest upright with the rear of the landing skids embedded in grass at the side of the apron, see Figure 1. The skin of the helicopter's tailboom had buckled and its supporting structure had become distorted. The pilot was uninjured.

Ground marking produced by G-BXUC during the incident
