No: 5/90

Ref: EW/G90/01/05

Bell 222A, G-OSEB

Main Rotor Transmission nodal suspension arm fractured.

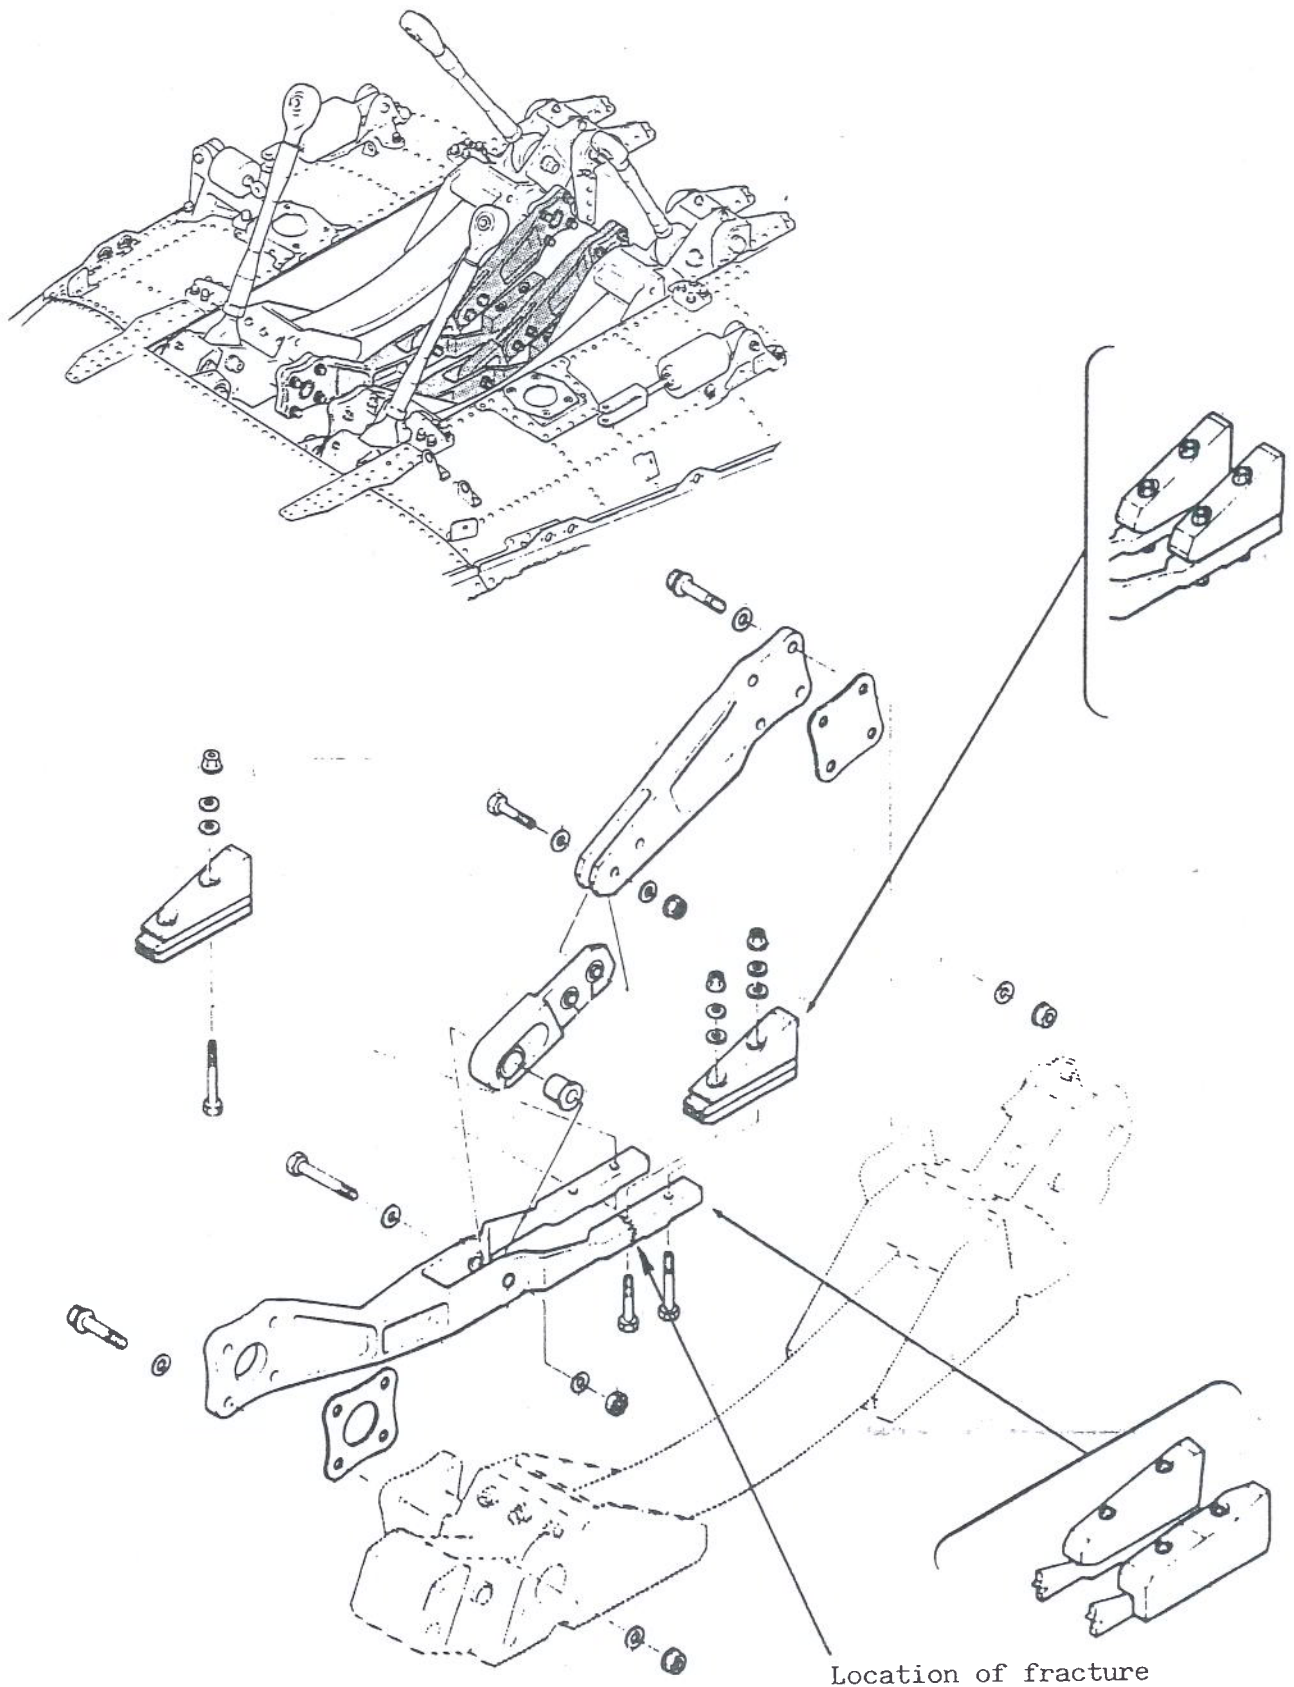
Upon examination, it was found that a main rotor transmission suspension tuning weight had detached following failure of one of the fork ends of the arm, assembly part number 222-031-611-107 (see diagram). Subsequent metallurgical examination concluded that the fork end had failed in fatigue at the position where one of the holes through which the bolts retaining the weight pass. The fatigue origin appeared to be associated with a deep counterbore on the bottom face of the arm. It was also noted that the replacement arm, assembly part number 222-031-611-111, had a significantly shallower counterbore at this location. Total service life on the failed component was 1,328 hours.

G-OSEB FAILED NODAL SUSPENSION ARM

A recommendation has been made to the Civil Aviation Authority that they require periodic inspection of these parts and monitor the performance of the later standard of arm, with a view to withdrawal of the earlier standard with deep counterbores.
