AAIB Special Bulletin S6/2013, published on 5 September 2013, provided initial information on the circumstances of the accident. This bulletin provides an update on the significant investigation findings to date.

Final Approach to Runway 09

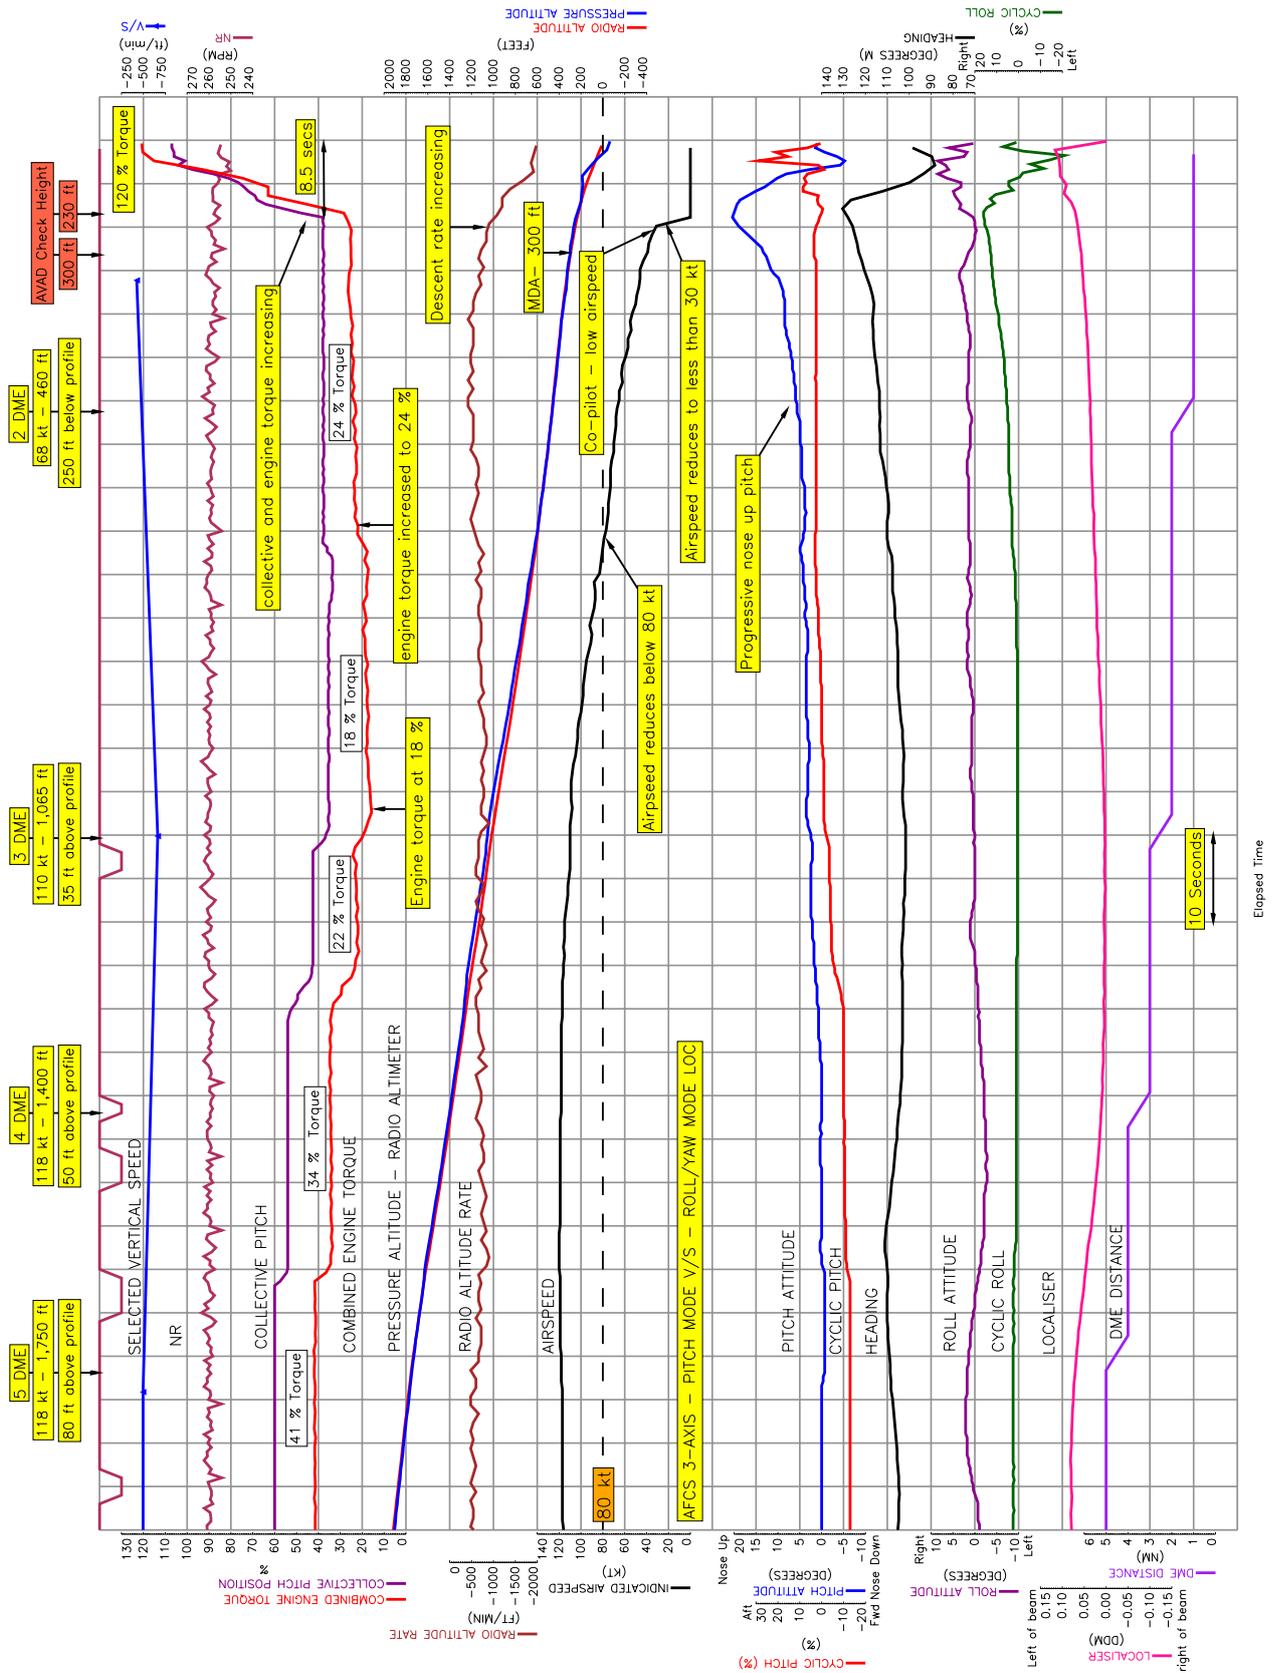
Figure 1 presents the salient recorded data for the final approach to Runway 09.

Recorded data parameters for the Final Approach

At 3 nm, the collective pitch was reduced and the engine torque stabilised at 18%. The airspeed was reducing at a rate of about 1 kt per second.

At approximately 2.6 nm and an altitude of 800 ft, the co-pilot advised they had 500 ft to go to the MDA, which the commander acknowledged. The airspeed was 87 kt and the descent rate was about 700 ft/min. When the airspeed reached 80 kt the collective pitch was increased, with an accompanying increase in engine torque to 24%.

At 2.2 nm, the helicopter was at an altitude of 560 ft and the airspeed was 74 kt. The helicopter's pitch attitude started to increase slowly as the autopilot maintained the selected vertical speed, whilst the airspeed continued to decrease.

With the co-pilot having advised that the target altitude at 1 nm was 390 ft, the commander stated that he was reducing the rate of descent; the rate reduced from about 700 ft/min to about 500 ft/min. Several seconds later, the co-pilot advised they had 100 ft to go to their MDA and the commander acknowledged. The descent rate was being maintained at about 500 ft/min, but the airspeed had by then decreased to 54 kt and the pitch attitude was 8° nose-up with engine torque stabilised at about 24%.

The AVAD aural "CHECK HEIGHT" function activated at a height of 300 ft above the sea. The airspeed had reduced to 43 kt and the pitch attitude was now 12° nose-up. The co-pilot alerted the commander to the airspeed.

At a height of 240 ft, the helicopter's pitch attitude was 20° nose up, the airspeed 32 kt and the rate of descent about 1,000 ft/min and increasing. There was then an increase in collective pitch and engine torque and the cyclic stick was moved forward. A second AVAD "CHECK HEIGHT" callout occurred at this time. The helicopter was at 230 ft and the airspeed had reduced to below 30 kt (airspeeds of less than 30 kt are not recorded on the CVFDR).

In response to the increase in collective pitch, engine torque increased at a rate of about 14% per second. The helicopter's descent rate nevertheless continued to increase. As it descended through 100 ft, the AVAD 100 ft call was recorded. Engine torque was now at 115% and the descent rate was approximately 1,800 ft/min.

This initial analysis also showed that the combination of the nose-high attitude, low airspeed, high rate of descent and high power placed the helicopter in a vortex-ring state⁷ entry condition (VRS) during the final stages of

the flight. The manufacturer's modelling indicated that, in this condition, the reduced helicopter performance, together with the limited height available, meant that the impact with the sea was unavoidable.
