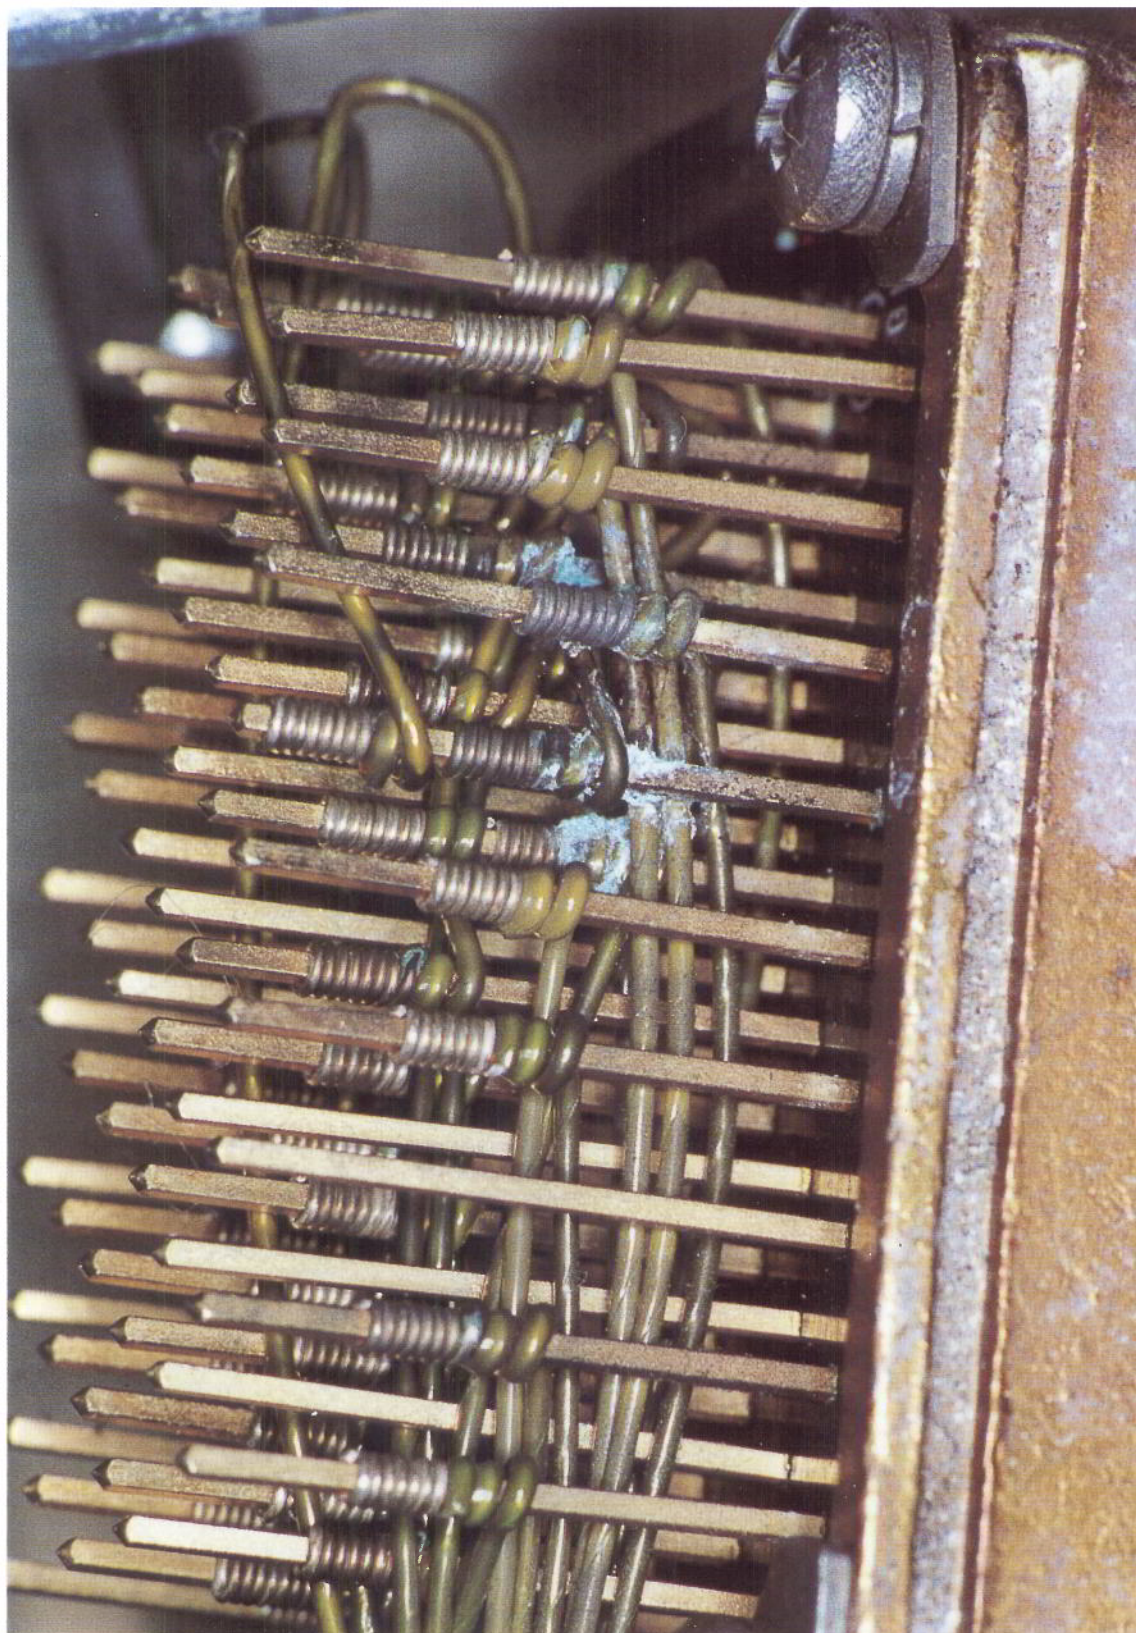
APPENDIX 4
FIGURE 1

Close-up view of terminal posts at the back of Yaw Damper Coupler connector showing accumulation of electrolytic/corrosion deposits around wire-wrapped joints

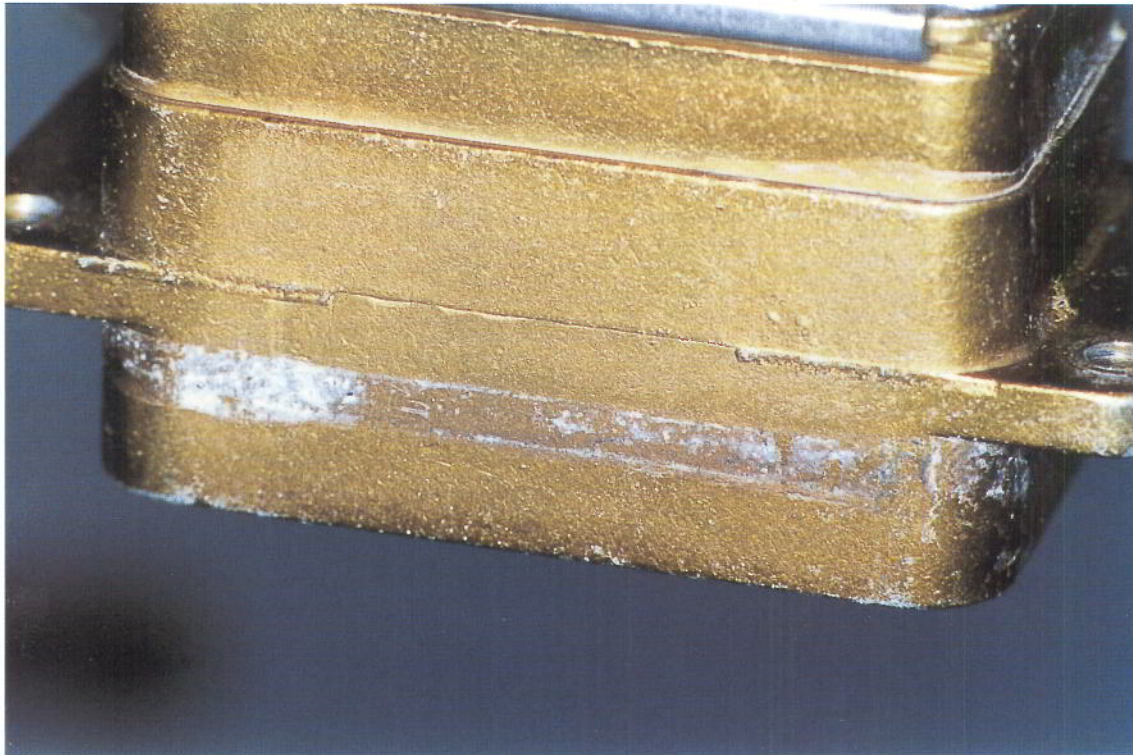
APPENDIX 4
FIGURE 2

View of YDC connector shell showing evidence of dry
corrosion products on exterior surface

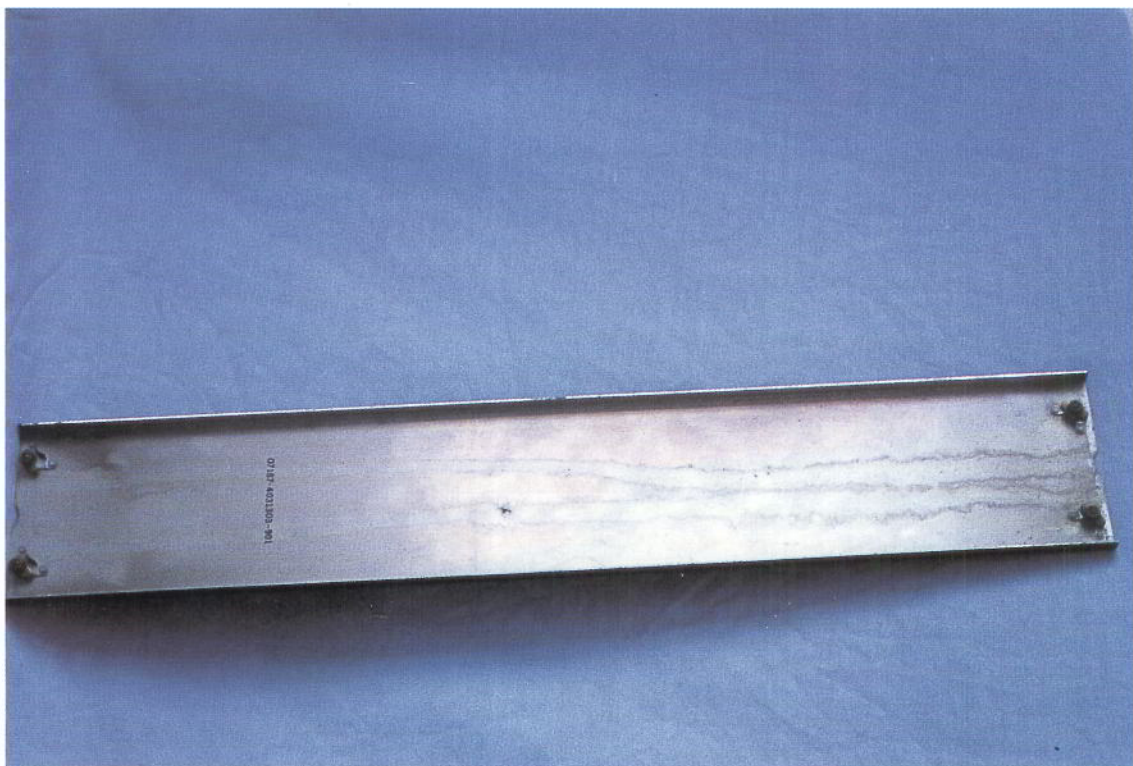
APPENDIX 4
FIGURE 3

View of YDC lower cover plate showing evidence
of dried fluid runs on the inner face

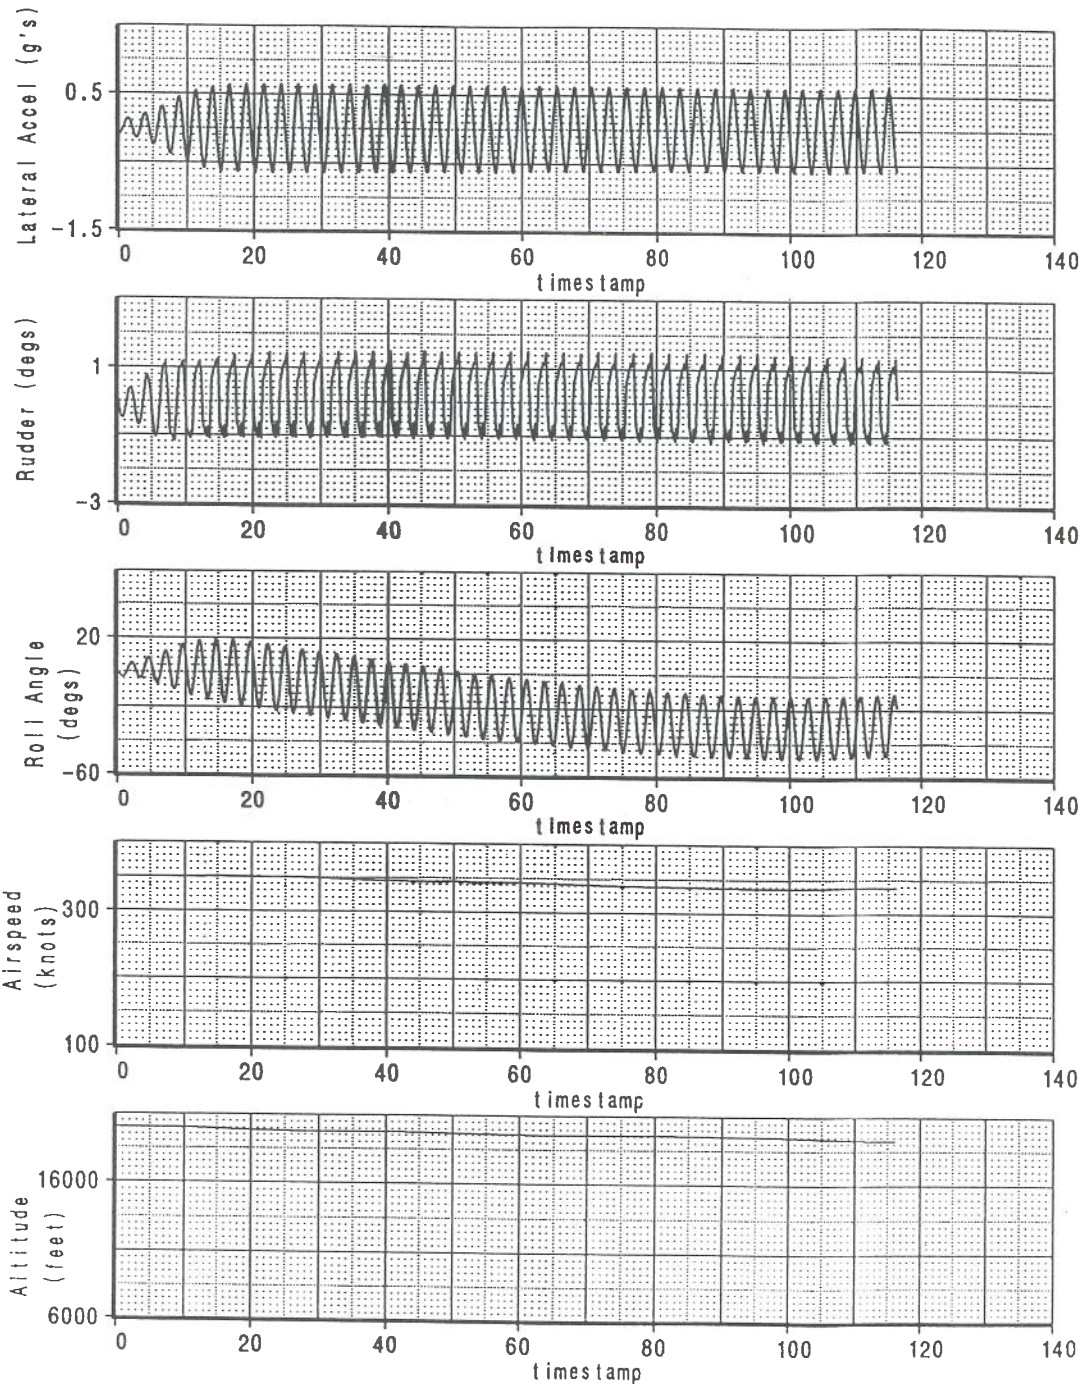
FIGURE 1

CALC	S.White	15Dec95	REVISED	DATE	PK775 - M Cab studies Test Case 17 from Tues 12/12/95 30kohm across Pins 37/38 BOEING	PAGE
CHECK						
APPD.						
APPD.

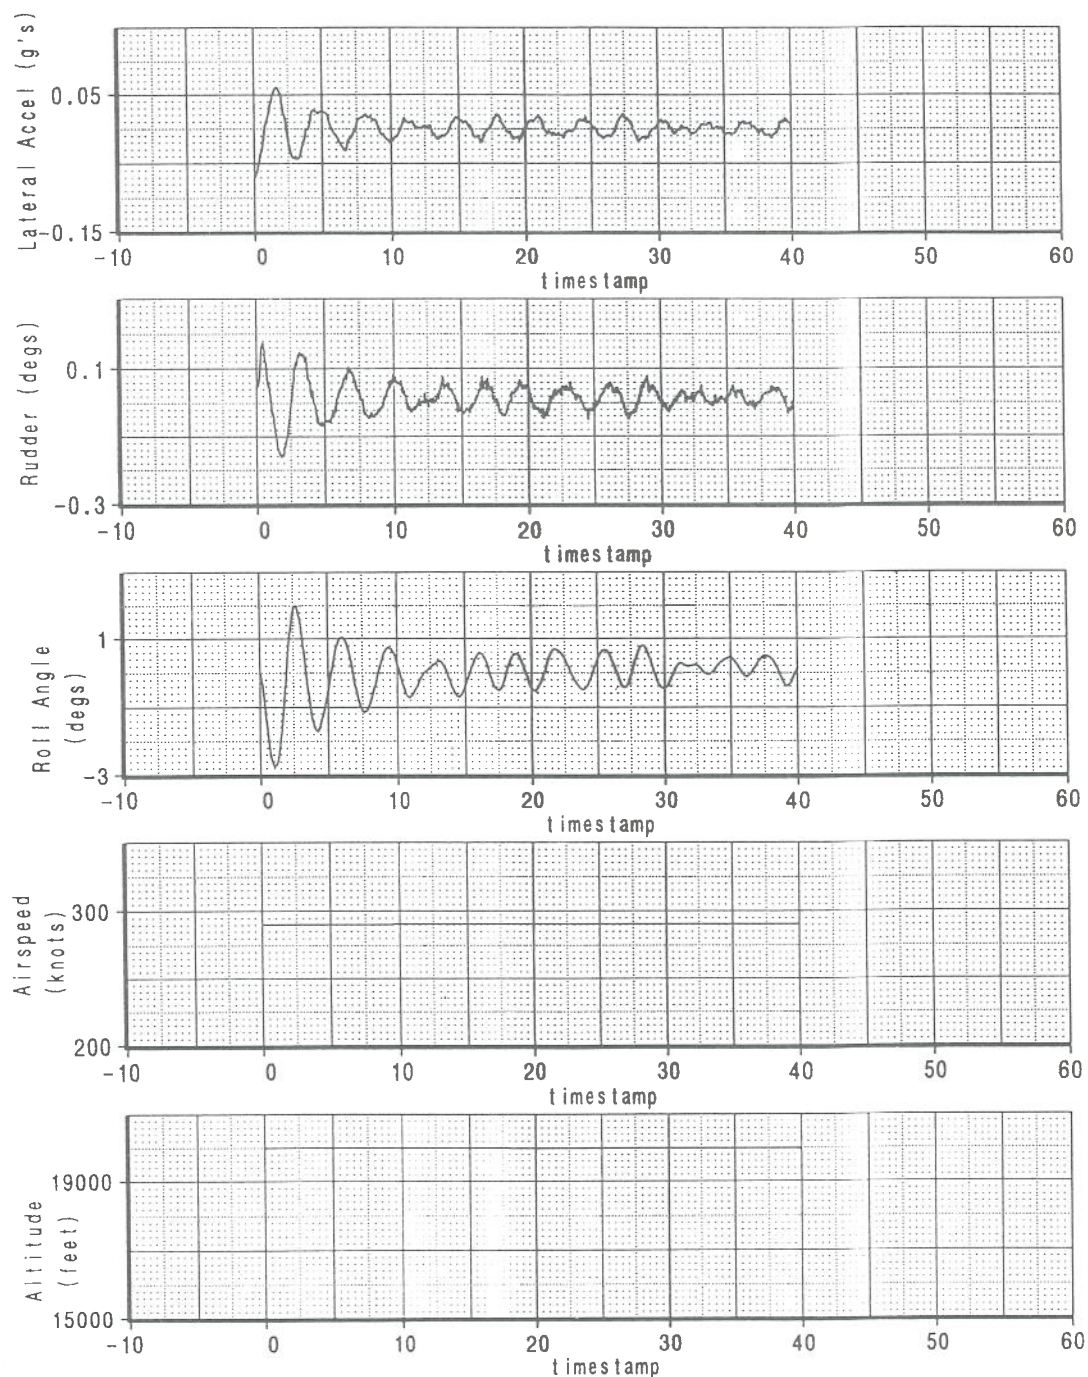
APPENDIX 8
FIGURE 2

CALC	S.White	19Jan96	REVISED	DATE	PK775 - M Cab studies Test Case 10 from Thur 01/11/96 230kph across 40/51, med turb BOEING	PAGE
CHECK						
APPD.						
APPD.

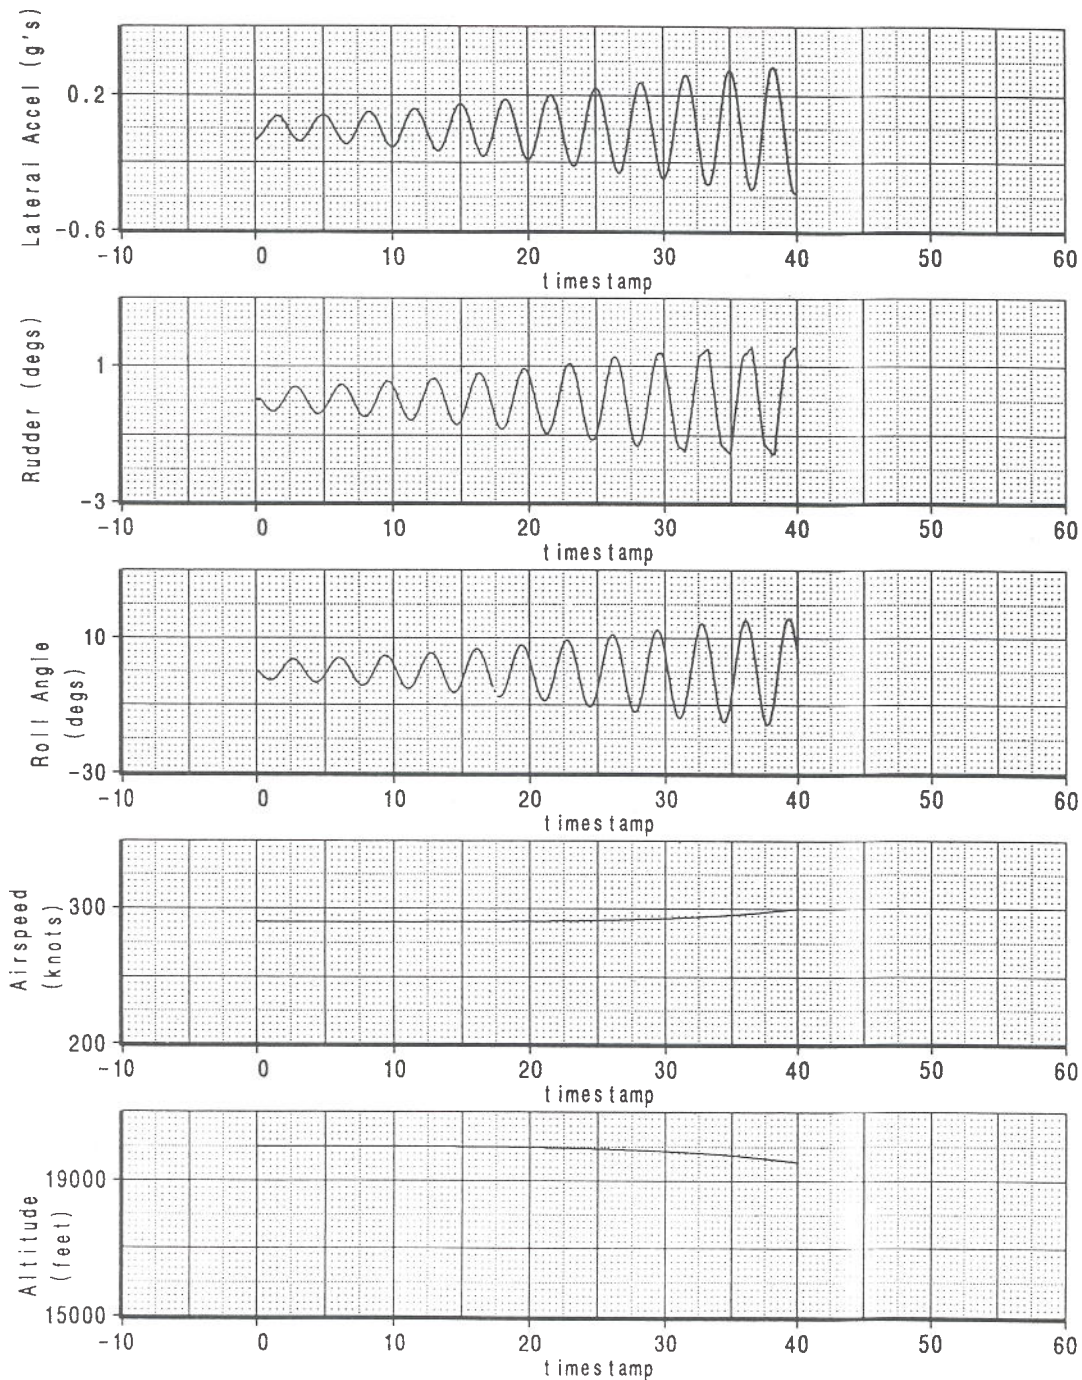
CALC	S.White	19Jan96	REVISED	DATE	PK775 - M Cab studies Test Case 27 from Thur 01/11/96 230kph across 40/51 & 37/38, light turb BOEING	PAGE
CHECK						
APPD.						
APPD.

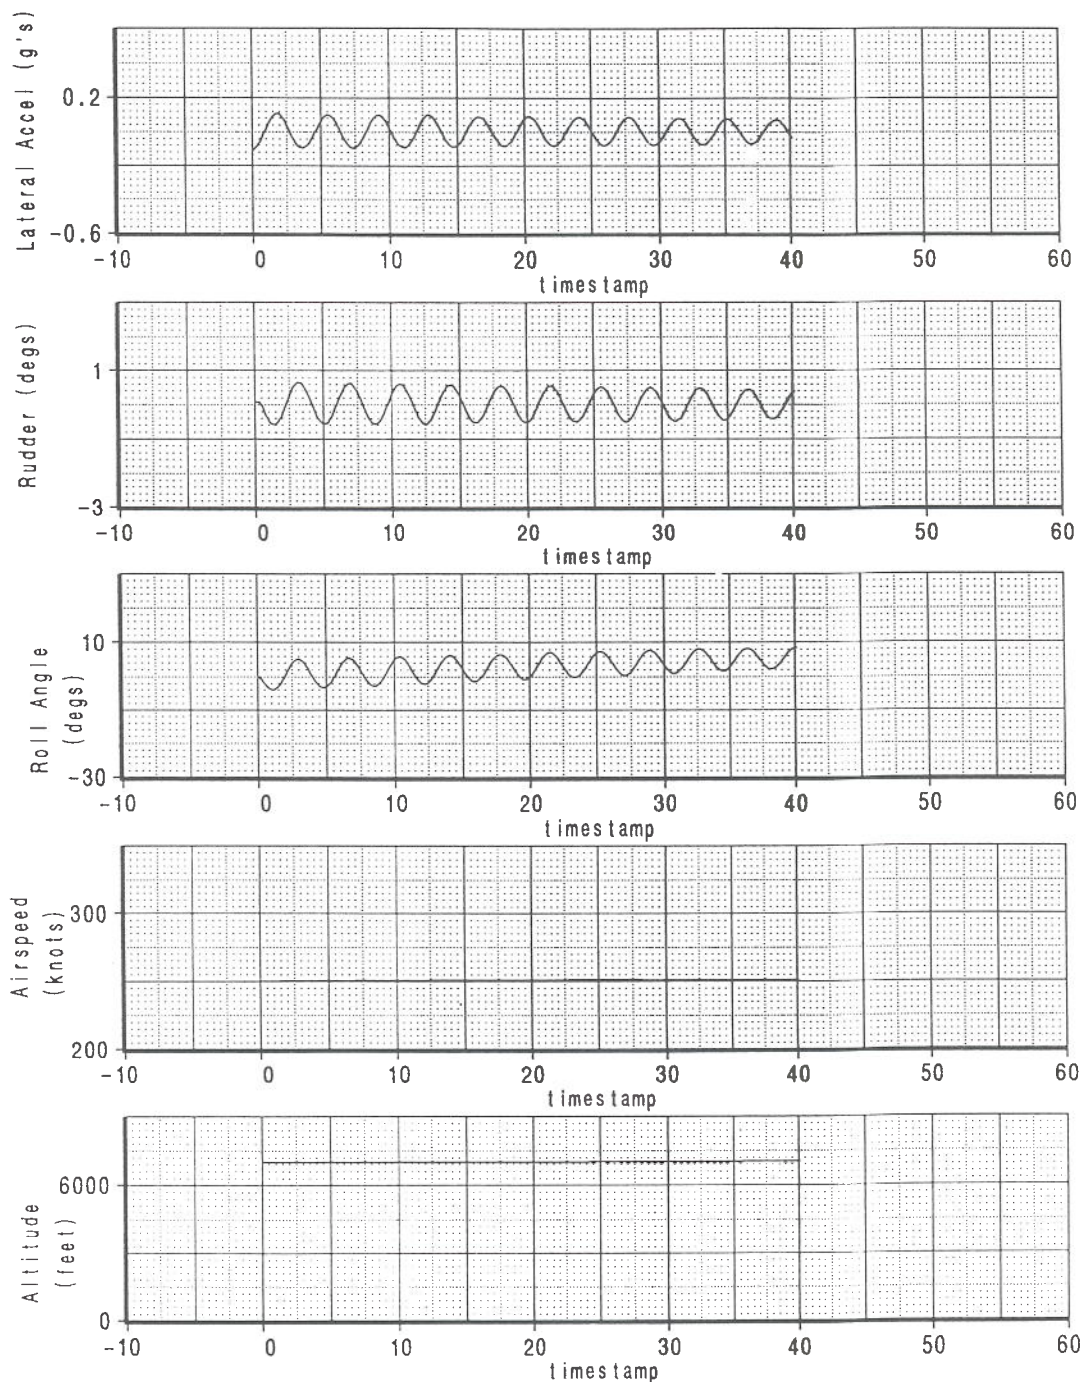
APPENDIX 8
FIGURE 6

CALC	S.White	19Jan96	REVISED	DATE	PK775 - M Cab studies	
CHECK					Test Case 33 from Thur 01/11/96	
APPD.					230kohm across 40/51 & 37/38, light turb	
APPD.					BOEING	PAGE

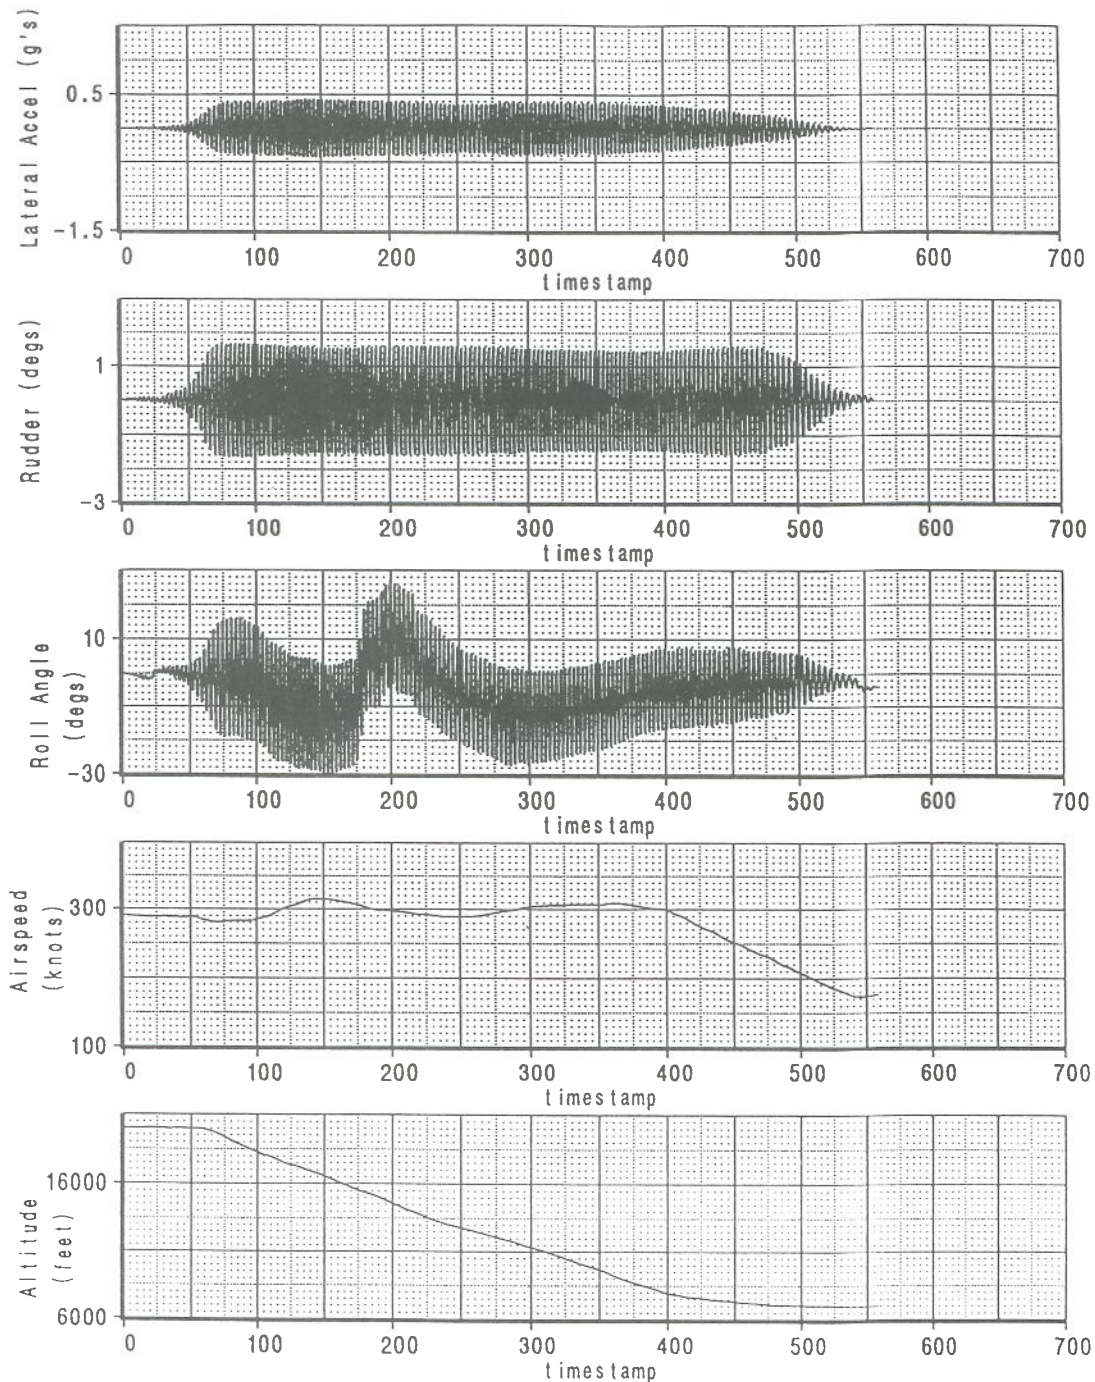
CALC	S.White	18Dec95	REVISED	DATE	PK775 - M Cab studies Test Case 70 from Wed 12/13/95 Pins 40/51 & 37/38, 200k & 200k, low turb BOEING	PAGE
CHECK						
APPD.						
APPD.
