AAIB Bulletin No: 11/93

Ref: EW/C93/9/1

Aircraft Type and Registration: Cessna 340A, G-XGBE

Date & Time (UTC): 7 September 1993 at 1318 hrs

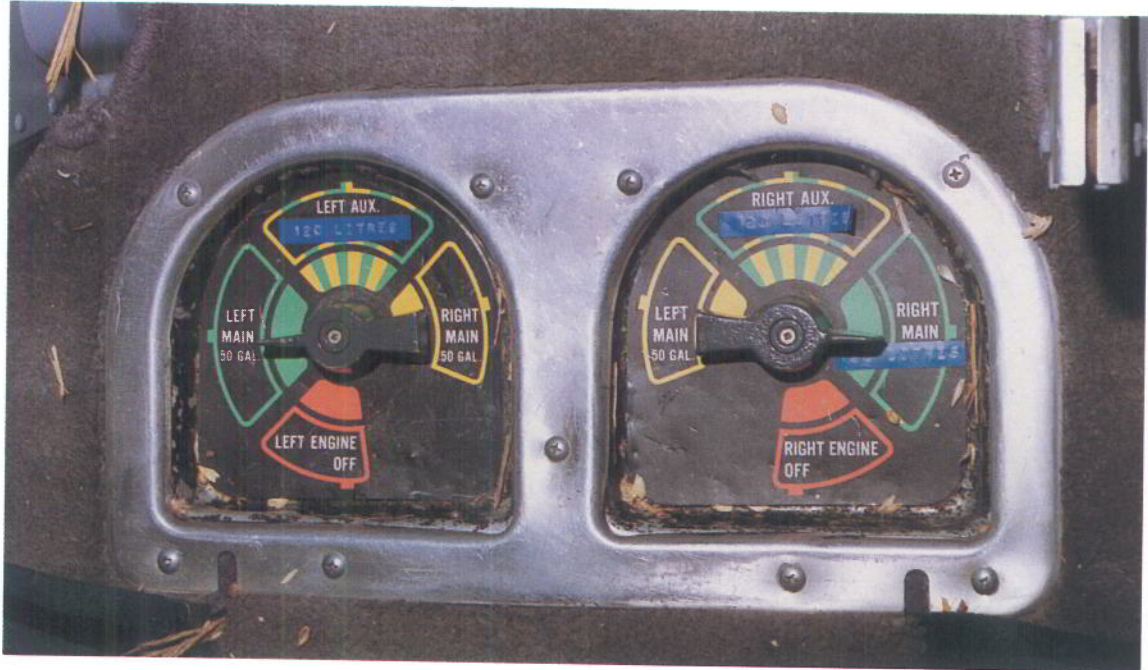
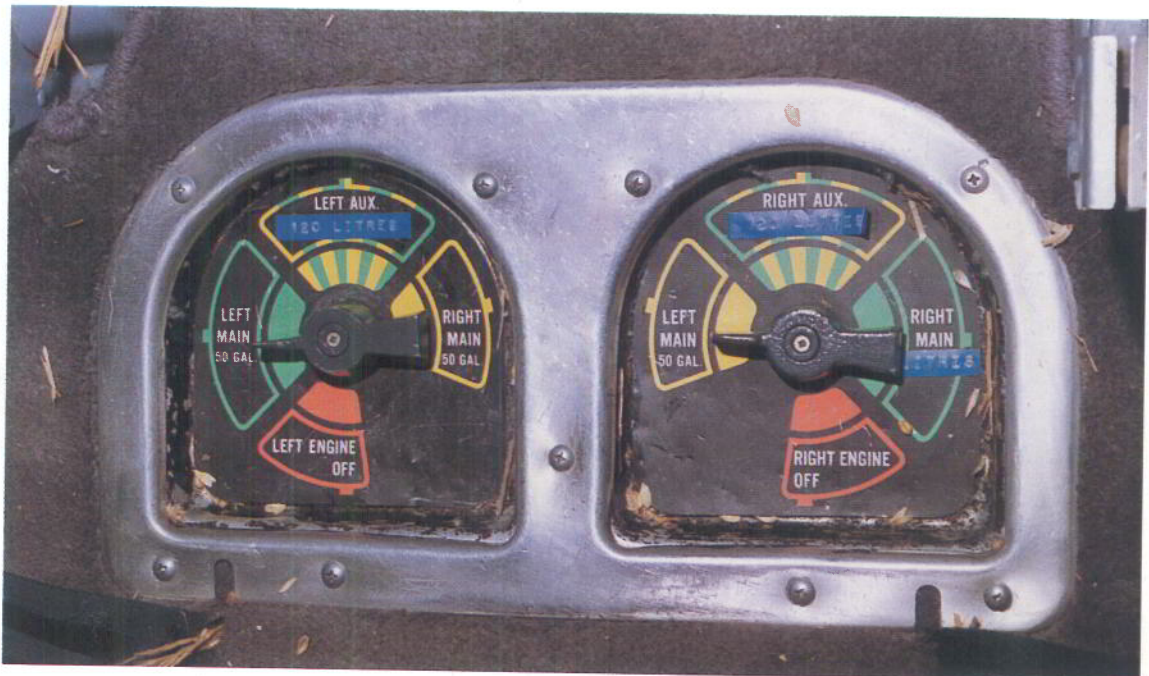
Fig 1

The flight was the first since a 50 hour maintenance check, during which the engines had been run by ground engineers. It was noted that with either main tank selected, the cockpit selector lever is positioned athwartships and, whilst in this position, it is not instinctively recognisable whether the thick or the thin end of the lever is pointing at the selected tank.

Fuel Selector Valve Levers set horizontally in Cockpit Floor between Pilot's Seats
