**INCIDENT**

<b>Aircraft Type and Registration:</b>	Boeing 747-443, G-VLIP	
<b>No &amp; type of Engines:</b>	4 CF6-80C2B1F turbofan engines	
<b>Year of Manufacture:</b>	2001	
<b>Date &amp; Time (UTC):</b>	5 July 2006 at 0905 hrs	
<b>Location:</b>	Taxiway Lima, London (Gatwick) Airport	
<b>Type of Flight:</b>	Public Transport (Passenger)	
<b>Persons on Board:</b>	Crew - 18	Passengers - 289
<b>Injuries:</b>	Crew - None	Passengers - None
<b>Nature of Damage:</b>	Trailing edge skin of right winglet damaged	
<b>Commander's Licence:</b>	Airline Transport Pilot's Licence	
<b>Commander's Age:</b>	34 years	
<b>Commander's Flying Experience:</b>	8,000 hours (of which 6,500 were on type) Last 90 days - 209 hours Last 28 days - 75 hours	
<b>Information Source:</b>	Aircraft Accident Report Form submitted by the operator

**Synopsis**

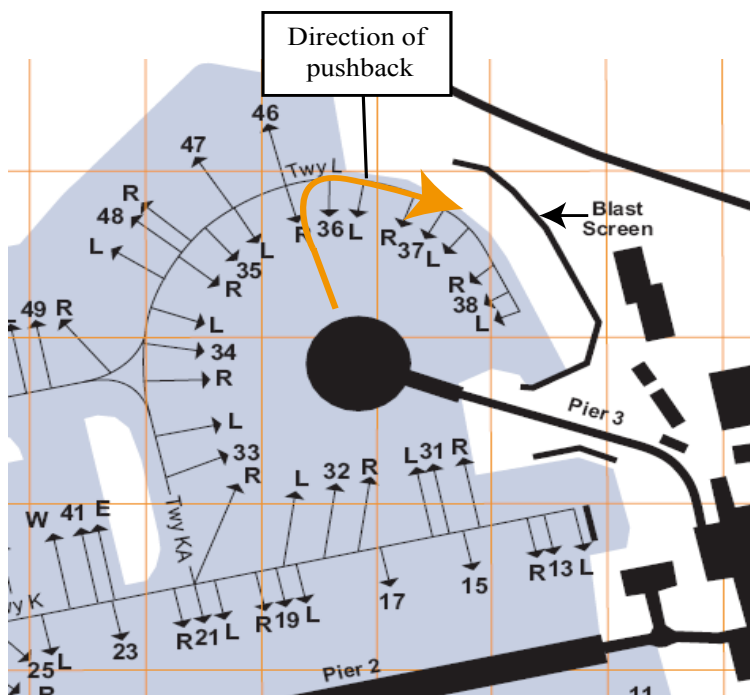
**Figure 1**

Stands 31 to 38 are arranged around the circular head of Pier 3, which is located at the north-west end of a spur attached to the South Terminal at Gatwick Airport (see Figure 1). To increase parking flexibility, each stand has Left (L) and Right (R) parking positions, which can be occupied simultaneously by narrow-body aircraft, and a Middle parking lane which is used by single wide-body aircraft. Aircraft manoeuvre to and from the stands via Taxiway Lima, which runs circumferentially around the Pier 3 apron area. The north-east segment of this taxiway is bounded by a blast fence which protects adjacent roadways and buildings.

Pier 3, Stands 31-38 and blast fence

The aircraft fuselage was positioned over the taxiway centreline when the wingtip collided with the blast fence.

The collision occurred when the aircraft was pushed back into an area of Taxiway Lima where insufficient clearance existed between the blast fence and the taxiway centreline to accommodate its wingspan. The pushback was conducted in accordance with standard procedures and the request to conduct a long push onto the taxiway area adjacent to Stands 37 and 38 was not specifically prohibited by existing local instructions. The tug driver had no means of determining when the extremities of a particular aircraft type had entered this area.

On 5 July 2006 the airport operator issued a Managing Director's Instruction to all operators of large aircraft and all handling agents prohibiting pushbacks into the area of Stands 37 and 38.

- a. Ground staff involved in pushback operations may enter the manoeuvring area adjacent to stands to the extent necessary to provide position guidance.
- b. During pushback operations the nosewheel of any wide-bodied aircraft should not be pushed rearwards beyond the Stand 36L lead in arrow.
