**SERIOUS INCIDENT**

<b>Aircraft Type and Registration:</b>	Dynamic WT9 UK, G-DYNM	
<b>No &amp; Type of Engines:</b>	1 Rotax 912-UL piston engine	
<b>Year of Manufacture:</b>	2007	
<b>Date &amp; Time (UTC):</b>	26 February 2011 at 1250 hrs	
<b>Location:</b>	Chiltern Park Aerodrome, Oxfordshire	
<b>Type of Flight:</b>	Training	
<b>Persons on Board:</b>	Crew - 2	Passengers - None
<b>Injuries:</b>	Crew - None	Passengers - N/A
<b>Nature of Damage:</b>	Nosewheel, nose leg and engine cowling	
<b>Commander's Licence:</b>	Airline Transport Pilot's Licence	
<b>Commander's Age:</b>	60 years	
<b>Commander's Flying Experience:</b>	9,000 hours (of which 20 were on type) Last 90 days - 4 hours Last 28 days - 4 hours	
<b>Information Source:</b>	Aircraft Accident Report Form submitted by the pilot

**Synopsis**

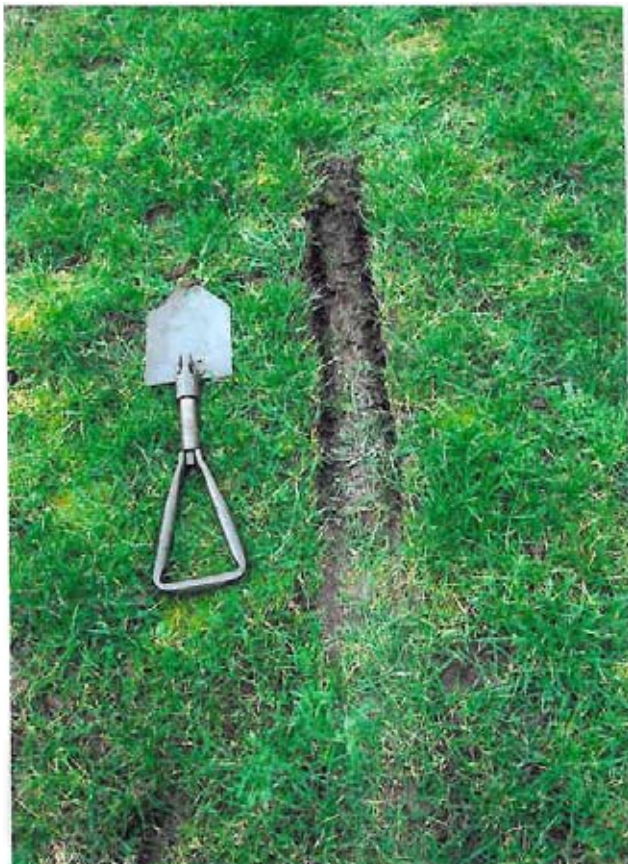
Ground marks left by the aircraft consisted of a short depression, 1 m long and the width of the nosewheel (Figure 1), followed 21 m later by two propeller strike marks and then a further depression that became a deep gouge (Figure 2), next to where the nosewheel was found detached. The pilot stated that the field had a reputation for good drainage and there had been no rain in the preceding days.

After consultation with other pilots and the aircraft owner, the pilot considered that the most likely cause of the initial depression was the nosewheel sinking into soft ground, with the aircraft then pitching up as the wheel contacted firmer ground again. He considers

**Figure 1**  
Initial depression

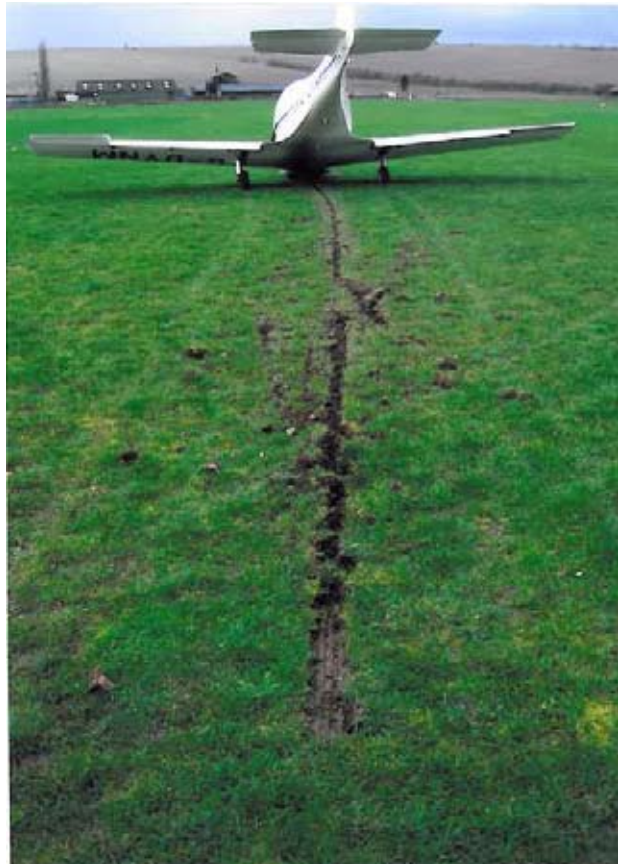
that this may have damaged the nose gear causing the nosewheel to detach, though he could not rule out pre-existing damage to the nose gear.

**Figure 2**  
Ground marks
