Aircraft Type and Registration:	Airbus A320-231, G-JOEM	
No & Type of Engines:	2 IAE V2500-A1 turbofan engines	
Year of Manufacture:	1993	
Date & Time (UTC):	17 March 2004 at 1540 hrs	
Location:	Birmingham Airport, West Midlands	
Type of Flight:	Public Transport (Passenger)	
Persons on Board:	Crew - 6	Passengers - 168
Injuries:	Crew - None	Passengers - None
Nature of Damage:	Damage to forward left cabin door	
Commander's Licence:	Airline Transport Pilot's Licence	
Commander's Age:	36 years	
Commander's Flying Experience:	7,000 hours (of which 4,400 were on type) Last 90 days - 155 hours Last 28 days - 50 hours	
Information Source:	Aircraft Accident Report Form submitted by the pilot and further enquiries by the AAIB

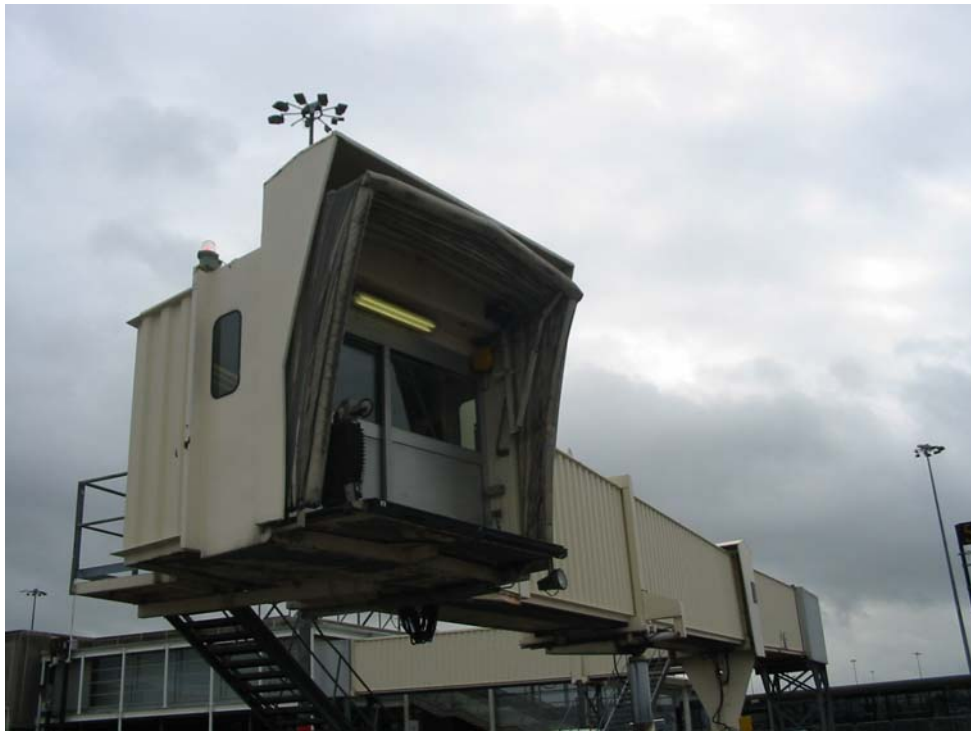
Figure 1

Passengers were boarding the aircraft through the forward left cabin door, via an airbridge (see Figure 1). When approximately two-thirds of the passengers had embarked, the cabin crew noticed that the bottom of the door, which opens outwards and forwards, was in contact with the floor of the airbridge. The crew contacted their handling agent and one of their staff attended the aircraft.

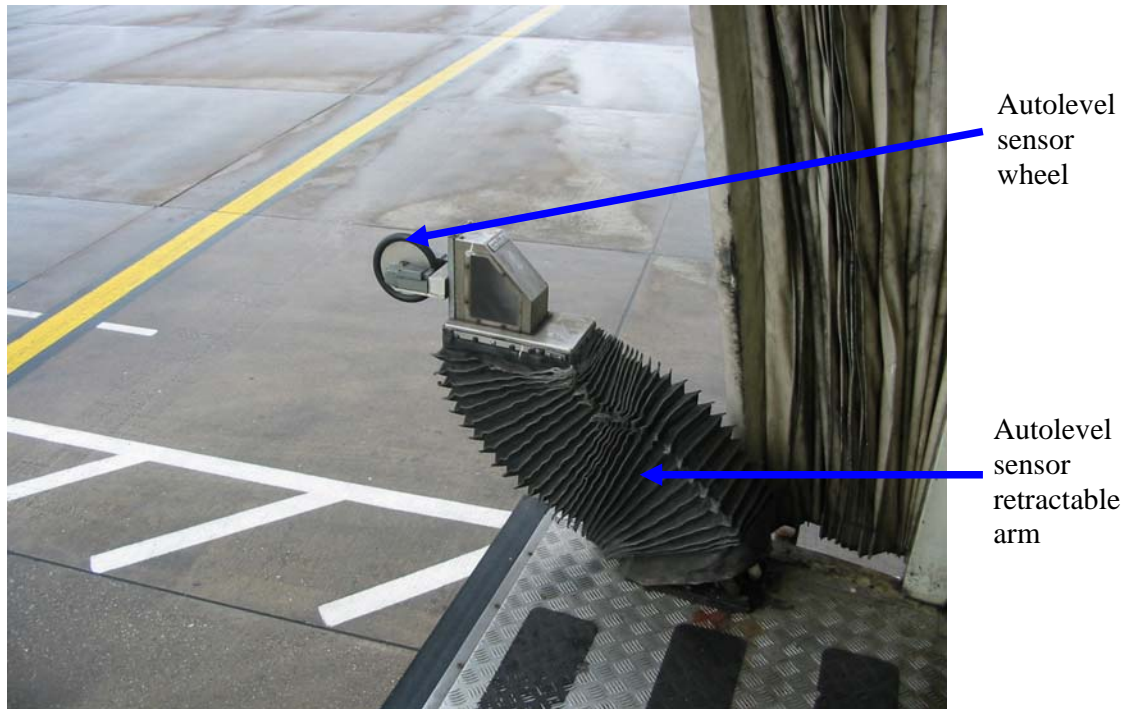
Figure 3

Examination of the autolevel sensor on the airbridge (see Figure 3) showed that the wheel had rotated to its full extent and jammed, indicating that the aircraft had descended relative to the floor of the airbridge. Once the wheel had been freed, the autolevel system was tested and found to operate correctly.

The autolevel system sensor wheel had rotated to its fully 'down' position and jammed, suggesting a protracted movement of the aircraft in that direction. The autolevel alarm had activated and this indicated that there was a malfunction in the autolevel system or that there had been continuous 'levelling' of the airbridge for a maximum of six seconds. Following this alarm, the correct procedure would have been for an operator to operate the airbridge manually. Why the airbridge moved up slightly after the autolevel reset button had been pressed, as reported, is not clear. Nor was it apparent which of the two causes had triggered the alarm.

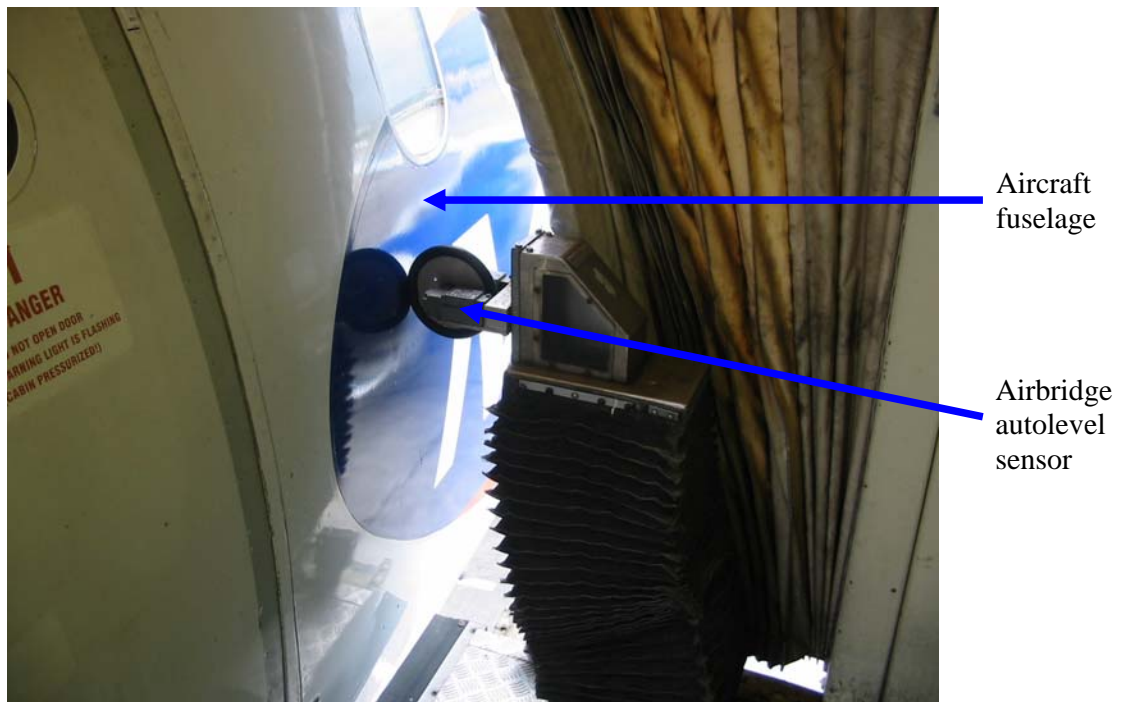
Figure 4

the end of a retractable arm located on the airbridge head floor. The wheel rests against the aircraft fuselage and rotates as the aircraft rises or falls with respect to the airbridge (see Figure 4). The autolevel circuit also contains an adjustable timer, which permits the vertical travel motor to operate continuously for a maximum of six seconds. At the end of this time all power to the system is removed, an audible alarm sounds and a warning light is energised at the control panel.
