ACCIDENT

Aircraft Type and Registration:	Beech 90, N46BM	
No & Type of Engines:	2 Pratt & Whitney PT6A-28 turboprop engines	
Year of Manufacture:	1978	
Date & Time (UTC):	18 May 2011 at 1131 hrs	
Location:	Kinson Manor Farm, Bournemouth	
Type of Flight:	Private	
Persons on Board:	Crew - 1	Passengers - 1
Injuries:	Crew - None	Passengers - None
Nature of Damage:	Substantial damage to airframe and powerplants; landing gear collapsed	
Commander's Licence:	FAA Commercial Pilot's Licence	
Commander's Age:	47 years	
Commander's Flying Experience:	800 hours (of which 660 hours were on type) Last 90 days - 13 hours Last 28 days - 6 hours	
Information Source:	AAIB Field Investigation

Synopsis

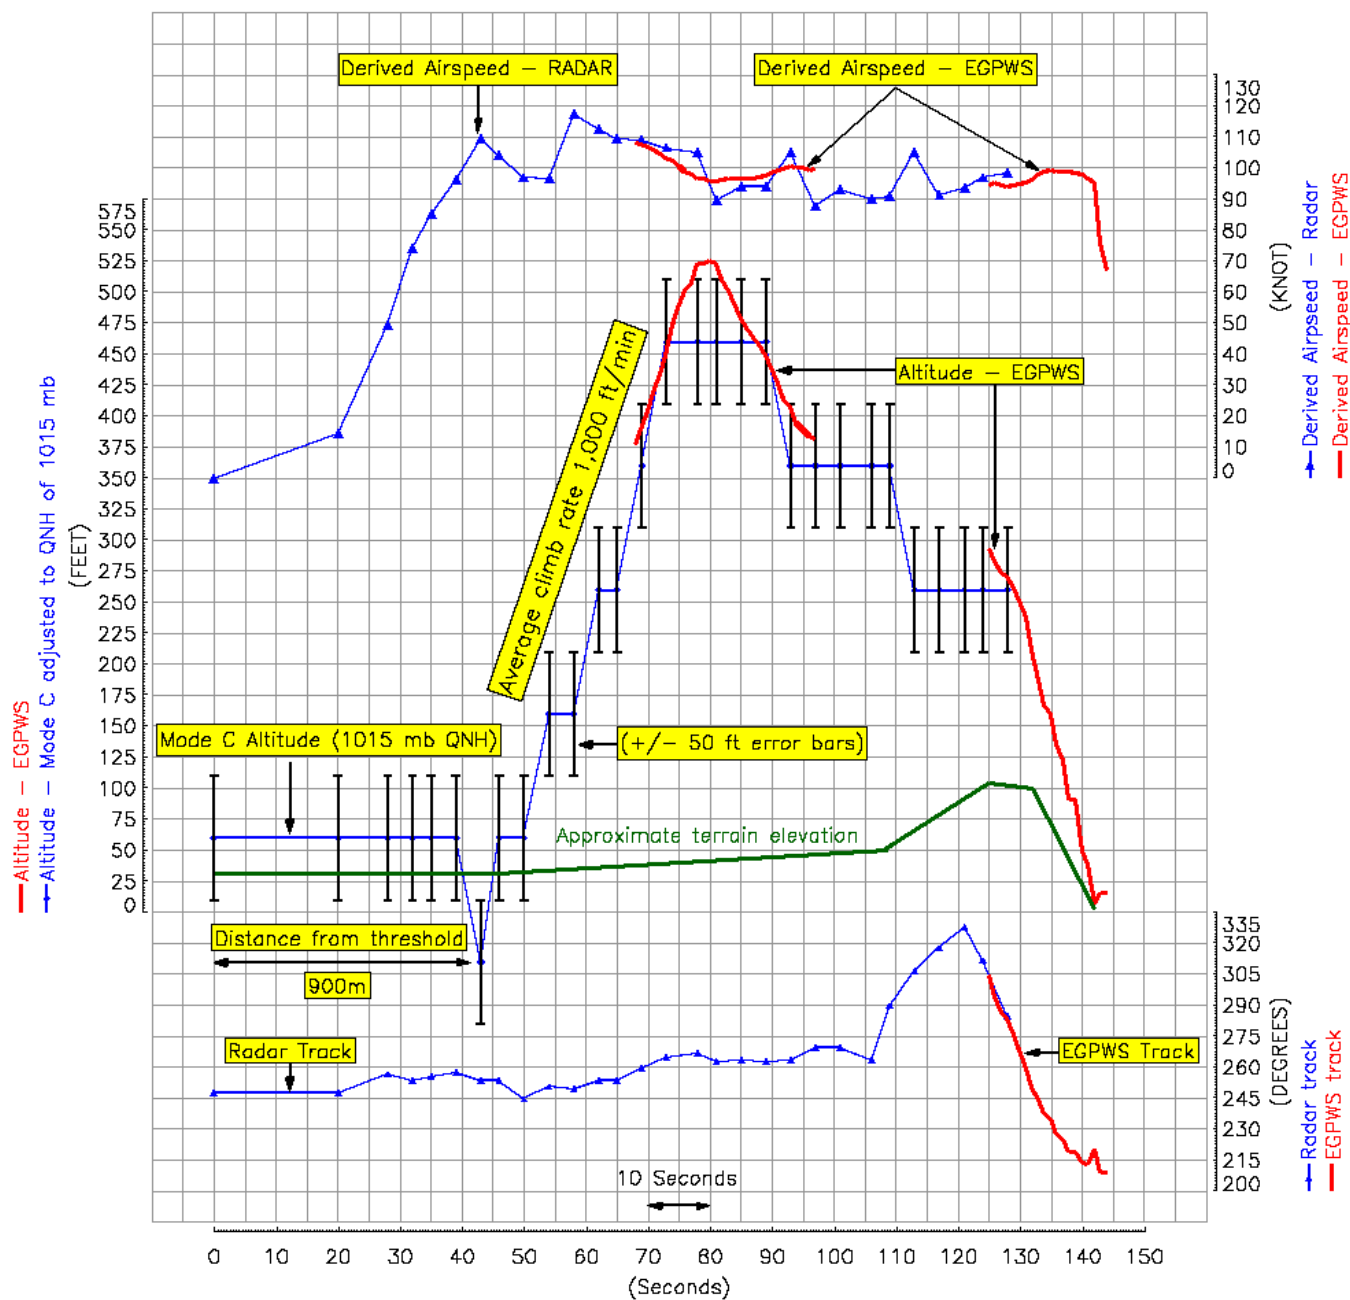
Figure 1

Recorded data for takeoff from Bournemouth Airport Runway 26 and descent into the field

The Mode C altitude readout, which is based on a sea level pressure setting of 1013 hPa, was adjusted to a QNH value of 1015 hPa and an approximate airspeed was derived from the radar and EGPWS groundspeeds, based on a wind of 230° at 10 kt. At approximately 1128:08 hrs, the aircraft was positioned on the threshold of Runway 26. After 20 seconds, the first radar point was recorded as the aircraft commenced its takeoff run. Due to the ± 50 ft quantisation of Mode C altitude, it was not practicable to determine the exact point on the runway that the aircraft left the ground. However, when the aircraft was approximately 900 m (2,953 ft)

from the threshold, and at an airspeed of about 109 kt, there was a momentary decrease in the Mode C altitude from 60 ft to 10 ft, which is indicative of rotation for takeoff. Four seconds later, approximately 1,090 m (3,575 ft) from the threshold, the adjusted Mode C altitude returned to 60 ft (± 50 ft) (the runway elevation is approximately 30 ft at this point). After takeoff the aircraft drifted left of the runway⁶, tracking approximately 255° (M), and was displaced to the south of the centreline by approximately 120 m when it passed the upwind threshold.

During the 30 seconds after lift-off, the average climb rate (based on the Mode C altitude) was approximately 1,000 ft/min. As the aircraft climbed, its airspeed reduced progressively and, at an altitude of 525 ft, its airspeed was about 97 kt. The aircraft levelled off briefly before descending and an EGPWS Mode 1⁷ SINK RATE warning was generated with the aircraft at an altitude of 460 ft and with a descent rate of about 540 ft/min. As the aircraft descended, its airspeed stabilised at about 100 kt. At 1.2 nm from the end of Runway 26, and at an altitude of about 350 ft, the aircraft made a right turn onto a track of 330°. This was shortly followed by a left descending turn from an altitude of 290 ft (170 ft agl) onto a track of about 215°. As the aircraft banked to the left, the airspeed was maintained between 96 kt and 100 kt, but the rate of descent increased progressively to about 1,000 ft/min. Shortly before impacting the line of trees, the descent rate was reduced; the airspeed was approximately 98 kt at the time. The estimated groundspeed at touchdown was 88 kt and the aircraft was airborne for approximately 95 seconds.

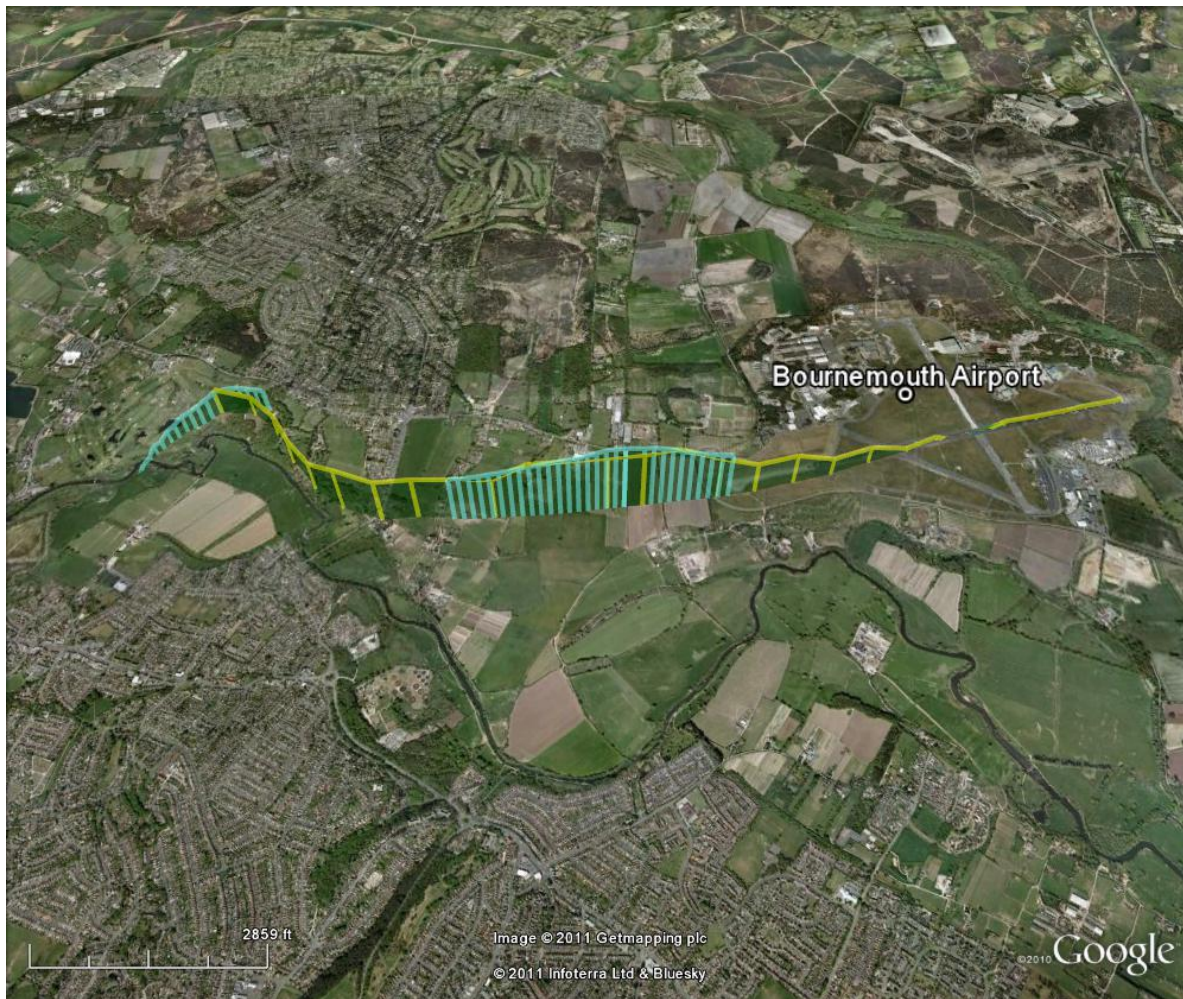
Figure 2

Aircraft track (Radar in yellow and EGPWS in blue)
