BAe 146-RJ100, G-BZAT

AAIB Bulletin No: 7/2003	Ref: EW/C2003/02/01	Category: 1.1
Aircraft Type and Registration:	BAe 146-RJ100, G-BZAT	
No & Type of Engines:	4 Lycoming LF507-1F turbojet engines	
Year of Manufacture:	1997	
Date & Time (UTC):	10 February 2003 at 0840 hrs	
Location:	Birmingham Airport	
Type of Flight:	Public Transport (Passenger)	
Persons on Board:	Crew - 5	Passengers - 94
Injuries:	Crew - None	Passengers - None
Nature of Damage:	Left nose wheel detached	
Commander's Licence:	Airline Transport Pilot's Licence	
Commander's Age:	30 years	
Commander's Flying Experience:	3,500 hours (of which 2,600 were on type)	
	Last 90 days - 135 hours	
	Last 28 days - 45 hours	
Information Source:	AAIB Field Investigation

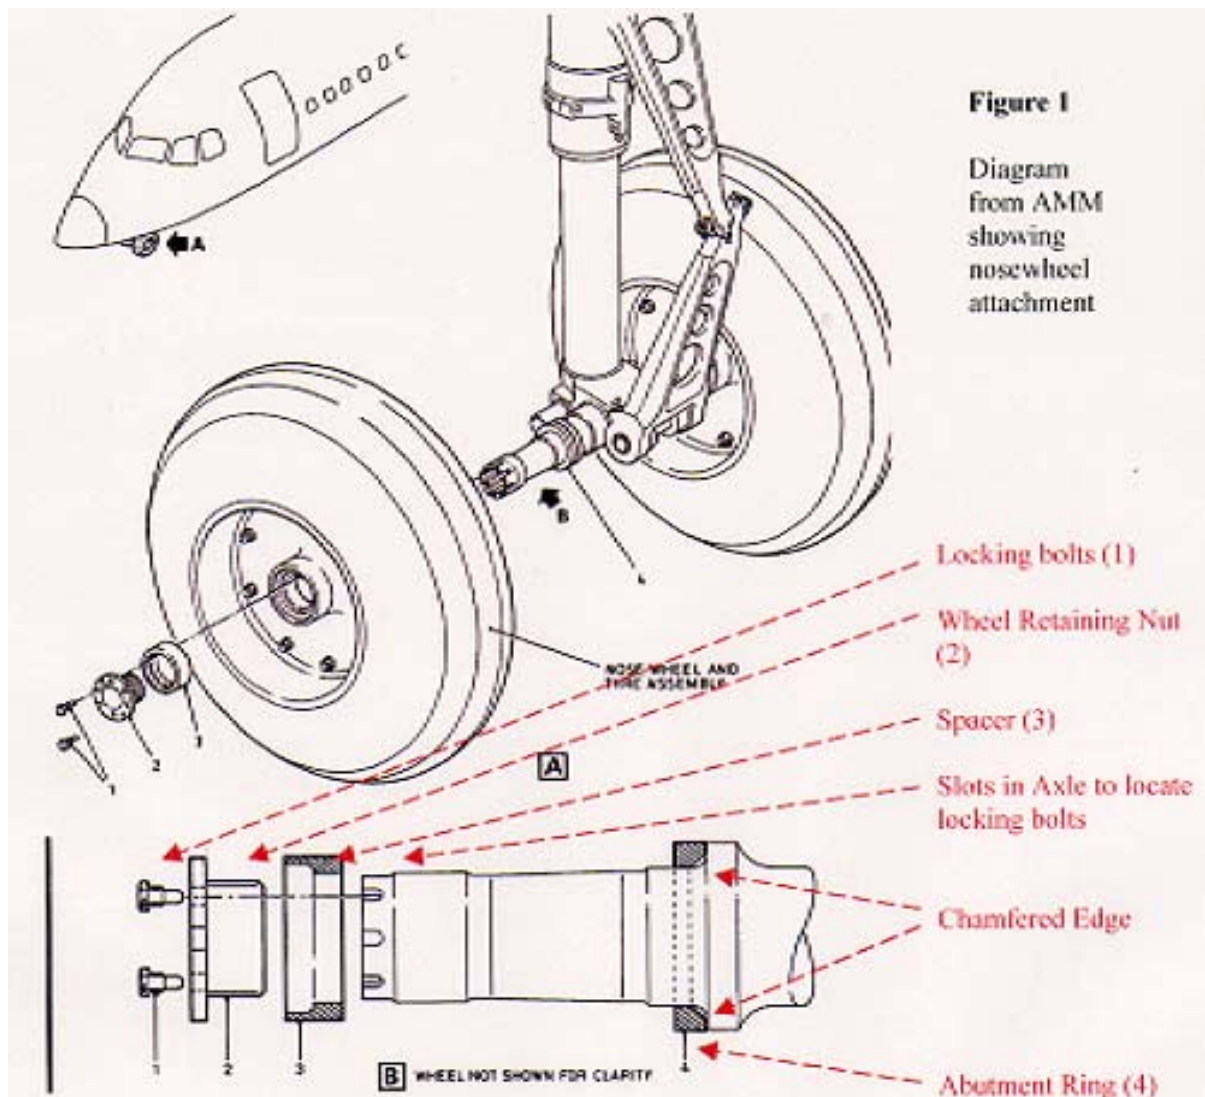
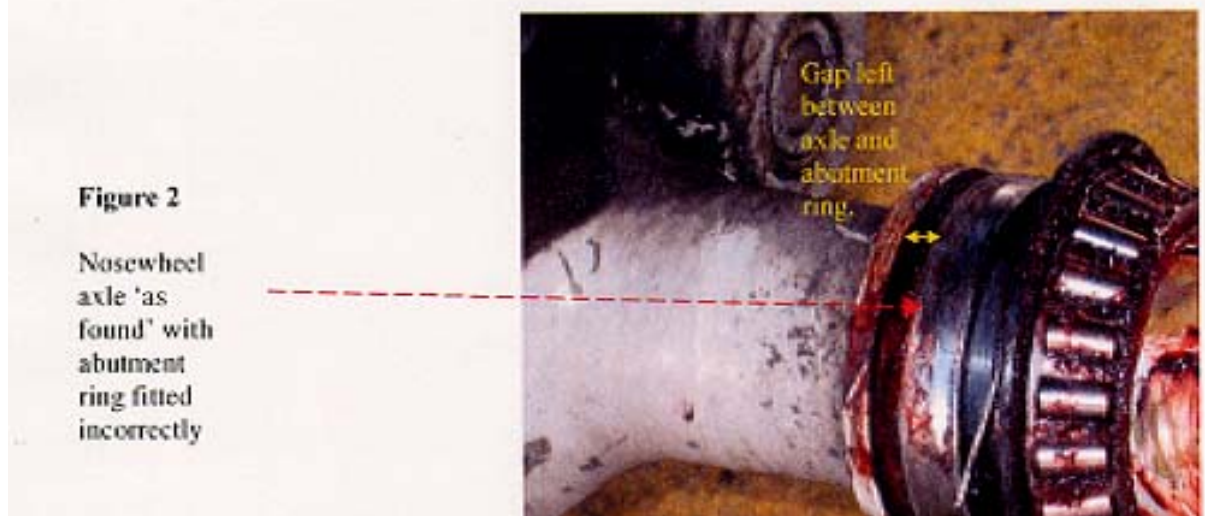
The Nose Landing Gear (NLG) has two independent wheels, positioned either side of the noseleg, Figure 1, and these are each located on the axle by means of an inboard spacer, referred to as an 'abutment ring' and an outboard spacer. The abutment ring inner diameter is chamfered on one side and this allows it to abut directly against a flange at the inboard end of the axle and not foul a blend radius between the axle and the inboard flange of the axle. The nosewheel is secured by a wheel retaining nut, which is torque tightened to 25 ft lbf and, in order to secure this nut, two special locking bolts are screwed in to a flange on its outboard side. The ends of these bolts locate into slots in the axle, and any movement of the wheel retaining nut is prevented by the location of the bolts within the slots. The two locking bolts are then wire-locked together.

The NLG was found with only the right wheel attached. On the left axle, the inboard wheel bearing and the abutment ring were present. The abutment ring, however, was found to have been fitted with the chamfered edge facing outboard. With no chamfer on the inboard face to accommodate the blend radius on the axle, a gap was present between the abutment ring and the inboard flange of the axle. With such a gap present, it is possible to fit and torque-load the wheel retaining nut, but the nut locking bolts are then not long enough to engage with the slots in the axle. Thus, since the subject wheel was fitted, the wheel retaining nut would not have been locked. The normal rotation of the left wheel is such that, over a period of time, frictional forces through the wheel bearing would tend to unscrew the wheel retaining nut completely, and allow the wheel to migrate off the axle. The missing left nose wheel was subsequently located on the grass approximately 150 m to the right side of Runway 15 at Birmingham Airport but the wheel retaining nut, locking bolts and outboard spacer were not found, despite searches at both Glasgow and Birmingham Airports.

The wheel detached due to the incorrect assembly of the abutment ring on the axle. The design of abutment ring allows it to be fitted the wrong way round and, in this circumstance, the locking bolts do not perform their locking function of the wheel retaining nut. The locking bolts can still be fitted and wire locked without it being apparent that they are not located into the slots in the axle and are, therefore, free to move with the wheel retaining nut. The incorrect assembly of the right nosewheel may not result in its detachment since the direction of rotation of the right wheel will tend to tighten the wheel retaining nut. In the two previous incidents the left nosewheels both detached two days following the nosewheel changes.

It is recommended that the Civil Aviation Authority, in conjunction with the NLG and airframe manufacturers, review the design of the NLG nose wheel installation on the BAe 146/RJ aircraft with a view to precluding the possibility of incorrect assembly of the wheel abutment ring.

It is recommended that BAE Systems review the AMM procedures for the removal and installation of the nose wheel of the BAe 146/Avro RJ series aircraft to include a specific caution with respect to the fitment of the nose wheel abutment ring located at the inboard end of the NLG axle.

BAE Systems should ensure that the introduction of an awareness programme to highlight the possibility of incorrect assembly of the nose wheel abutment ring to the NLG axle is instigated, and include this awareness as an item in the aircraft type and recurrent training courses.
