Aircraft type and registration: Cessna 310 G-BGRJ

Date and time (UTC): 7 April 1987 at 0852 hrs

Location: Near Tatsfield, Kent

Information Source: AIB Field Investigation

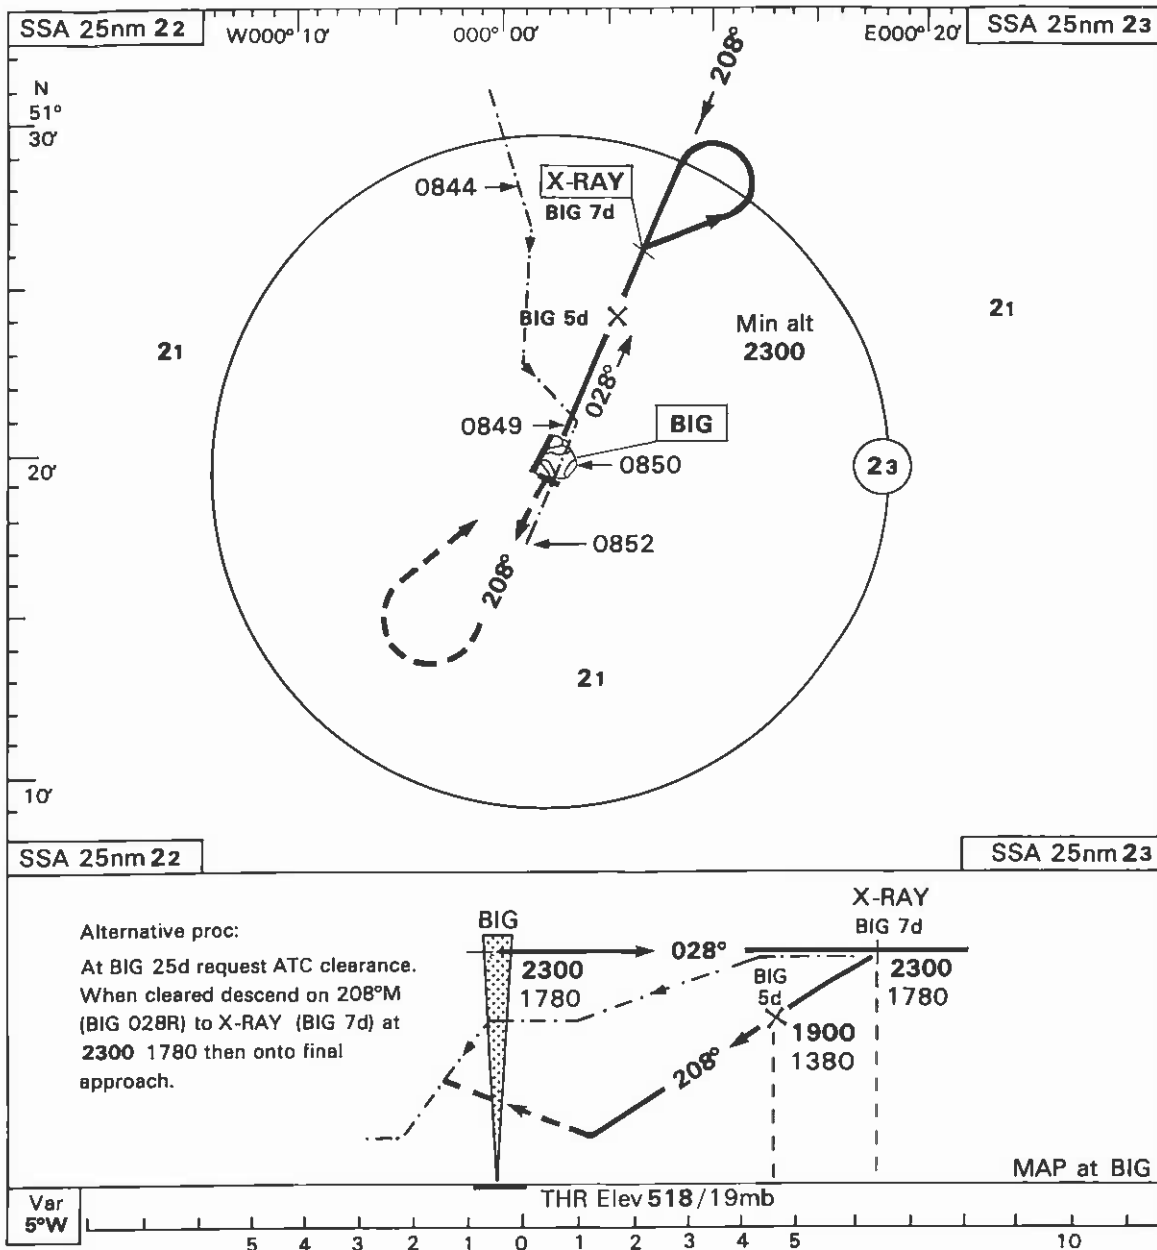
Shortly before passing over the "BIG" VHF omni range (VOR) beacon, the descent was commenced. From the overhead the aircraft was flown away from the beacon on, approximately, the 208° radial, continuing to descend until, 2 nm from the VOR, it was flown level at about 860 feet above mean sea level (amsl). This is the minimum descent altitude published for the VOR Distance Measuring Equipment (DME) approach to runway 21. At about 0852 hrs the aircraft struck the top part of a tree which is about 840 feet amsl. It subsequently struck the ground about half a mile from the tree between a radio mast and the service road to the British Gas above ground installation at Tatsfield.

Figure 1 Flight path relative to VOR/DME approach.

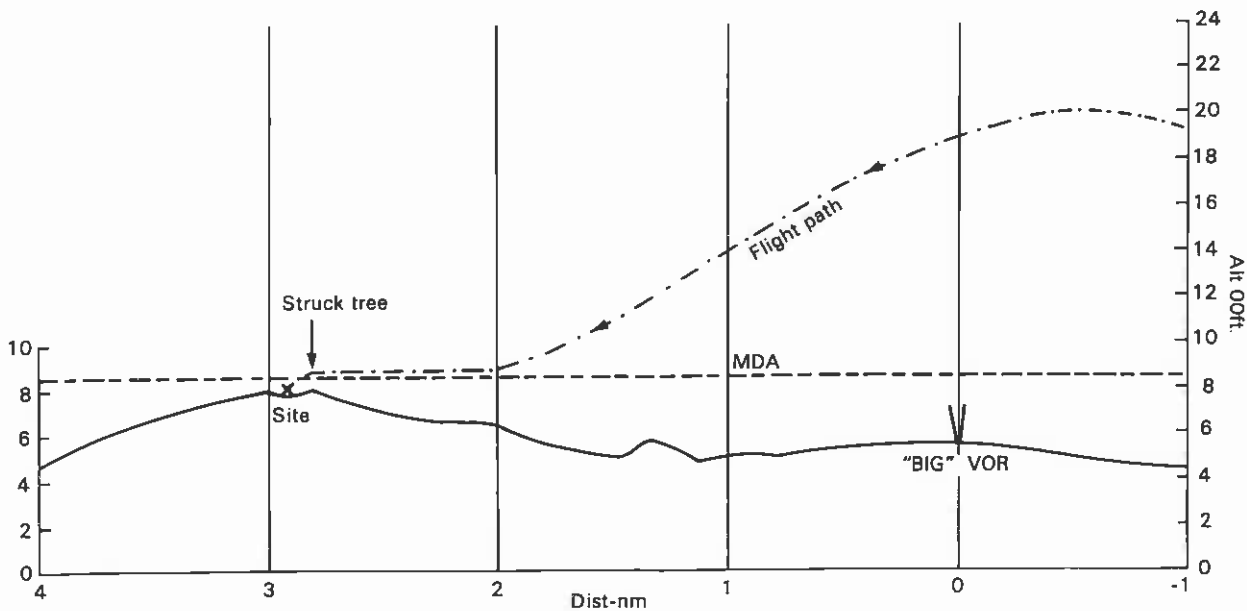
Figure 2 Flight path relative to ground
