**No: 4/90**                      **Ref: EW/C/1146**                      **Category: 1a**

**Aircraft Type and Registration:** Grumman G-159 Gulfstream 1, G-BMOW

**Location:** Birmingham International Airport

**Nature of Damage:** Nose landing gear wheels disintegrated, minor damage to left propeller

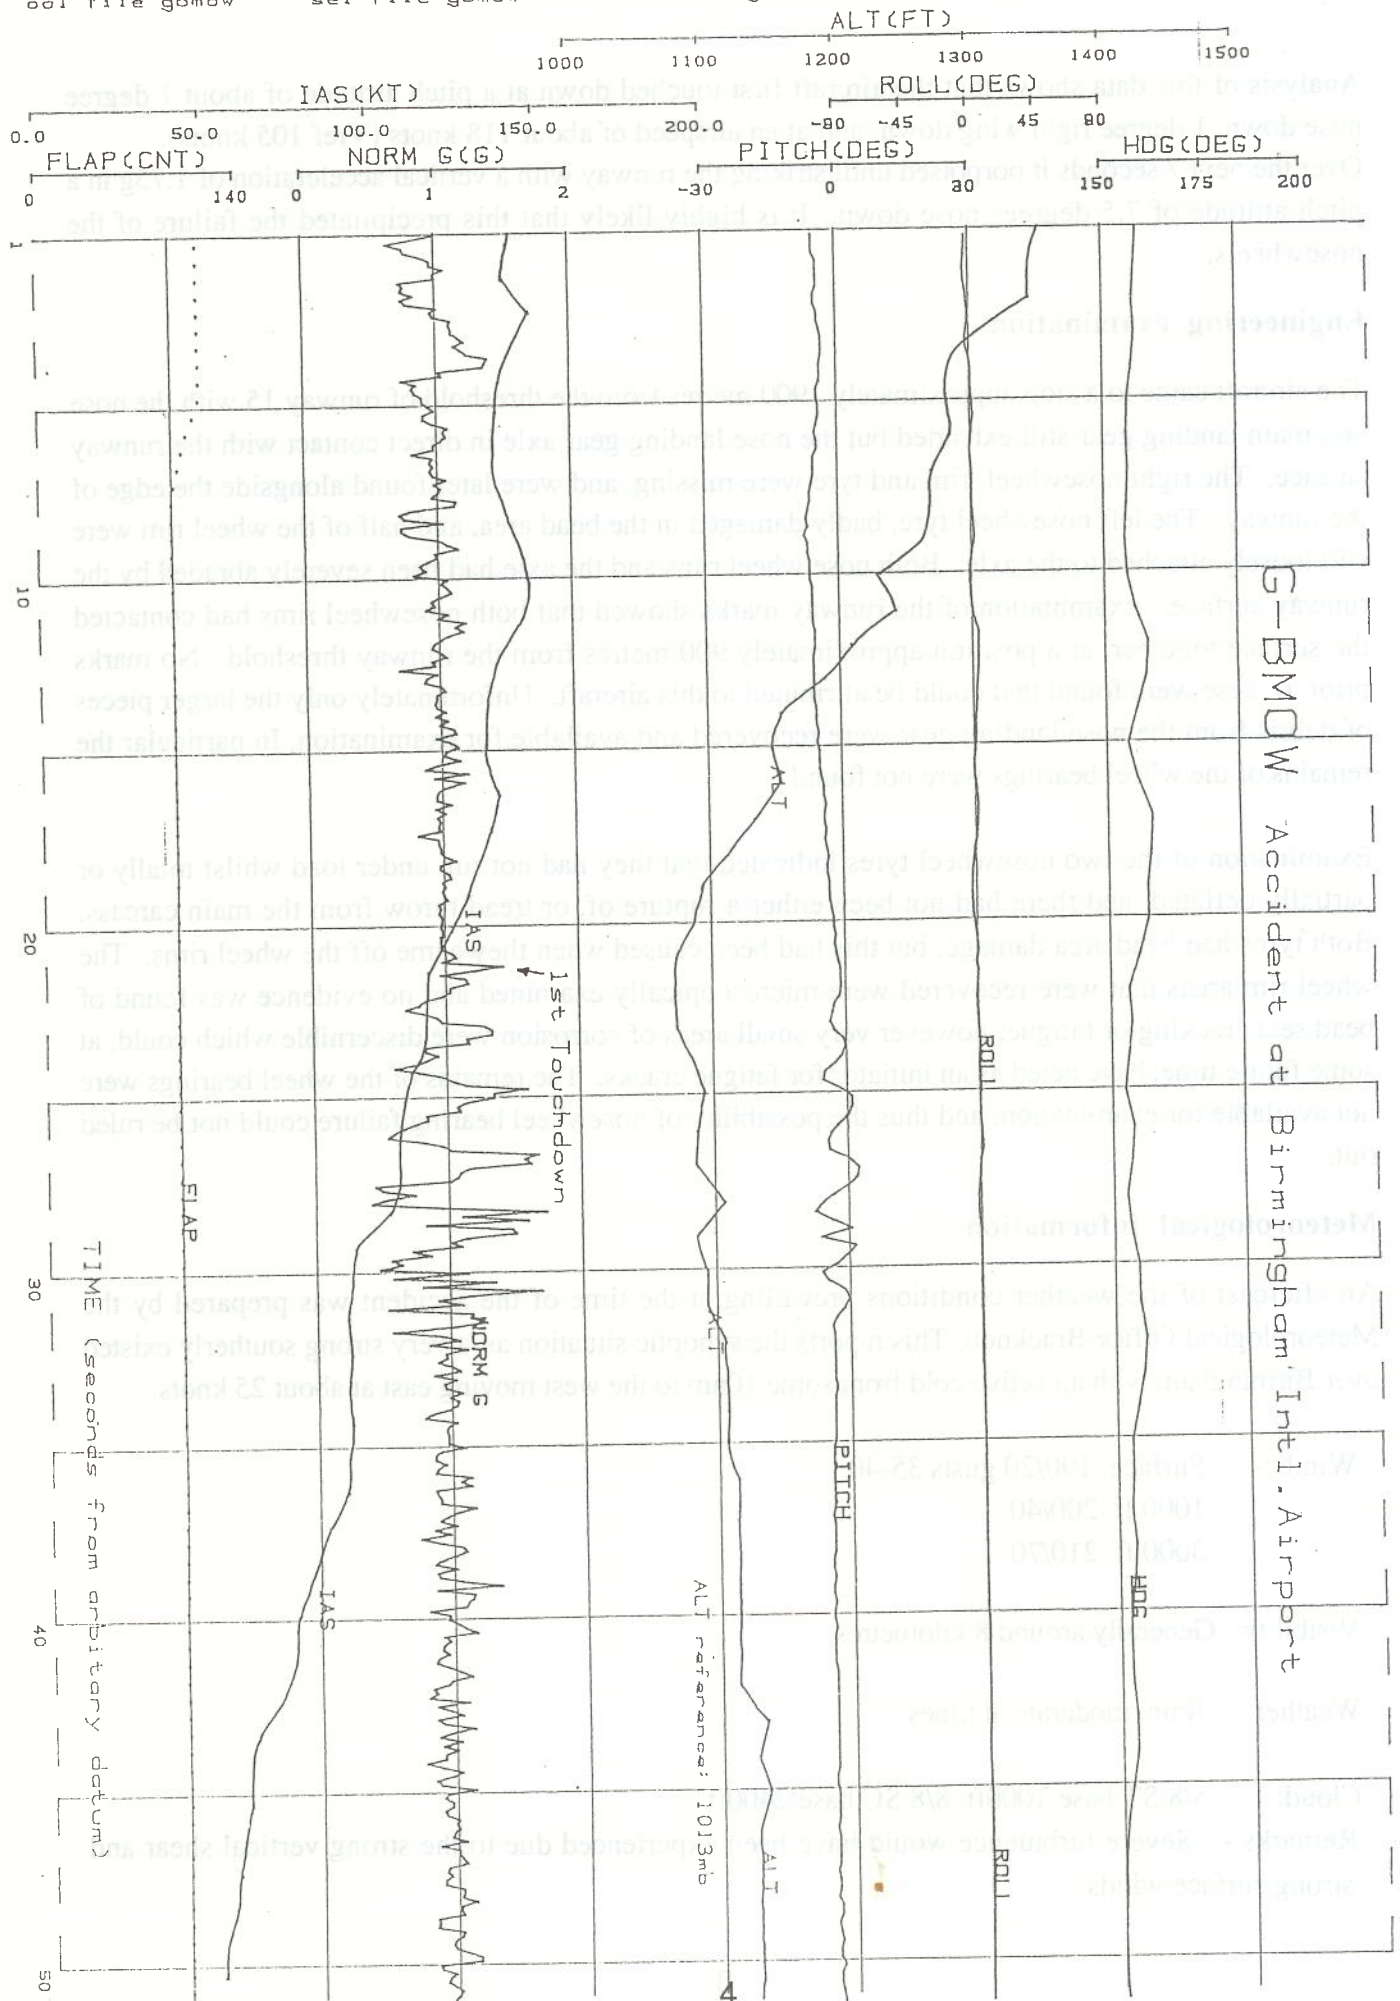
Air Accidents Investigation Branch.....plotted on Tue Mar 20 08:34:06 1990  
 ool file gbmow sel file gbmow dato file gbmowb

The Flight Data Recorder (FDR) was a Sundstrand UFDR which recorded 6 analogue parameters and 2 discrete events. The quality of the playback was good except that the airspeed trace was found to be outside tolerance. A summary of data relevant to the landing is included in graphical form at the end of this Bulletin. It should be noted that the airspeed trace, even after re-calibration, is considered to be accurate only within + or - 10 knots.

Analysis of this data shows that the aircraft first touched down at a pitch attitude of about 1 degree nose down, 1 degree right wing down, and at an airspeed of about 118 knots (Vref 105 knots).

Over the next 7 seconds it porpoised until striking the runway with a vertical acceleration of 1.75g in a pitch attitude of 7.5 degrees nose down. It is highly likely that this precipitated the failure of the nosewheels.
