SERIOUS INCIDENT

Aircraft Type and Registration:	Boeing 777-200, V8-BLF
No & Type of Engines:	2 Rolls Royce Trent 892-17 turbofan engines
Year of Manufacture:	2000 (Serial no: 30869)
Date & Time (UTC):	27 December 2012 at 1140 hrs
Location:	Over Broxbourne, Hertfordshire
Type of Flight:	Commercial Air Transport (Passenger)
Persons on Board:	Crew - 12 Passengers - 256
Injuries:	Crew - None Passengers - None
Nature of Damage:	Damage to right engine thrust reverser assembly
Commander's Licence:	Airline Transport Pilot's Licence
Commander's Age:	56 years
Commander's Flying Experience:	17,052 hours (of which 1,539 were on type) Last 90 days - 152 hours Last 28 days - 51 hours
Information Source:	Aircraft Accident Report Form submitted by the pilot and additional enquiries by the AAIB

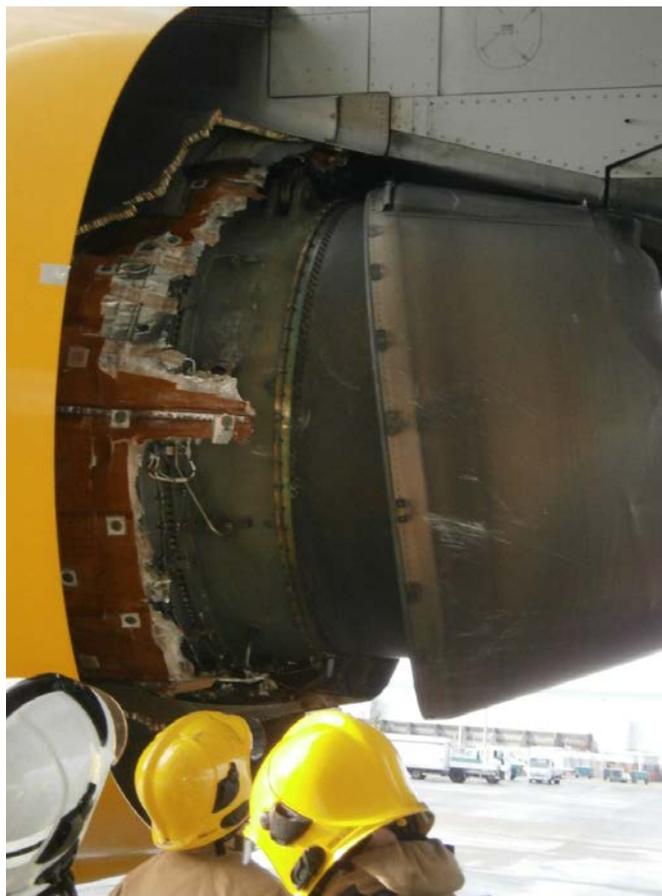
Figure 1

Upon examination, it was found that the right engine inboard thrust reverser half was missing a large amount of material from its inner wall and consequently, the exhaust nozzle had been damaged and was loosely attached (Figure 1). A considerable amount of the missing composite structure was recovered later that day from a property in Broxbourne, Hertfordshire. All parts, including the damaged reverser half, were despatched to the aircraft manufacturer for further examination.

Right engine thrust reverser showing material missing from inner wall and dislodged exhaust nozzle

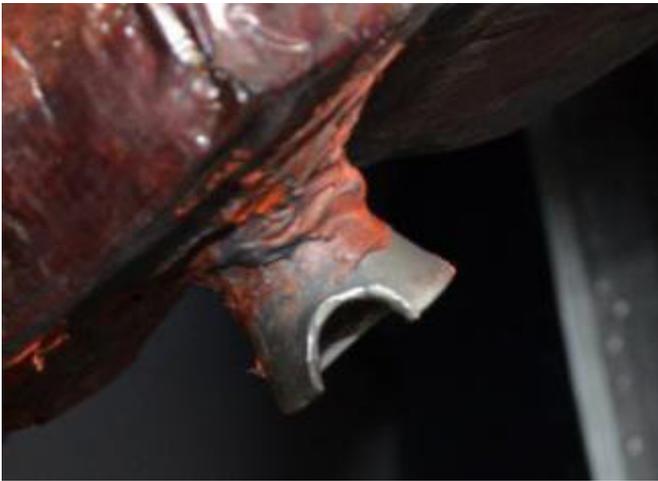
Figure 2

four compression rods which carry the hoop stresses in the inner wall was not correctly engaging the receptor cups when the thrust reverser was closed (Figure 2). Because of this, the end of the compression rod had damaged the insulation blanket in that area, although no evidence of associated heat distress was found, as well as wear to the hanger brackets (Figure 3). The manufacturer reports that the cause for the misalignment and subsequent incorrect engagement has not been determined, but that investigation continues.

Receptor cup showing witness mark where compression rod has not engaged (Boeing picture)

Whilst an additional inspection has been required to inspect for evidence of disconnection or wear in the compression rods, the manufacturer has devised a programme of thrust reverser inner wall replacement for reversers, because existing non-destructive test techniques may not reliably detect previous thermal damage. They further advise that the Federal Aviation Administration may mandate inner wall replacement on all Rolls-Royce powered Boeing 777 aircraft.

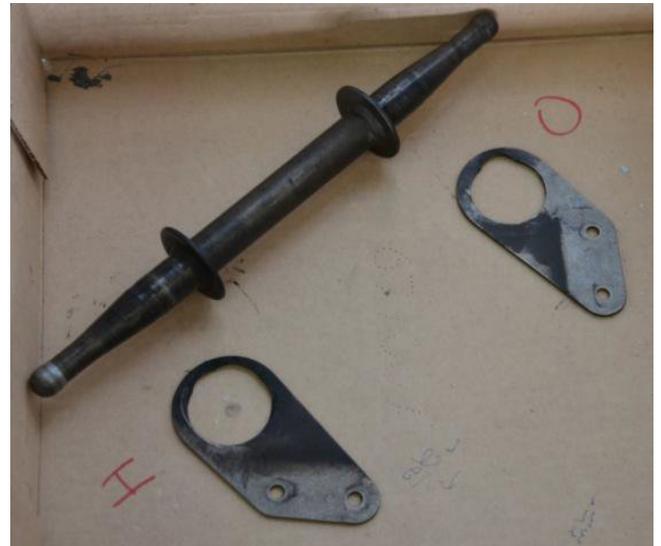
Figure 3

No.1 compression rod and worn hanger plates (Boeing picture)
