**No:** 4/92

**Ref:** EW/G91/12/04

**Aircraft Type and Registration:** Boeing 747-236, G-BDXE

**Nature of Damage:** Damage to leading edge flap section (No. 12) inboard of No. 2 engine

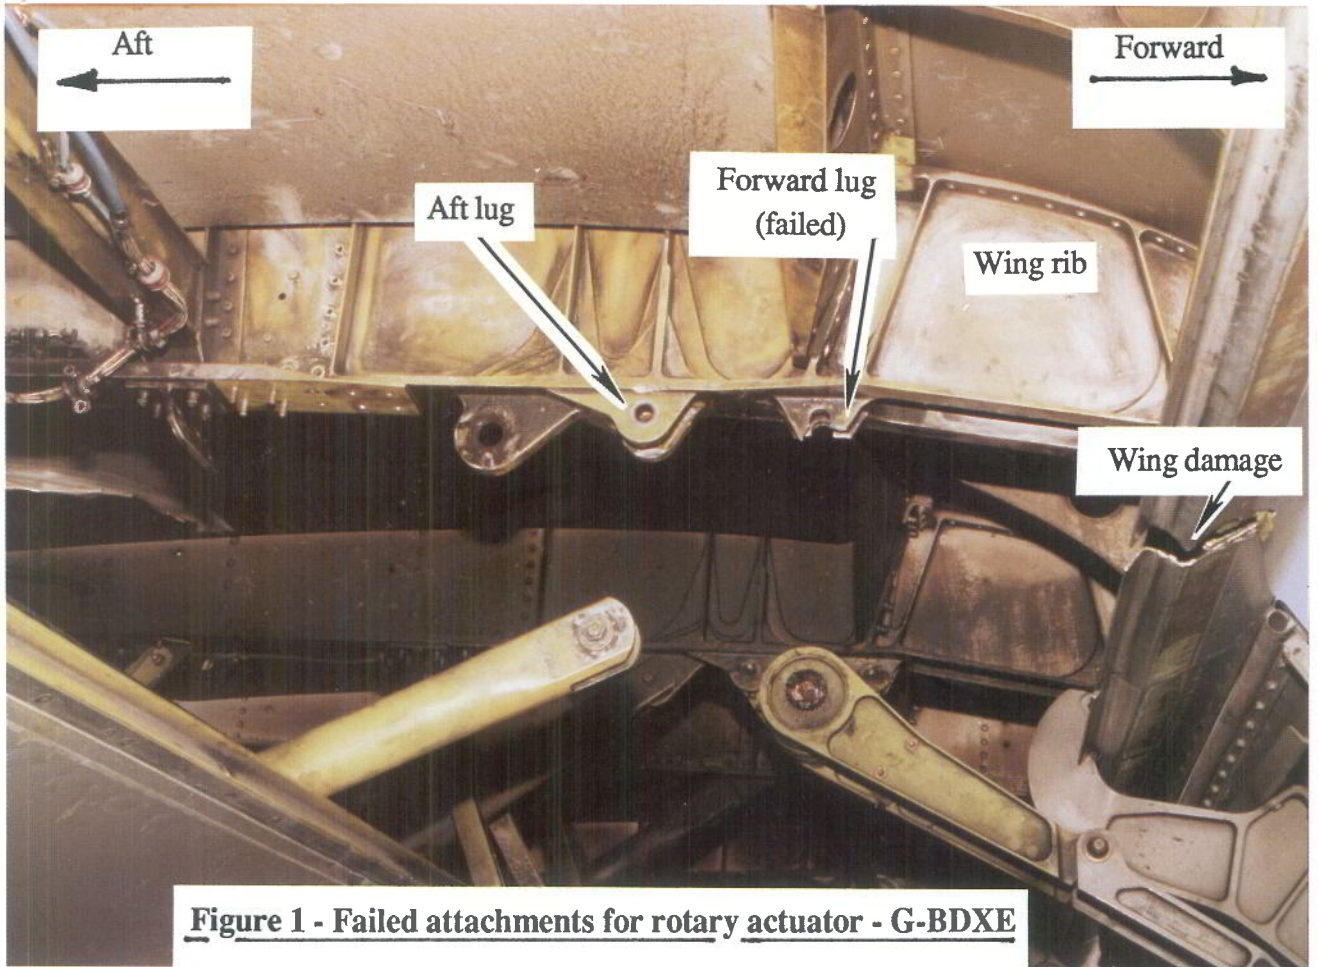
Further examination showed that one of the flap's two rotary actuators had become separated from its attachment lugs on the wing rib structure (Fig. 1). The rotary actuators connect the drive-shaft from the flap motor to the Krueger flap itself (Fig. 2) and each actuator comprises a simple gearbox and lever arm. The loss of one rotary actuator had allowed the flap's hinge arm to damage the wing leading edge while the flap was extended and had then prevented the flap from retracting properly.

The damage to the forward lugs and the lack of damage to the aft lugs (Fig. 1) showed that the initial event had been the separation of the rotary actuator from the aft lugs and that this had been followed by the overloading and failure of the forward lugs. Both of the corresponding lugs on the rotary actuator were intact, indicating that the separation at the aft lugs had occurred because of the migration of the stepped bolt out of the aft attachment. As there was no trace of the bolt, washer or lock-nut, it could not be determined exactly how the bolt had been free to migrate and whether or not the lock-nut and washer had been correctly installed.
