## Cessna 120, G-BRJC

<b>AAIB Bulletin No: 4/2004</b>	<b>Ref: EW/C2003/09/08</b>	<b>Category: 1.3</b>
<b>Aircraft Type and Registration:</b>	Cessna 120, G-BRJC	
<b>No &amp; Type of Engines:</b>	1 Continental C85-12F piston engine	
<b>Year of Manufacture:</b>	1946	
<b>Date &amp; Time (UTC):</b>	20 September 2003 at 1412 hrs	
<b>Location:</b>	Cromer (Northrepps) Airfield, Norfolk	
<b>Type of Flight:</b>	Private	
<b>Persons on Board:</b>	Crew - 1	Passengers - 1
<b>Injuries:</b>	Crew - None	Passengers - None
<b>Nature of Damage:</b>	Damage to landing gear, wings, engine and propeller	
<b>Commander's Licence:</b>	National Private Pilot's Licence	
<b>Commander's Age:</b>	51 years	
<b>Commander's Flying Experience:</b>	239 hours (of which 180 were on type)	
	Last 90 days - 4 hours	
	Last 28 days - 1 hour	
<b>Information Source:</b>	AAIB Field Investigation

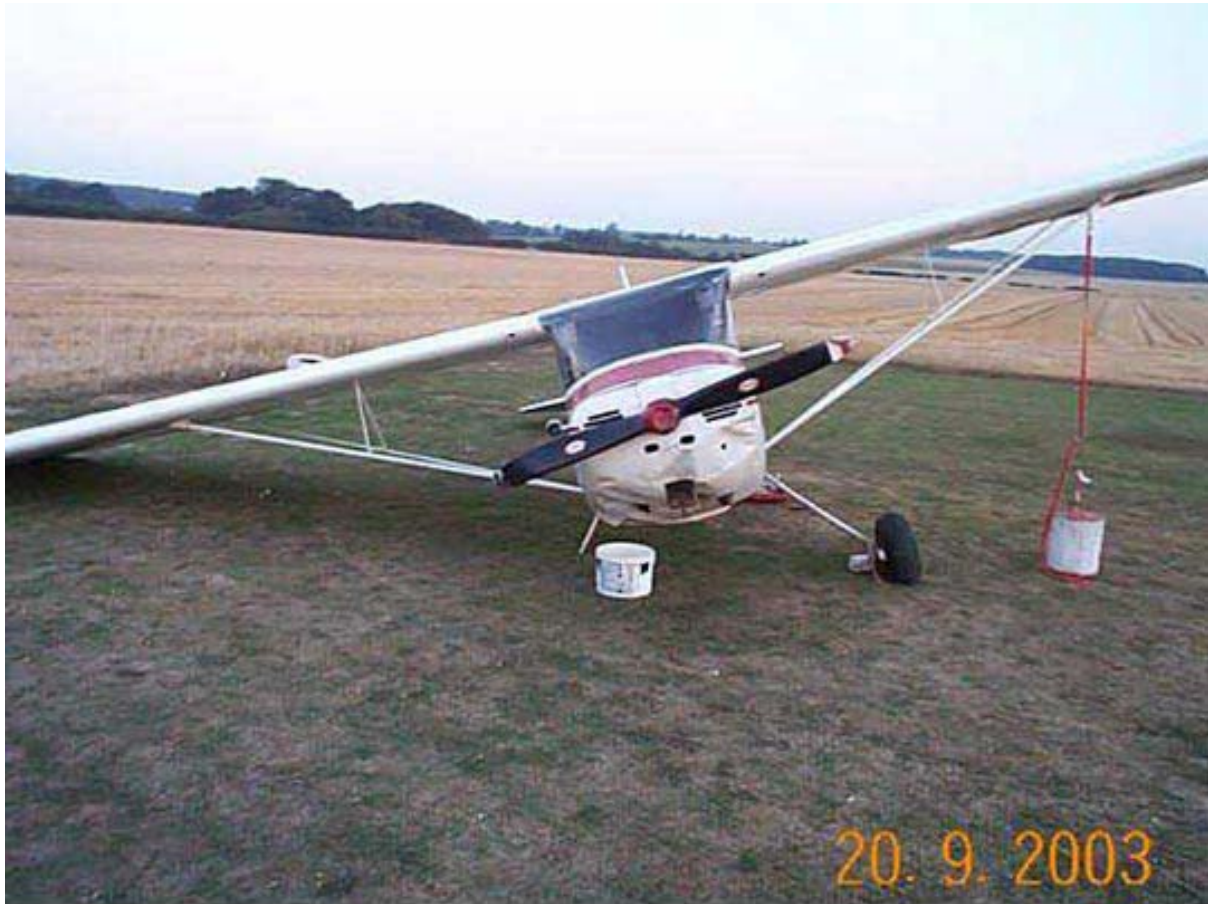
It was immediately clear that the right landing gear leg had fractured (Figure 1) and that the stub of the leg had supported the aircraft during its slide. The initial concern was that the aircraft had hit the embankment but there were no marks to confirm this impact and there were ground marks indicating that both wheels were still in place when the aircraft touched down on the runway.

Figure 1 - Failure of right gear leg on G-BRJC

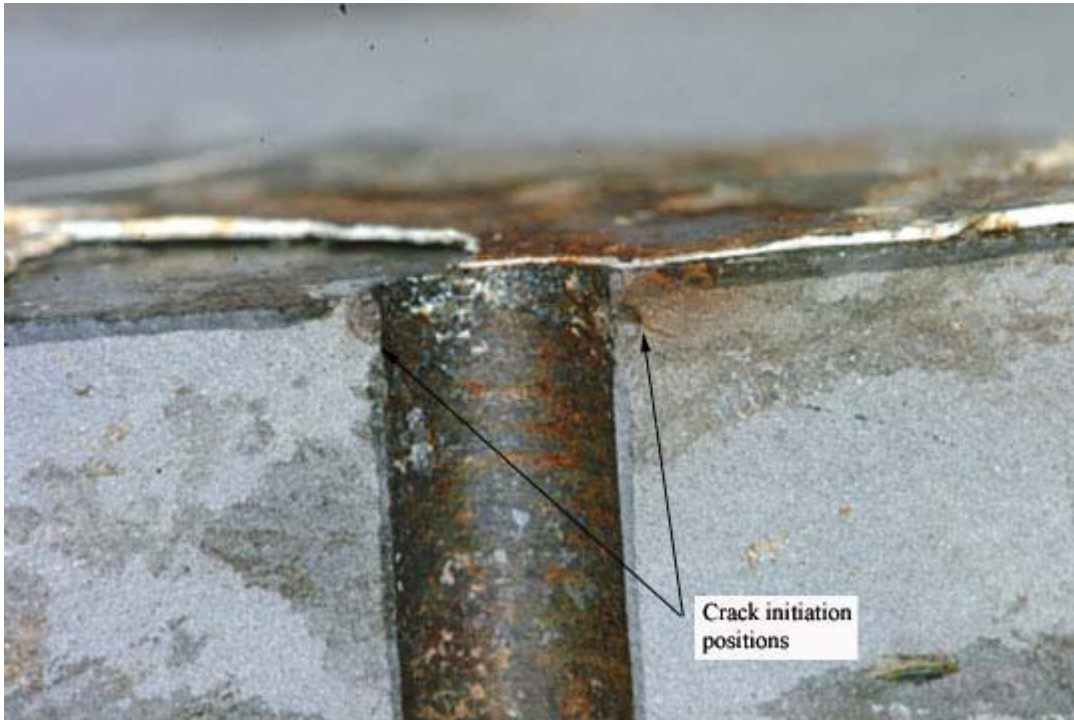
The surface of the fracture was examined in detail by an independent metallurgist. He detected areas of fatigue crack initiation (Figure 2) within the lower end of the bolt hole, in each case associated with corrosion damage within this hole. These areas extended only about 0.7 mm into the plate material but were sufficient, in this type of high tensile steel, to initiate an overload failure through the material. The failure itself was a simple bending mechanism, consistent with the repeated application of tensile landing loads into this lower surface of the leg. There was also substantial corrosion in the area of contact between the step assembly and the landing gear leg.

Figure 2 - Detail of fracture face (G-BRJC)

Examination of a prepared cross-section of the leg material indicated that the steel was a hardened and tempered low-alloy steel. There was, however, evidence of surface decarburisation, possibly occurring during the heat treatment of the material. Vickers hardness tests suggested that the depth of this layer was about 0.8 mm and would have led to a substantial reduction in the tensile strength of this layer. The aircraft's records show that it was manufactured in 1946 and indicate that there had not been a change of landing gear leg during the aircraft's life.
